# The October 13, 2010 Landslides on the Azenge Mountain in Imande Ukusu, Nkomon District, Benue State, Nigeria

Ako Thomas Agbor\*, Abba Francis Mohammed, Onoduku usman Shehu, Nuhu Waziri Musa, Alabi Adekola A., Mamodu Adegbe

Department of Geology, School of Natural and Applied Sciences, Federal University of Technology, Minna, Nigeria

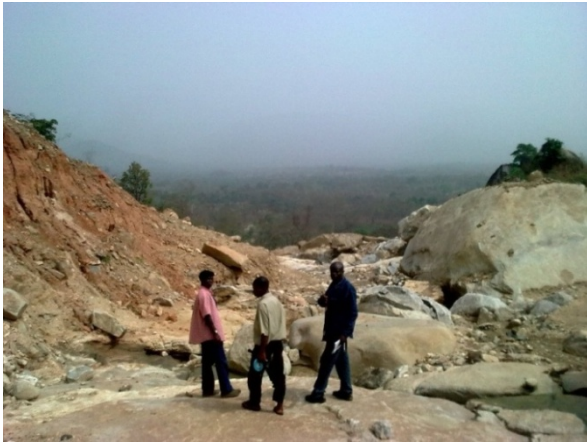
**Figure 3.** Photograph of major landslide out of the fourteen that occurred in the area

The landslide scar increased in width from the top (20m) to the base (75m) with an average depth of 58.73m and a total length of 950m. The largest boulders moved measured 15m long, 10.6m wide and 52.5m high (Figures 7a and b ). The sites of the 14 slides correspond to old fault planes

which have acted as conduits for the flow of water.

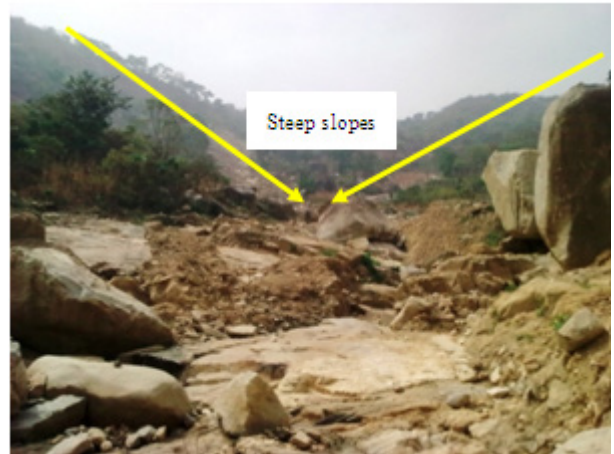
**Figure 5.** Photograph of steep slopes the facilitated the movement of material down slopes

Slope and topography are seen as the main morphological factors that triggered the landslides of Azenge Hills in Nkomo District of Benue State. Field measurements indicated that the area is characterized by steep slopes ranging from  $17^\circ$  at the top to  $50^\circ$  at the base, deep valleys and generally rugged relief. This type of slope angle greatly affects the relative magnitude of the driving force on slopes. As the angle of potential slip plain increases, the driving force also increases, thus, landslides should be most frequent on steep slopes. A study of landslides that occurred during two raining seasons in California's San Francisco Bay area established that 75 to 80 percent of landslide activities is closely associated with urban areas on slopes greater than 15% or  $8.5^\circ$  [20].

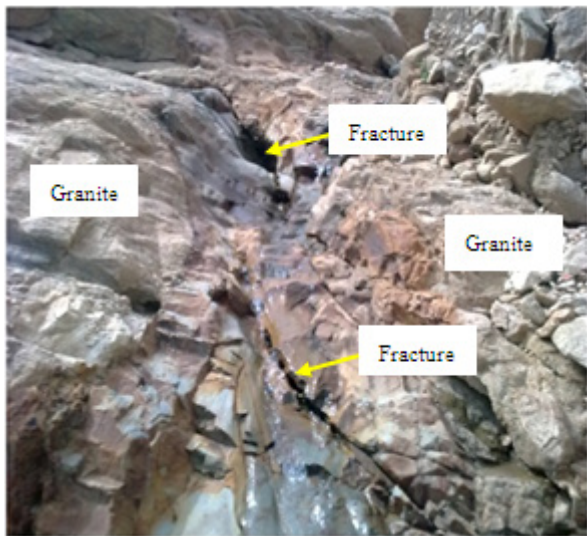
The rock types encountered in the area include gneisses, granites, dolerite dykes and basaltic rocks. Field evidence indicated the existence of granites, gneisses and dolerites lying uncomformably on basaltic rocks. The rocks in the study area have a general strike of 340°NW with a dip of 038°NE and were highly fractured. The deep and penetrating

fractures in the rocks must have brought about gradual weathering (Figure 4). This resulted in slow but steady decrease in the strength of the materials, thus increasing the likelihood of sliding along slopes with gradients of 50° from the top to 5° at the toe (Figure 5).

**Figure 4.** Photograph of fractures that permit water to percolate and cause weathering and weakness of the rock unit

The presence of too many fractures on both the rocks that were moved and those in the adjoining area suggests fractures in the rock provided passage for weathering fluids (Figure 4). Fractures in the rocks acts as common translational slip planes. The presence of some clay minerals along some fracture zones in the rocks supports the view that the landslides occurred as a result of absorption of water by these clay minerals [14, 18].

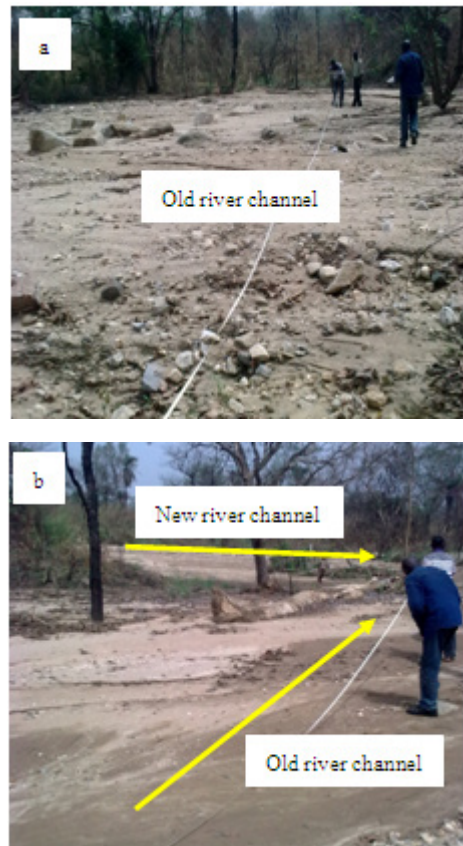
The materials from the slide were made up of fine debris to large fragments of the granitic and gneissic basement complex which has been intruded by dark coloured rocks believed to be volcanic rocks. The materials were deposited along the sliding path and the grain size of the materials decreases from the top to the bottom of the hill. The materials that were moved to the foot of the hill were deposited in the bed and flood plain of the then existing river with a width of 38.5m (Figure 6a). The deposition of the materials resulted in the diversion of the river course and development of a new river tangential to the old one (Figure 6b). Materials deposited were mainly small rock fragments, sand, mud and dead plant materials. The saturated soils following heavy rainfall acted as a lubricant for the materials to move rapidly and in mass down slope. The Azenge Mountain where the

**Figure 6.** Photographs showing (a) materials deposited on the then river valley and (b) the development of a new river valley tangential to the old one

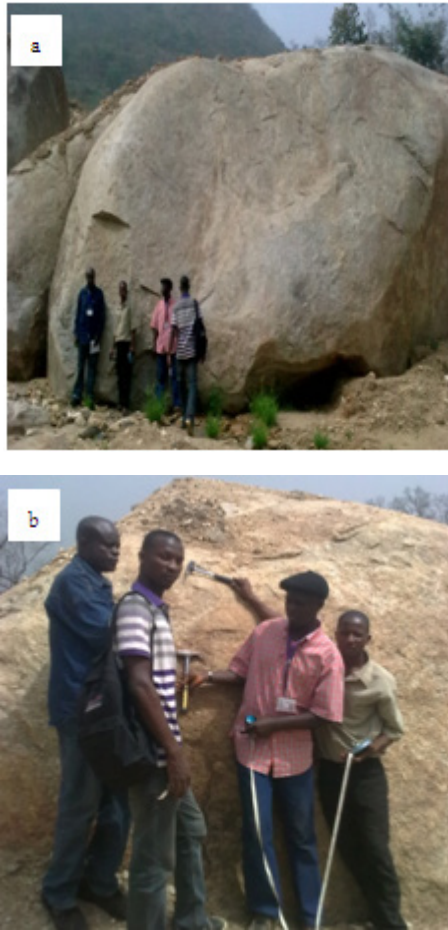
**Figure 7.** Photographs of boulders moved down slope (a) has a diameter of 71.2 m while (b) has a diameter of 88.5m. Size of materials moved decreases down the slope.

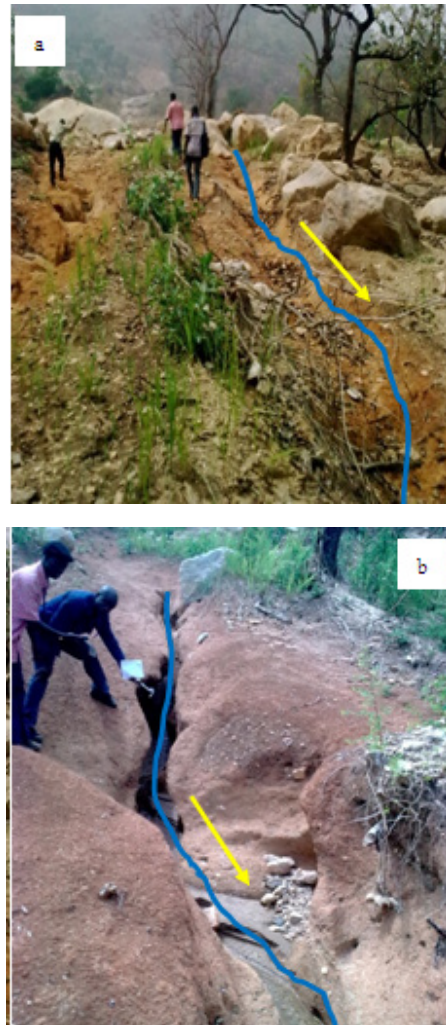
Human activities like farming and lumbering have been taking place within the area where the sliding occurred. The erosive action of the river and flood waters at the toe or foot of the hill was very visible as small and steep gullies appeared within the area where the landslides occur (Figures 8a and b).

**Figure 8.** Photograph of gullies produced (a) at the top and (b) at the foot of the hill. Note the that depth and width of the gullies increases from the top to the foot of the hill

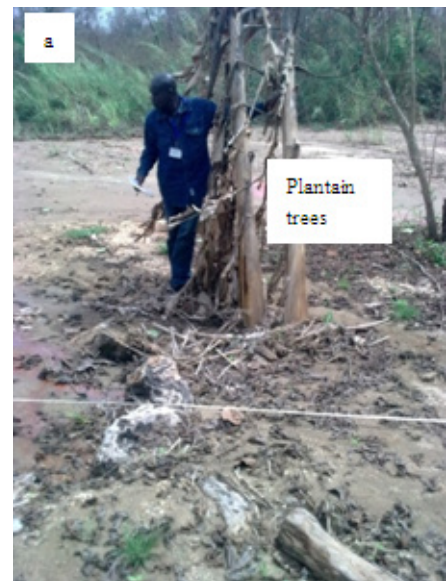
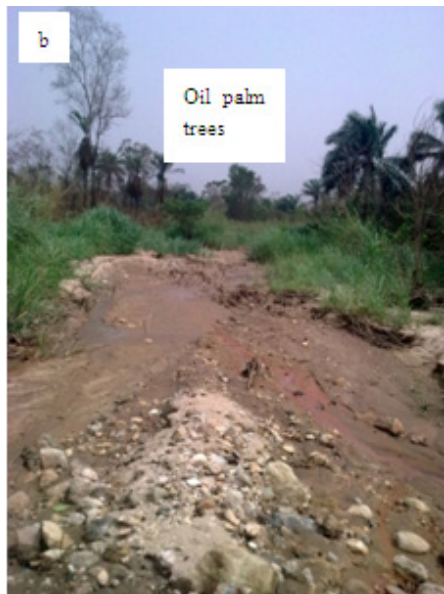
Field investigation equally showed that three rice farms, plantain and yam farms of about 200 square km and a large

number of palm trees and other economic trees were destroyed (Figures 9a and b).

**Figure 9.** Photograph of (a) plantain and (b) oil palm trees destroyed by the landslide

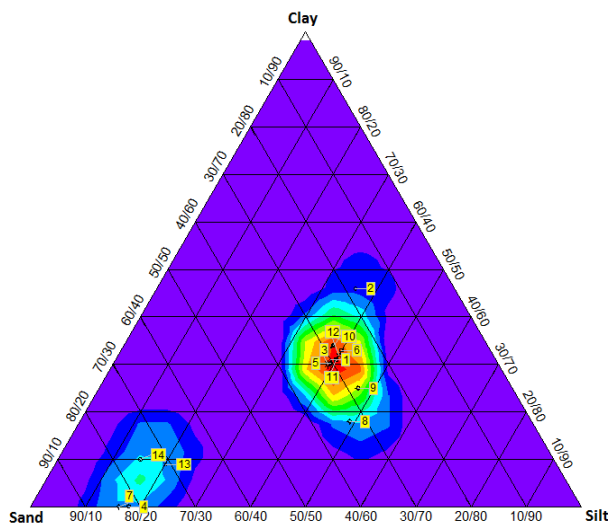
**Figure 10.** Plots of results of grain size analysis showing two groups of soils based on their susceptibility to sliding (modified from [12]).

The results of sieve analysis of the fourteen soil samples collected from the landslides site is presented in table 1 and plotted figure 8. These show that the soil display a wide range of grain sizes including clay, silt and sand fractions. However, most of the samples (1,2,3,5,6,7,8,9,10,11, and 12) are composed of mainly clay sized particles (Table 1). They are interpreted as soils of grain sizes that are mostly

susceptible to sliding. These soils combined with water act as lubricant. A plot of these samples on the grain size triangle (Figure 10) reflects soil with very high degree of susceptibility to sliding above the sliding surface. However, four samples (i.e. 4, 7, 13, and 14) that were collected below the sliding and away from the sliding surfaces are mostly made up of sand and are less susceptible from sliding and plot outside the failure zone. These samples tend to be predominant of one grain size fraction that tends to cause instability within the unit (Figure 10).
