Exploring the Circle of Consumption Around Reused Construction Demolition Waste: Evidence from Construction Sites

Sokolayam F. Akale^a, E. I. Daniel^b, Oluseun O. Olubajo^a

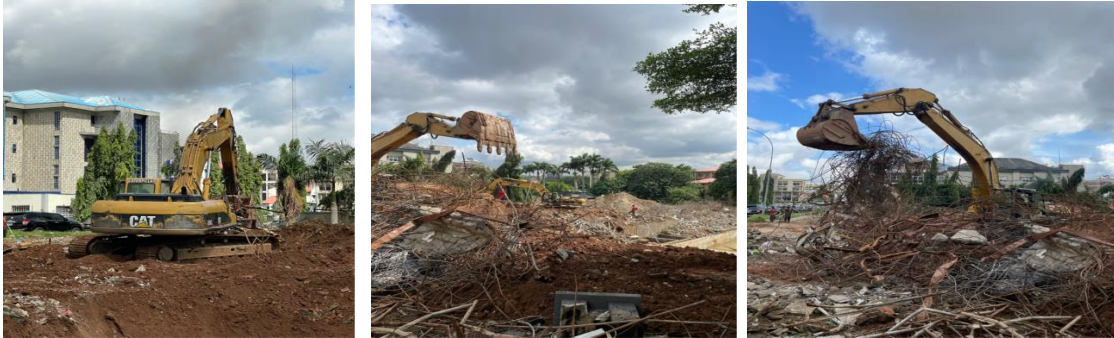
Figure 1, 2 and 3: Pictures showing two operators with the backhoe excavators demolishing and clearing

This statement shows that there was not enough room for the team of professionals on site to dismantle or deconstruct carefully the many components before the building collapsed. Due to the unexpected collapse of the structure, many reusable components that were fragile were damaged and scattered on site such as glass windows, aluminium frames and electrical fittings. They operators used the arm of the backacter and discharge bucket to dig into the collapse debris, break further the concrete elements into rubble and move the reinforcements to a set location with the assistance of the labourers. This is evidenced in figure 3 below. The fragile or shattered component such as broken glass, broken blocks, broken tiles and concrete rubble were packed together and heaped at the designated places on the site. This is evidenced in Figure 1 and 2 below.

Other components that were not fragile and survived the impact of the collapse were carefully removed by the labourers and kept openly on site because they had potentials of being reused. The labourers sorted out the items the recovered items into three main categories: wood/furniture were placed in a specific point; reinforcement rods were placed at another point and utility components were placed at another point.
