Architect's and Geologist's View on the Causes of Building Failures in Nigeria

Article in *Modern Applied Science* · May 2012

Amadi A. N.¹, Eze C. J.², Igwe C. O.³, Okunlola I. A.¹ & Okoye N. O.¹

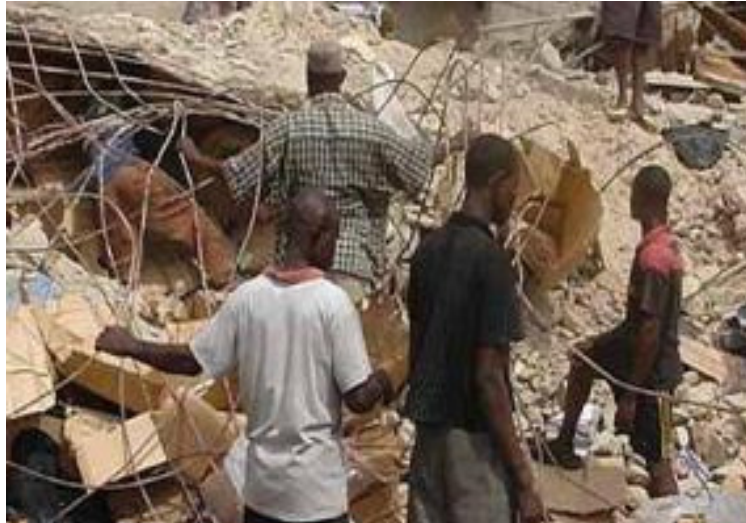
Figure 1. A collapse building due to use of sub-standard material (Source: Author, 2012)

A building is a structure that serves as shelters for man and his activities in an environment (Tauheed, 2007). Building can be defined as a roofed and walled structures built for permanent use for man's living, working and storage (Encyclopaedia Britannica, 2004). In order to obtain the desired satisfaction, comfort and safety, every building whether temporary, permanent or monumental structures needs to be properly designed, well planned, constructed and maintained. According to Hornby (2001), failure is defined as non-occurrence, running short, ill success, breaking down, in solvency and unsuccessful attempt. Building collapse is a global phenomenon. Oyewande (1992) observed that building failures are attributed to the following causes: design faults (50%), faults on construction site (40%) and product failure (10%). While Akinpelu (2002) categorized the following as major causes of structural failures: environmental changes, natural and man-made hazards; improper presentation and interpretation in the design. Failure could occur in the form of partial or total collapse of the structure as illustrated in Figure 1.

The use of sub-standard (inferior) material in building construction account for about 10% contributing factor to cases of collapse building in Nigeria (Oyewande, 1992). Poor mixing of concrete aggregate, poor quality steel reinforcement and use of sub-standard blocks from some block industries contribute their own factor to building collapse in Nigeria. Some of these constructional materials did not meet specified standard nor any quality control checks conducted on them before they are used for the construction. The frequent use of inferior and untested local building material leads to structural failures in buildings as shown below.

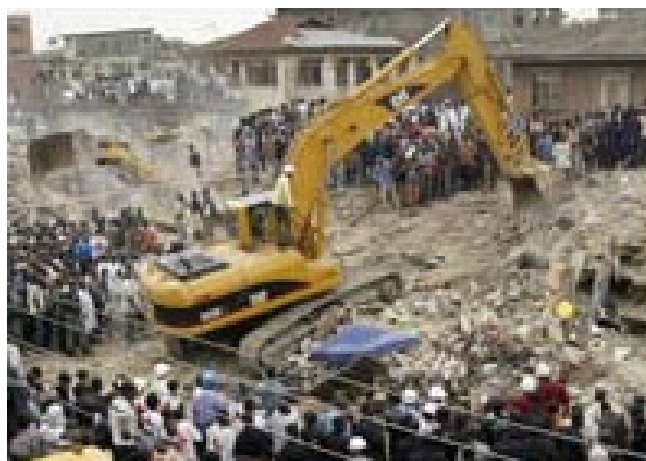
Figure 2. Collapsed building arising from foundation failure (Source: Author, 2012)

All engineering works start with the foundation. The purpose of a foundation is to transfer the load of structure to the ground without causing the ground to respond to uneven or excessive movement. Such load must be transferred in such a way that there will be no shear failure in the underlying soils. Many buildings have collapsed due to faulty foundation (Figure 2). Most of the foundations in Nigeria are designed without considering the soil type on which they rest upon. Therefore, it is vital that adequate soil investigation should be carried out before designing of foundation in-order to have a suitable design to suit the local geology of the area.

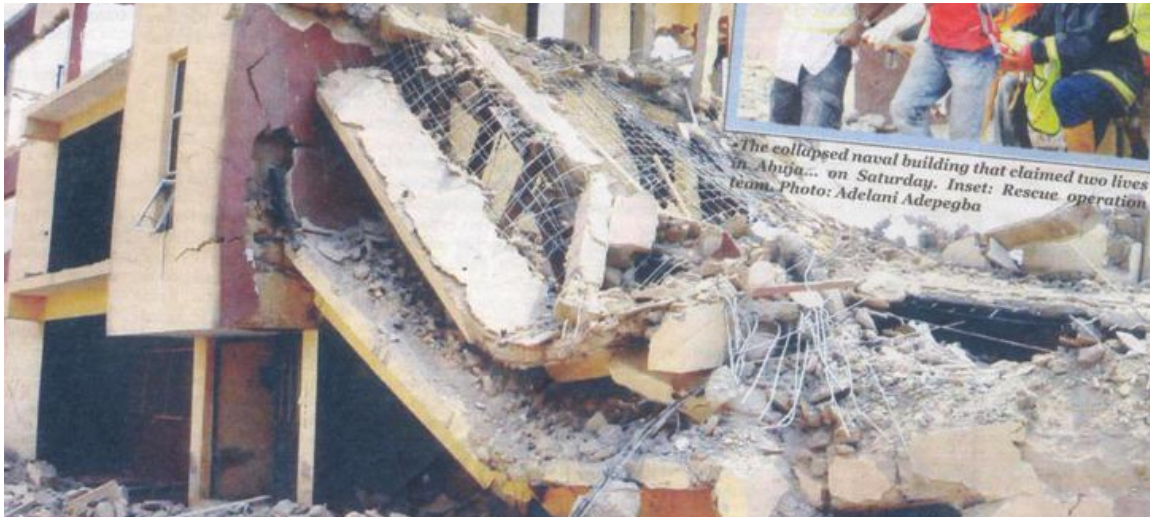
Figure 3: Building collapse as result of engagement of quacks/non-professionals (Source: Sunday Sun Newspaper of January 29, 2012)

A number of professionals (stakeholders) exist in the building industry, but in most cases their services are not sought for due to one reason or the other, such professionals include: Architects, Quantity Surveyors, Land Surveyors, Builders/Contractors, Engineers (Structural, Civil, Mechanical, Electrical, and Geotechnical). It has been observed that due to high cost of consultancy fees needed to engage the services of these professionals, most Nigerians prefer to cut cost by engaging the services of non professionals (quacks) who lack the needed experience in construction sector. This is reflected in poor workmanship and low standard of construction, which results in structural failure and collapse of part or the entire building. Take for instance, the recent loss of human lives in the collapse of two storey building located at road 45, 1st Avenue Gwarinpa, Abuja on the 28th of January, 2012; according to 'Sunday Sun Newspaper' of January 29, 2012 on page 11; the collapse was as a result of involving non-professionals in the demolition of the said building for further renovation which led to collapse of the structure (Figure 3).
