Integrated Geology, Mineralogy and Geochemistry Investigations of the Minna-Tegina-Makera Road North Western Nigeria: Implication on Failed Portion

Department of Geology, Federal University of Technology, Minna

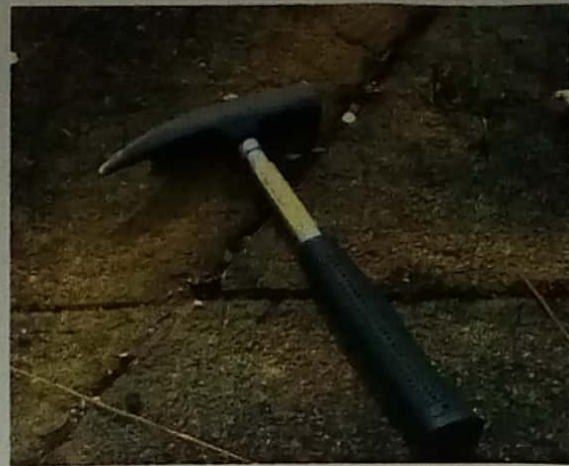
Plate II: Jointed granite in Maikunkele

The rock that underlain the stable road sections are made up of granite-gneiss, granites, amphibole schist and quartz schist and sandstone while the failed road sections are underlain by mica schist, phyllite and coarse grained granite (Plate I). Structurally, most of the granites are open jointed (Plate II) and in some areas dissected by quartzofeldspathic veins. The granitic rock underlies about 45% of the study area while phyllite, schist and amphibolite schist are about 45% and sandstone 5%. Schist is strongly foliated ranging from muscovite schist to biotite schist, trending in NE - SW and occurred mostly in the northern section of the study road network. In hand specimen the schist varies from leucocratic to melanocratic, the leucocratic show effects of chemical weathering (Plate III). Amphibolite schist occurred in Zungeru inter-layered with quartz schist and mylonite, this rock is restricted to Zungeru area and a times seen intruding the schist (Plate IV). Phyllite are also common in the northeast and northwest sections of the study area and are closely associated with schist, characterized by a silky sheen on the cleavage surface and show evidence of intensive weathering at the surface where they outcrop. Field evidence along the study road network show that the failed road section is underlies by mica schist, porphyritic granite and phyllite. The fairly stable section is underlain by granite while the stable section is underlain by medium grained granite/granite-gneiss, amphibolite schist and sandstone.

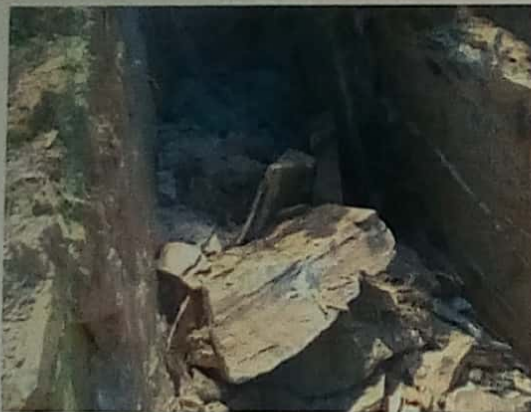
Plate III: Weathered Leucocratic schist

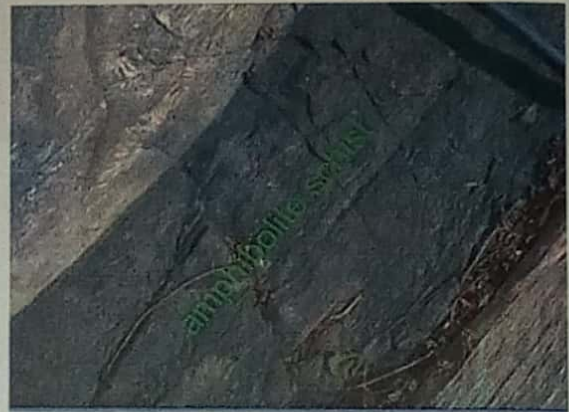
Plate IV: Intruded amphibolites

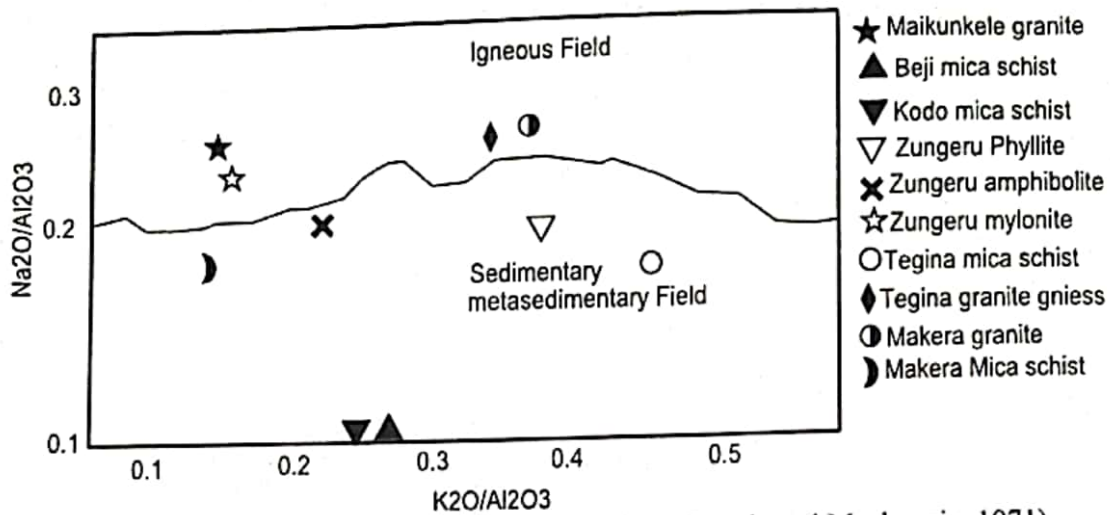
Figure 7: Na₂O versus K₂O plot for study area rocks (after Garrels and Mackenzie, 1971)

Geochemical binary plot of Na₂O/Al₂O₃ versus K₂O /Al₂O₃ show that the mica schist, phyllite and amphibolite schist are of sedimentary provenance while granite and granite gneiss are of igneous provenance (Figure 7).

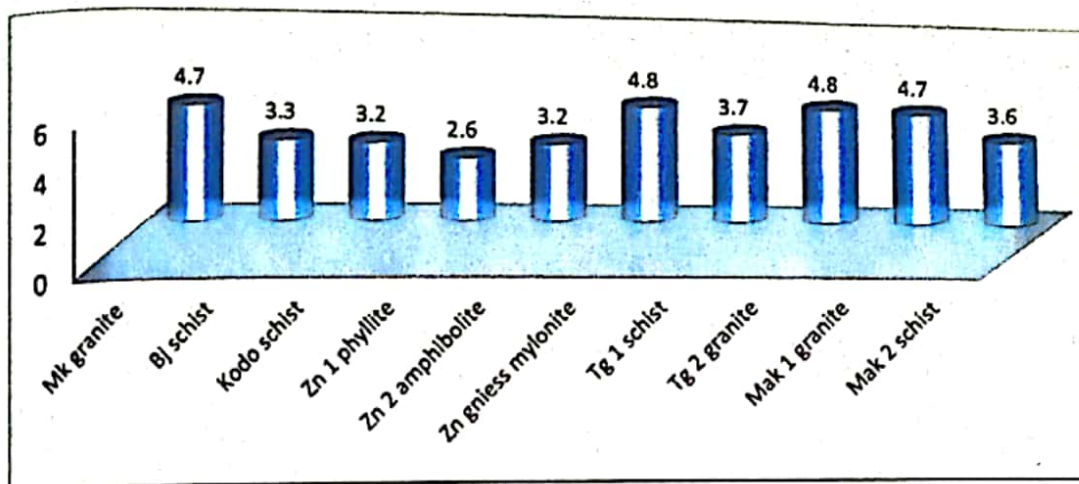
Figure 8: Weathering Intensity for study area adapted from Ruxton (1968)

Weathering intensity of igneous and metamorphic rocks in humid climatic region can be determined using Ruxton Ratio (SiO₂/ Al₂O₃) proposed by Ruxton (1968). He proposed Ruxton Ratio value of <3.8 for intensively weathered rocks, 4 – 4.5 moderately weathered rocks and >4.5 least weathered rocks. The Ruxton Ratio values of between 2.6 – 3.7 revealed the mica schist of Tegina, Makera, Kodo, Beji, Zungeru phyllite and Zungeru amphibolite schist to have been intensively weathered and constituted the underlying basement rocks of the failed sections of the study road networks while values of between 4.7 – 4.8 revealed the granite/granite gneiss of Maikunkele, Tegina, and Zungeru mylonite to be of least weathered intensity constituted the underlying basement rocks of the stable section of the study road networks (Figure 8).
