#### **Application of GIS as Support Tool for Pavement Maintenance Strategy Selection**

Keywords: Pavement condition, Pavement maintenance, GIS, Decision making

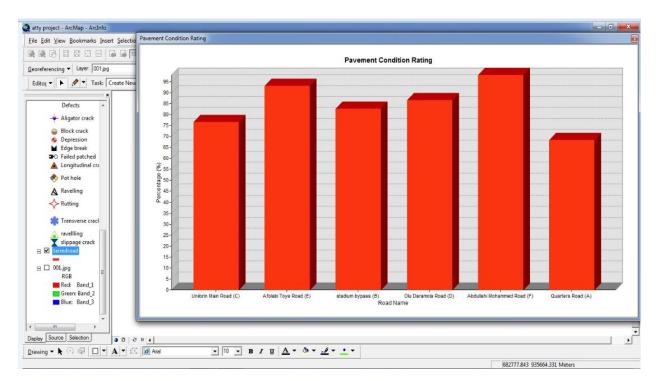
Fig. 7: Pavement condition rating of the road network

The pavement condition of each section of the road network was queried by the GIS and the result is shown in Fig. 7.

The results obtained from the analysis of the collected data and the pavement condition rating, gave the level of maintenance required in ascending order as Section A, Section C, Section B, Section D, Section E and Section F. The prepared budgets of each section clearly showed the financial implication of implementing maintenance program. The use of GIS in the management of pavement condition rating data allows for several analyses, queries and both visual and graphical display of information which lend their support to decision making.
