Abuja Journal Of Geography And Environmental Management Volume 5, No. 2, June 2019

ASSESSMENT OF THE GULLY EROSION AND DISASTER RISK IN RAFINGORA AREA OF KONTAGORA, NIGER STATE, NIGERIA

Dukiya J.J., Muhammed M., Ojoye S., Musa J., and Morenikeji G.

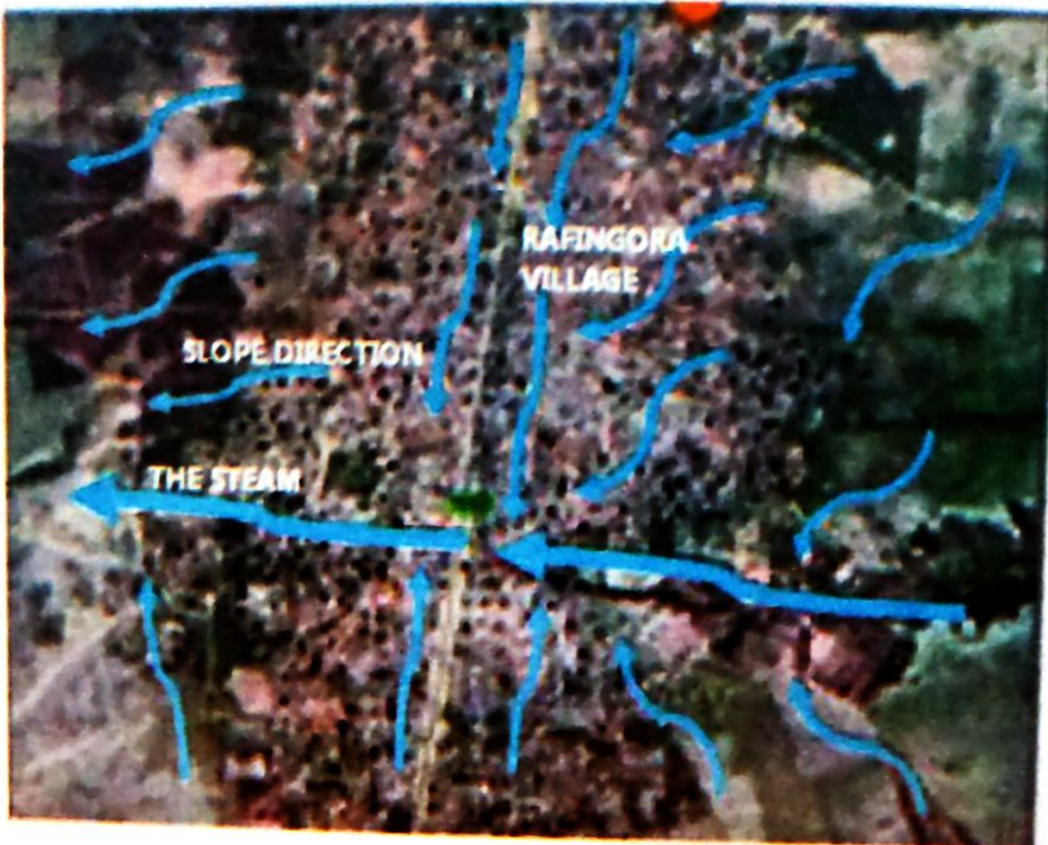
Figure 2. slope analysis of Rafingora village.

The topography of Rafingora and Babarami is of a gentle slope from all the directions toward the central part of the village. The nature of the soil surface enhances the development of rivulets and tributaries that are filled with sand flow from the northeastern and northwestern parts of the village up hills. These elevated areas of about 300m above sea level are highly degraded due to overgrazing and farming activities. The entire village is well drained with evidences of dry valleys as illustrated in Fig. 2 This is in consonant with the works of Michaelides et al (2012) and Turnbull et al (2011) that long slopes (especially those without adequate vegetal cover) are more susceptible to very high rates of erosion during heavy down pour than shorter, less steep slopes. Steeper terrain is also more prone to mudslides, landslides, and other forms of gravitational erosion processes.

The field observation further reveals the pattern and the rate at which the erosion activities are changing the morphology of the entire area. For instance, the eroded channels from the hills at the northwestern part of the village were less severe to an average breadth and debt of about 2.6m and 1.6m respectively. These channels toward the built up areas were later widely distributed forming a network of various channels with breath and height of about 4.0 to 1.8m within the village. At the eastern part of the village, the erosion activities were so prominent and severe, and this was where lives and houses were lost to flash flood in July, 2018.

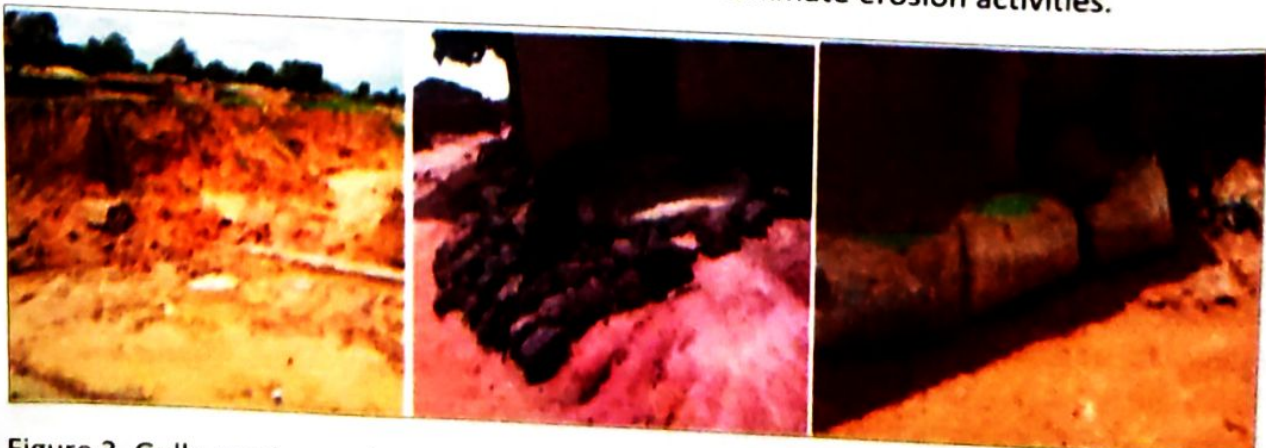
Figure 3. Gully erosion and sandstone used as foundation embankments in Rafingora.

The inhabitant of Rafingora majorly lives in mud houses. The physical examination and oral interview of the people revealed that the walling materials of their buildings were excavated from the major stream valley within the village. In other scenario, sand stone were also excavated from the stream valley to buttress their building foundations to mitigating the impact of gully erosion as revealed in Fig. 3. The only consolidated sand stone available in the area is been excavated by the villagers and this has made the entire area more vulnerable to gully erosion. The farming system is dictated by the short duration of the raining season of about three months effectively. Amidst of this, the villagers still depend on fuel-wood for their domestic energy supply. Apart from mango trees and other trees like lime, the entire area is covered with patches of grasses. There is therefore no cover crop after rain-fed harvest to checkmate erosion activities.

- i. The people residing in the eastern part of Rafingora should be evacuated to a more stable land so as to avoid the next unforeseen disaster associated with landslide
- ii. Mining of building material and excavation of sand stone from the drainage channels should be totally discouraged as more erosion problems are being created by so doing.
- iii. Retention walls and effective artificial drainage system should be constructed within the village to reduce the impact of runoff, while advocating for special tree planting.

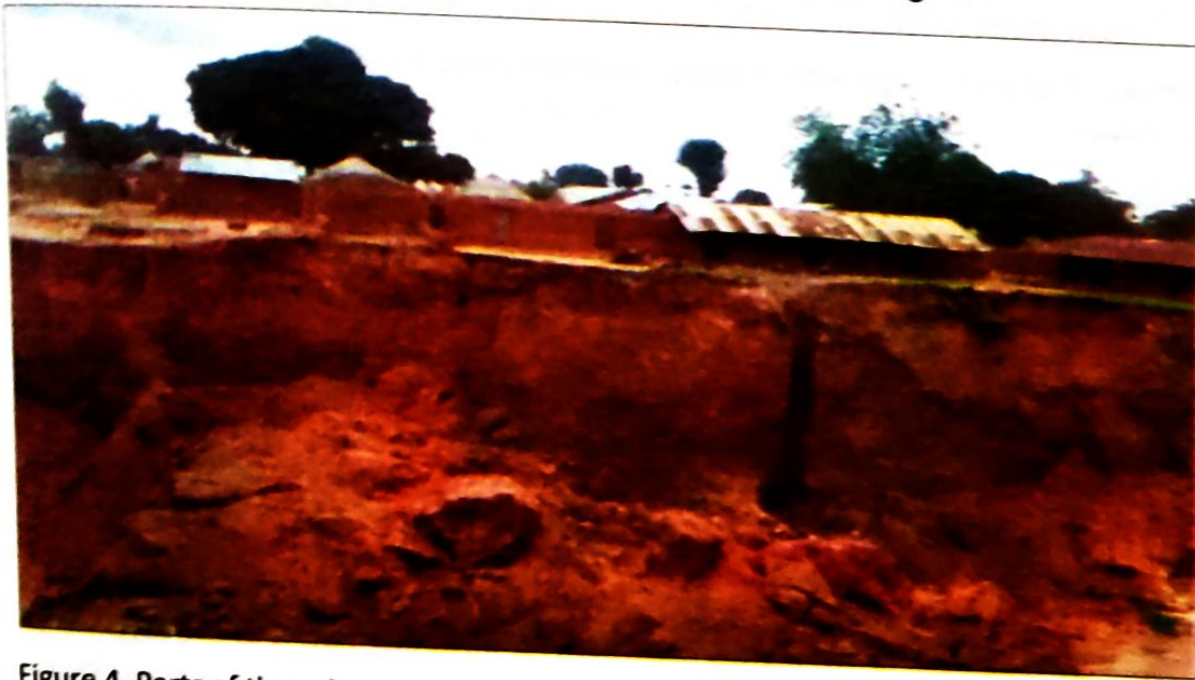
Figure 4. Parts of those houses that are more vulnerable to severe gully erosion.

One of the major challenges in the built environment where gully erosion is prevalent is landslide and soil creep that often threaten housing structures and other infrastructural facilities. The sporadic expansion of the major stream valley in the village has claimed lives and buildings, and still continues to threaten the livability of the existing ones. More than forty (40) houses are less than one meter (1m) away from the brim of the stream gully. Although, within the community there are areas with less severity of erosion, but the eastern part of the village where land sliding is more active, all houses situated close to the erosion channels are highly vulnerable as revealed in Fig. 4.
