# Environmental Technology & Science Journal (ETSJ)

VOLUME 7 No. 1

JUNE 2016

**INVESTIGATION OF SOME FACTORS RESPONSIBLE FOR GULLY EROSION  
ACTIVITIES ALONG RIVER YASHI, MINNA, NORTH-CENTRAL NIGERIA**

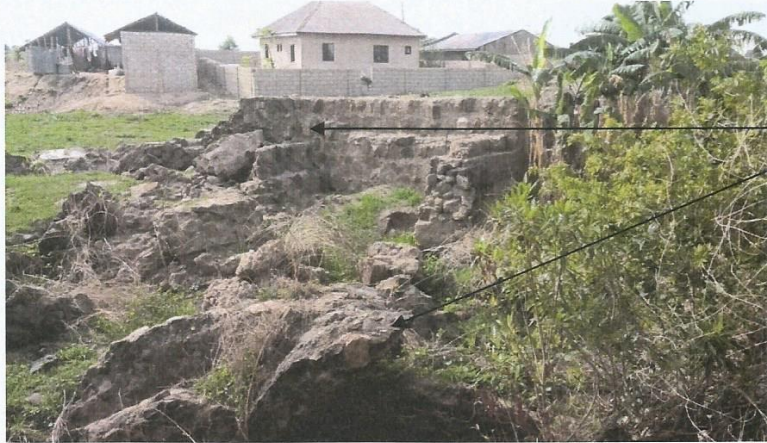
**Plate 1: Failure of remedial measure on River Yashi**

of remedial measures that was taken to control runoff which would have in turn help in reducing erosion along River Yashi (Plate 1 and 2). Sand and gravel

Structural failure of remedial measure

Structural failures of barriers constructed on various parts along the river Yashi channel to control flooding and erosion were observed in the area due to either poor construction or the velocity and volume of flowing water. Excavation of sand and gravel for construction purposes is a common practice in the area. These activities have rendered the water in the river to be less useful and have also contributed to the increase in the gully activity along River Yashi. Construction of any structures that will have impermeable surfaces such as roof, parking lots and roads on the flood plain/river bank is inimical to the river system. This is because the amount of water that would have flown on the river channel and its flood plain will be restricted to the river channel alone. This can result in the increase in the velocity of water flowing along the channel and thereby increasing the erosive power of the flowing water. It can also result to flooding.

Attempt should be made by relevant authorities to control human activities in the area. Any remedial or control measures should make slope stability a priority to ensure that the amount and velocity of runoff is reduced. Other methods that aid the stabilization of soil such as construction of rip-rap with weeping holes to control base flow which prevent collapse of the stream wall should be applied. Cultural or vegetation method may also be adopted for the same purposes.

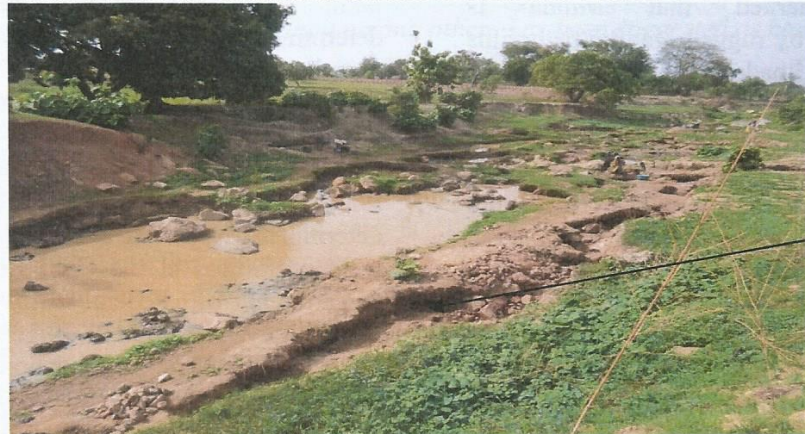
**Plate 3: Excavation of soil and gravel along the bank of River Yashi**

excavation were noticed along the river bank (Plate 3) and on the river bed (Plate 4) by people living around the area.

Excavation along the river bank

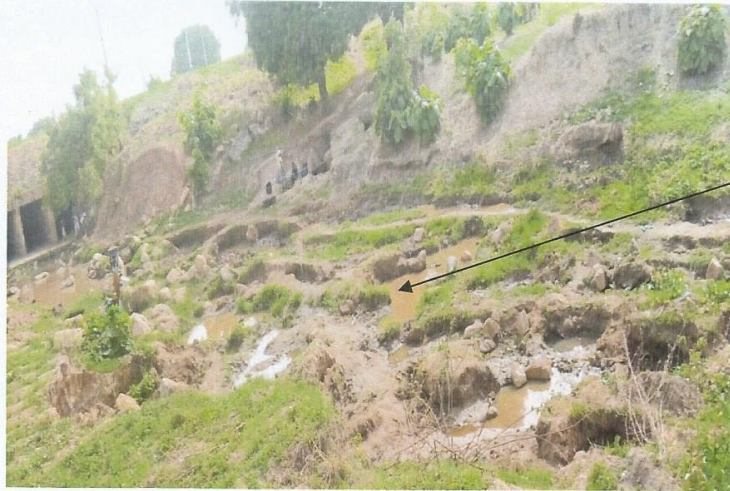
**Plate 4: Excavation of soil and gravel on the bed of River Yashi**

Excavation  
along the  
river bed

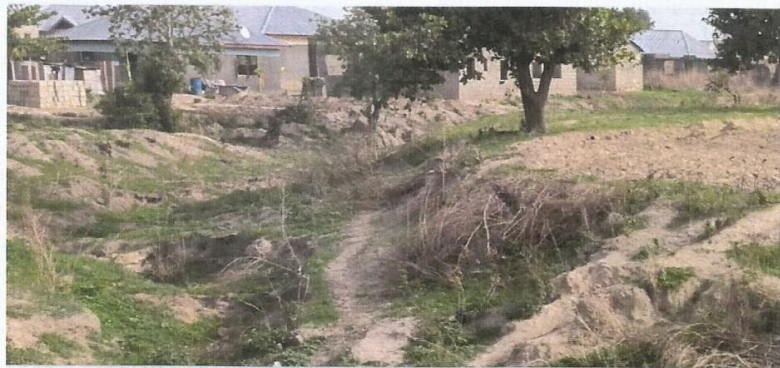
**Plate 5: Buildings on flood plain**

Buildings on Flood Plain/River Bank were observed. Houses at various stage of development were noticed on the flood plain of River Yashi is shown in Plate 5.

This practice is inimical to the river system as it can encourage erosion generally and gully erosion in particular.

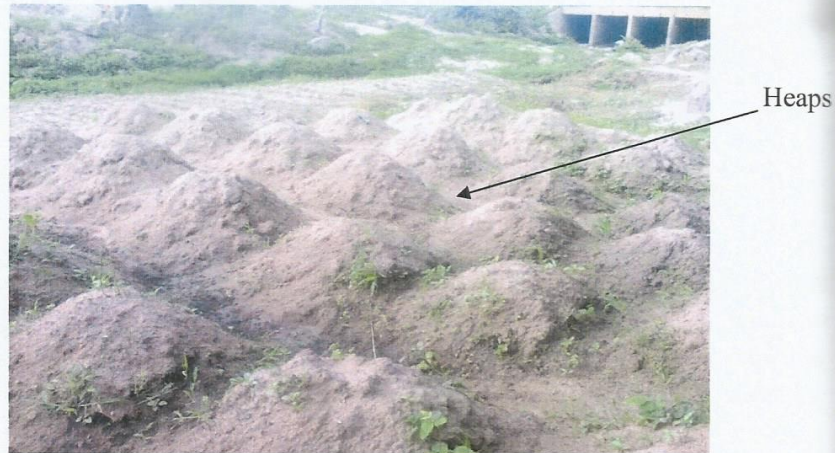
**Plate 6: Farming on the flood plain of River Yashi**

Farming around the floodplain was observed. Farm practice on and around the flood plain does not really favour gully erosion mitigation. The farmers in the area prefer heaping (Plate 6) and ridges parallel

to the slope of the river bank rather than making ridges perpendicular to the slope. This action encourages runoff which in turns lead to gully expansion.

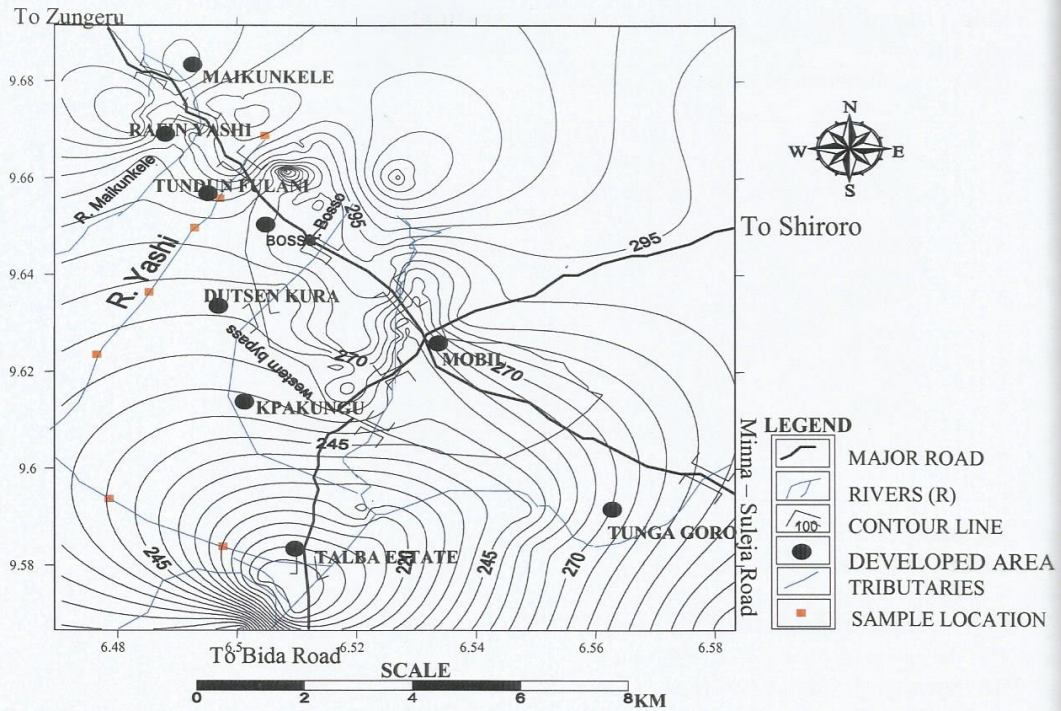
Figure 1: Samples map of River Yashi (Modified after Abdulfatai, 2014)

River Yashi flows from the North – Eastern to South-Western direction mainly. Table 1 shows the identification codes of samples, coordinates, depth and width of River Yashi gully site at various sampling points. The seven samples selected for analyses are shown in the sampling map in Figure 1. The outcome of geotechnical field index properties as presented in Table 2 shows that the dry strength varies from none for RY1 and RY2; medium for RY5 and RY7; and high for RY3, RY4 and RY6. The dilatency varies from low for RY3, RY4 and RY6 to medium for RY5 and RY7 to rapid for RY1 and RY2. The toughness varies from low for RY1 and RY2 through medium for RY5 and RY7 to high for RY3, RY4 and RY6. Only low plasticity for RY1 and RY2 and medium plasticity for RY3, RY4, RY5, RY6 and RY7 were recorded on the field. The in situ colour comprised of dark for RY4 and RY6; brown for RY1, RY2, RY5 and RY7 and mottled for RY3. Odours were recorded for all samples except sample RY5 which was odourless. The in situ moisture conditions were damp except sample RY5 which was dry. Soft consistencies were recorded for all samples except for RY3 and RY5 that were firm. The samples were all made up of fine grained soil. Presences of few roots were recorded in all samples except RY5. The soil types included sandy-silt for RY1, RY2, RY5 and RY7; sandy-clay for RY3; silty-sand for RY4 and sand with silt for RY6.

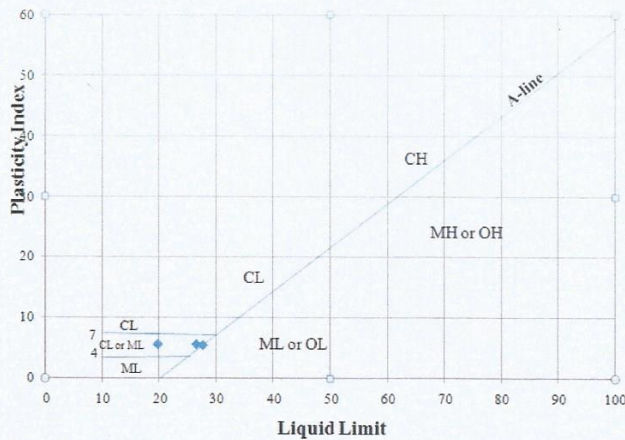
Figure 8: Graph of Plasticity Index (PI) against Liquid Limit (LL)

The Atterberg limit results indicated low plasticity for all sample tested. The result also show that the liquid limit for RY1, RY2, RY5 and RY7 were not attained after five trials, thus, they have no plasticity. The relative consistency values signified that the soil cannot be remoulded which is also an indication of low plasticity for all samples. The sieve analysis results show that samples were poorly graded except for samples RY2, RY4 and RY6 that were well graded. The sieve analysis along with Atterberg limit results had aided the classification of the
