# INTEGRATED GEOLOGY, MINERALOGY AND GEOCHEMISTRY INVESTIGATIONS OF THE MINNA-TEGINA-MAKERA ROAD NORTH WESTERN NIGERIA: IMPLICATION ON FAILED PORTION

## ABSTRACT

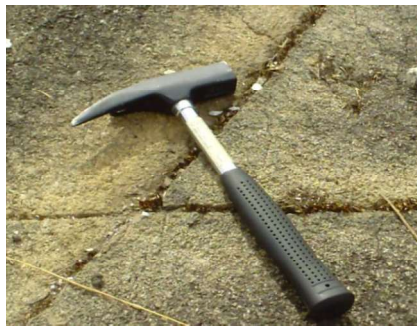
Figure 3: Jointed granite in Maikunkele area

The rock that underlain the stable road sections are made up of granite-gneiss, granites, amphibolites schist and quartz schist and sandstone while the failed road sections are underlain by mica schist, phyllite and coarse grained granite (Fig. 4). Structurally, most of the granites are open jointed (Figure 3) and in some areas dissected by quartzo-feldspartic veins. The granitic rock underlies about 45% of the study area while phyllite, schist and smphibolite schist are about 45% and sandstone 5%. Schist is strongly foliated ranging from muscovite schist to biotite schist, trending in NE - SW and occurred mostly in the northern section of the study road network. In hand specimen the schist varies from leucocratic to melanocratic, the leucocratic show effects of chemical weathering (Figure 5). Amphibolite schist occurred in Zungeru inter-layered with quartz schist and mylonite, this rock is restricted to Zungeru area and a times seen intruding the schist (Figure 6). Phyllite are also common in the northeast and northwest sections of the study area and are closely associated with schist, characterized by a silky sheen on the cleavage surface and show evidence of intensive weathering at the surface where they outcrop. Field evidence along the study road network show that the failed road section is underlies by mica schist, porphyritic granite and phyllite. The fairly stable section is underlain by granite while the stable section is underlain by medium graine granite/granite-gneiss, amphibolite schist and sandstone.

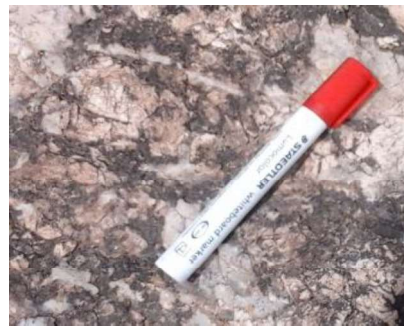
Figure 4: Coarse grain granite in Gobarawa area

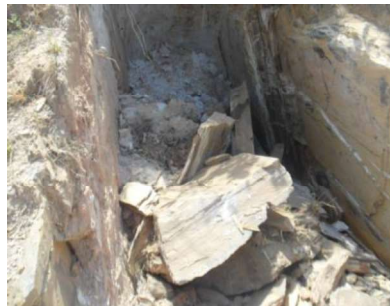
Figure 5: Weathered Leucocratic schist

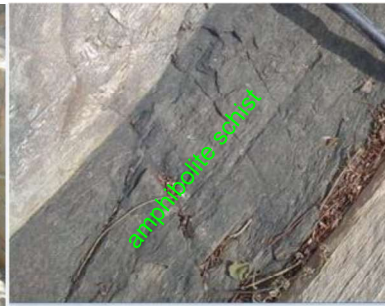
Figure 6: intruded amphibolites

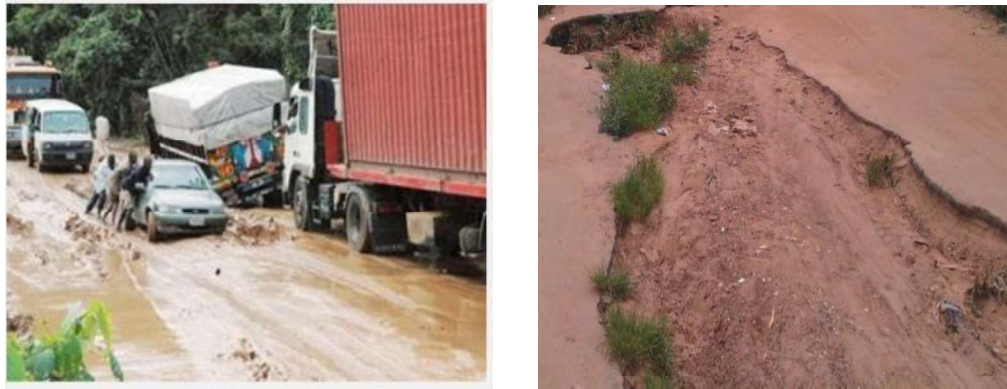
Weathering intensity of igneous and metamorphic rocks in humid climatic region can be determine using Ruxto Ratio ( $\text{SiO}_2/\text{Al}_2\text{O}_3$ ) proposed by Ruxton (1968). He proposed Ruxton Ratio value of  $<3.8$  for intensively weathered rocks,  $4 - 4.5$  moderately weathered rocks and  $>4.5$  least weathered rocks. The Ruxton Ratio values of between  $2.6 - 3.7$  revealed the mica schist of Tegina, Makera, Kodo, Beji, Zungeru phyllite and Zungeru amphibolite schist to have been intensively weathered and constituted the underlying basement rocks of the failed sections of the study road networks while values of between  $4.7 - 4.8$  revealed the granite/granite gneiss of Maikunkele, Tegina, and Zungeru mylonite to be of least weathered intensity constituted the underlying basement rocks of the stable section of the study road networks (Figure 8). Combined field evidence, provenance study and weathering intensity result shows that the meta-sedimentary rocks are of low grade metamorphism and have been intensively weathered while the meta-igneous rocks are more stable and resistant to chemical weathering. Weathering processes penetrate down discontinuities (planes of weakness), such as faults and joints, in the metasedimentary rock mass and then attack the faces, corners and edges of the joints in rock, which produces flakes of clay and sand. As the weight of cars and trucks pass over the weak spot (clay and sand) along the study road, pieces of the weathered material is weaken and cause the material to be displaced or broken down due to vehicle over weight, creating potholes. Interaction of weathered materials (clay and sand) with water and frequent movement of cars and trucks causes the enlargement of potholes that resulted in total failure of the road section.

Plate 10: Failed road sections along Minna – Tegina and Tegina - Makera federal road

In the light of this study, the failed portions of the study road need serious engineering attention. Excavation to fresh basement is required and filling with competent rocks to serve as basement and prevent persistent failure of this road.
