International Journal of Geology and Earth Sciences

GEOTECHNICAL CHARACTERIZATION OF GEOLOGICAL FORMATION AT SLUMP SITES WITHIN SOUTH-WESTERN OUTSKIRTS OF ZUNGERU, NORTH CENTRAL NIGERIA

Slumping is destroying farmlands on the south-western outskirts of Zungeru. Sieve analysis and Atterberg limit tests were conducted on samples of geological formation from the slump and stable sites to ascertain the geotechnical attributes that make the area susceptible to slumping. Surface geological reconnaissance revealed that the area is underlain by schist, amphibolite and granite. The schist unconformably underlay Doko member of Bida Formation, which is the lithostratigraphic unit undergoing slumping. Coefficient of Uniformity (C_u) ranges from 0.57 to 3.48 at the slump sites. This indicates that the slump sites' geological formation is poorly graded. Formation C_u at stable site is 5, which indicates fair particle size grading. Natural Moisture Content (NMC) is 1.9% at the stable site. The value tripled (2.2 to 6.6%) at the slump sites. Atterberg limits' value is similar at all the sites. Their liquid limit is less than 40%. Their plastic limit and plastic index are less than 20% and 7% res

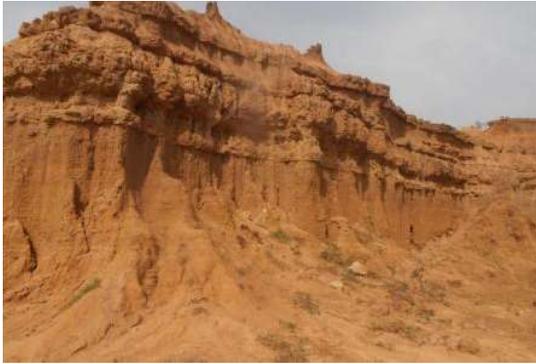
Figure 2: Slumping Site 1, Latitude N9°46'50" Longitude E6°8'32"

Figures 2, 3, 4 and 5 are some slumping sites revealed during surface geological reconnaissance. Vegetation is being destroyed in the sites (apart from site 3), and the road linking neighbouring communities is gradually etching away. The reconnaissance also revealed amphibolite and schist outcrops intruded by granites. These basement rocks are overlain by thick massive to vaguely bedded sandstone that belongs to Doko member of Bida Formation. The Doko member is the slumping lithostratigraphic unit. It consists of clay matrix conglomerates at its base, and a vaguely bedded fining upward sequence of medium-fine sand, siltstone and mudstone.
