Corrosion Resistance of Aluminium–Silicon Hypereutectic Alloy from Scrap Metal

Article in *Journal of Bio- and Tribo-Corrosion* · March 2019

DOI: 10.1007/s40735-019-0224-x

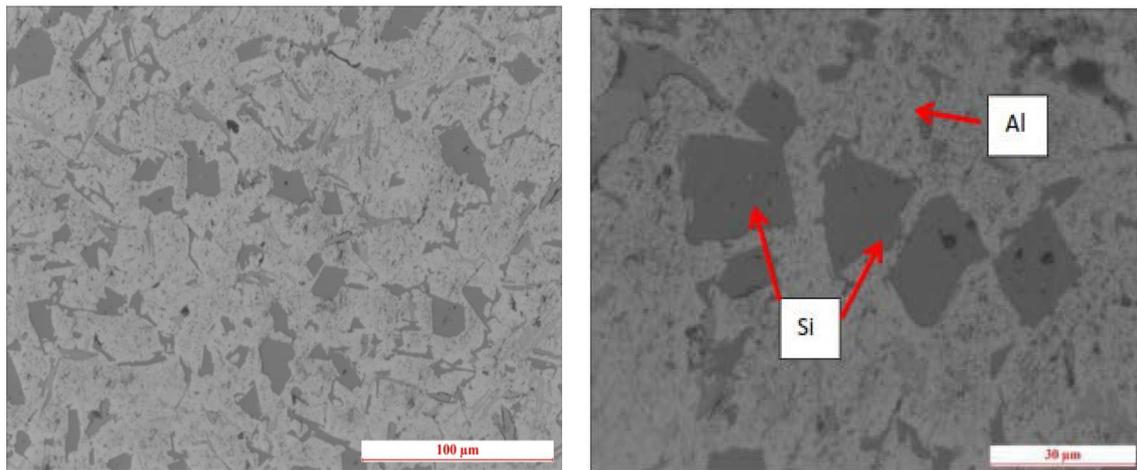
Fig. 1 Microstructural image of LM 30 with low and high magnification

The optical images of the material revealed the casting microstructure with hypereutectic Al–Si Alloy (LM30) as presented in Fig. 1 with low and high magnification. It is clearly observed that the hypereutectic Al–Si consists of aluminium (bright phase) and silicon structure (dark phase). The corresponding EDS pattern is presented in Fig. 2.

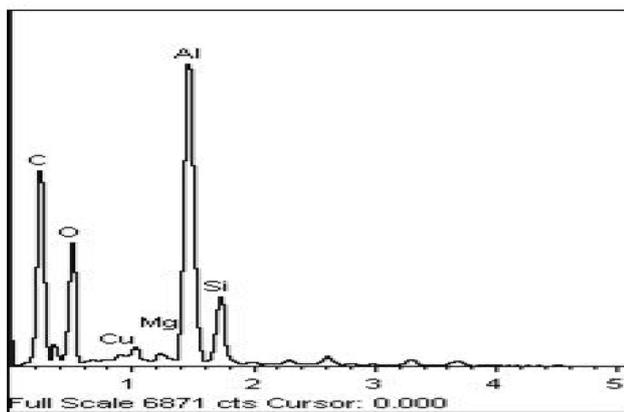
Fig. 2 EDX spectrum of the sample

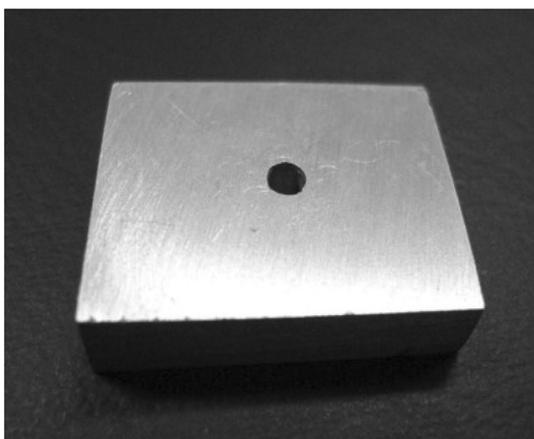
Fig. 3 Sample of LM 30 aluminium alloy before immersion test

Figure 3 presents the sample of LM 30 aluminium alloy before immersion test. By visual inspection, corrosion occurred on entire surface of the sample. An attempt was made to remove this corrosion product, but the grey layer of corrosion product remained yet, and it was hard to be detached. Four samples were immersed, each one for 7 days, 14 days, 21 days and 28 days. After immersion of LM 30 aluminium alloy for sometimes, the samples were inspected visually for any changes on the appearance. They appeared to corrode uniformly, and the surfaces were covered by grey colour corrosion products. This corrosion product layer was formed due to the dissolved salts which also accelerate the rate of corrosion. In addition, the corrosion product layer formed on the hypereutectic Al–Si Alloy became thicker successively from 7 to 28 days of immersion time. Increase in immersion period led to more change in appearance as shown in Table 1. As more corrosion product formed on the surface of the samples, corrosion rate reduced through the deposit which acts as a barrier between the metal and the environment (Table 2).

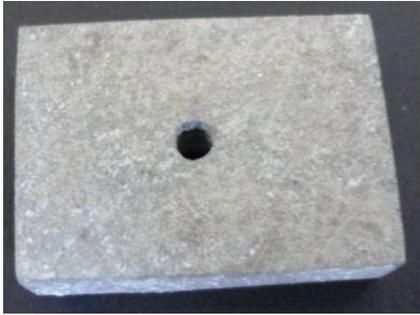
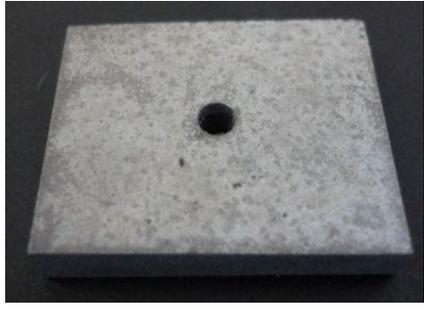
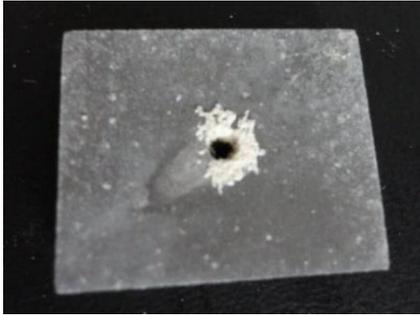
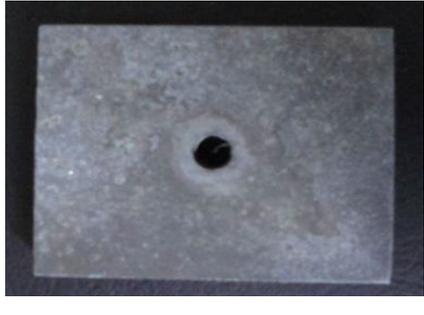
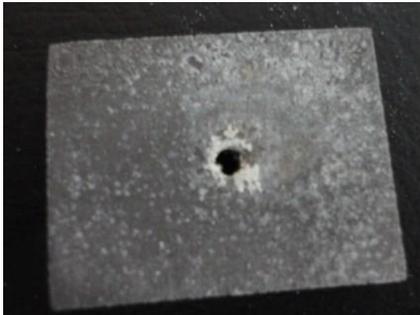
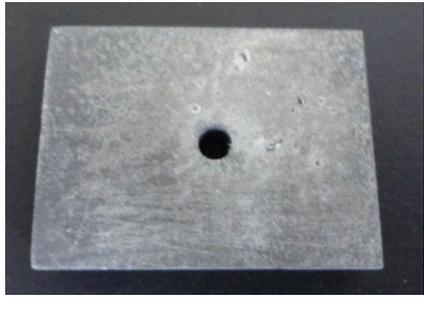
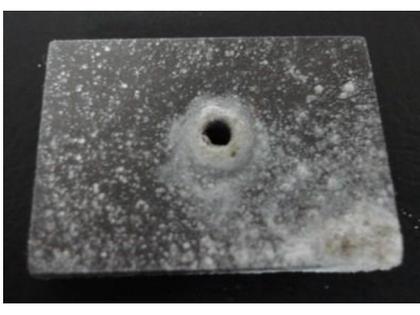
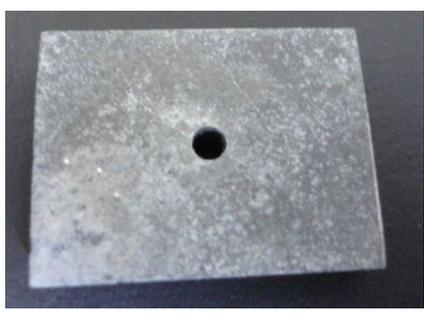
Table 1 Immersion of LM 30 samples in 5.0% NaCl solution for 7–28 days before and after remove corrosion product

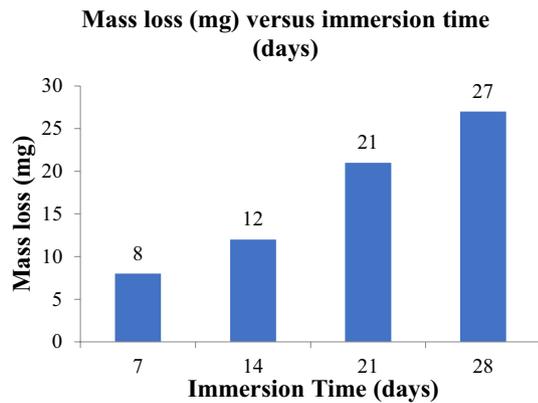
Fig. 4 Weight loss versus immersion time for 7 to 28 days in 5.0% NaCl solution

weight loss were calculated and plotted in graph as presented in Fig. 4. It is clearly shown that the weight loss

of immersed samples in 5.0% NaCl solution for 7 to 28 days increased dramatically. The weight loss ranges from 0.008 to 0.027 g.

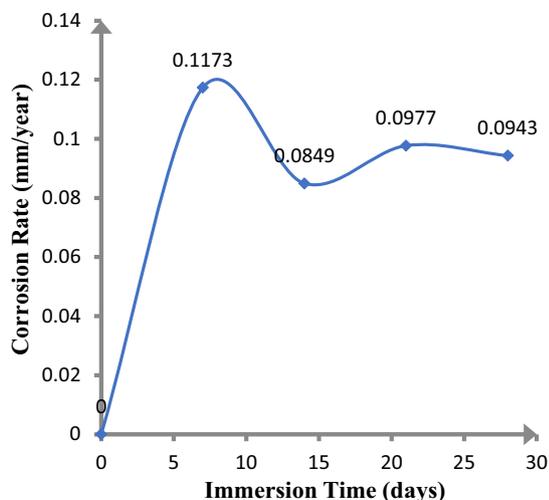
Fig. 5 Corrosion rates (mm/year) of LM30 sample for 7–28 days of immersion in 5.0% NaCl solution

Figure 5 shows increase in corrosion rate from initial day up to 7 days of immersion time. The increase in corrosion rate was due to the initial corrosion attached on the surface and, as a result, corrosion products were formed. As immersion time increased from 7 to 14 days, the corrosion rate started to decrease. This was because the corrosion product formed on the surface became thicker, hard and very protective from corrosion. Thus, there were less formed ions and electron migrating between anode and cathodic areas. The corrosion rate slightly increased from 14 to 21 days. The corrosion rate became almost constant after 21–28 days of immersion. In other words, the protective of oxide layer increased linearly with time and, as a result, the corrosion rate was reduced.

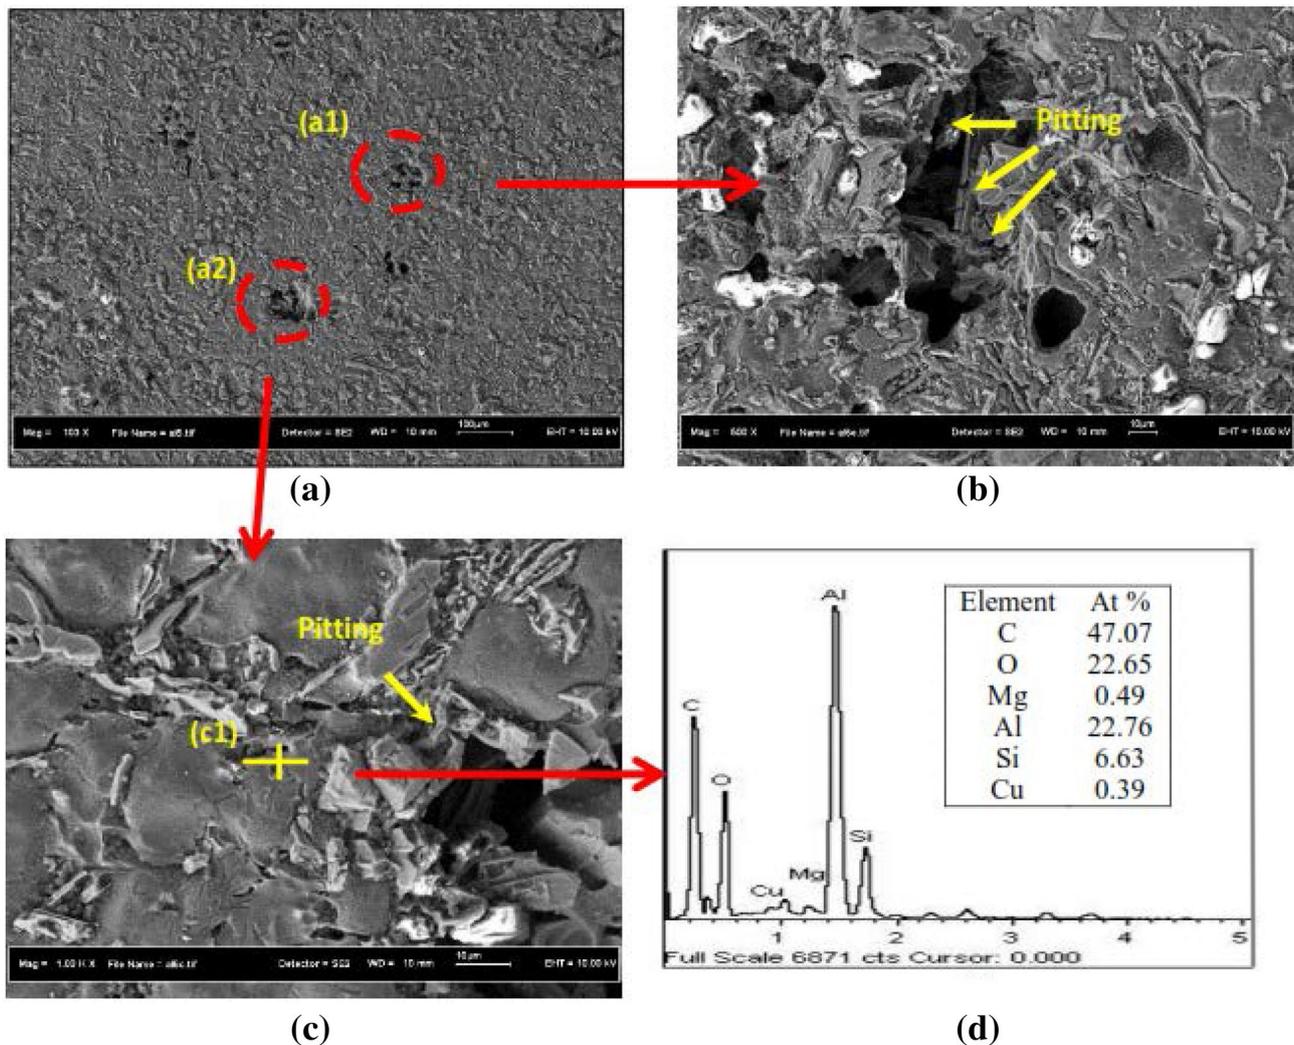
Fig. 6 SEM micrographs of LM30 after immersion test in 5.0% NaCl solution for 21 days; **a** with low magnification; **b** area of a1 with high magnification; **c** area of a2 with higher magnification; **d** EDX spectrum of area c1

Figure 6a shows typical small pit observed on the surface area of LM30. The higher magnification SEM image reveals details of the pit area as shown in Fig. 6b, c. The corresponding EDX result at the pitting adjacent of silicon (c1) shows the area contained Al, C, O, Si and Cu as presented in Fig. 5d. The mechanism of pitting corrosion occurred because NaCl acts as catalyst to corrosion. The area was not

consumed in the process but helps to break down the oxide passive layer and allow the corrosion process to continue. The pitting observed occurs at site of oxide film layer failure. Several factors that might cause this failure include casting defect due to solidification or hydrogen liberation and phase particles or other precipitants. However, once pitting initiated, corrosion proceeded at high rate due to crevice effect. The preference site of pitting was intermetallic–Al interface [13].

Surface examination of sample revealed several stages of corrosion attack. Initially, pitting on the sample occurred preferentially around the base metal surrounding the hypereutectic Si [14]. The cathodic side was hypereutectic Si and/or the intermetallic precipitate [13]. At side where uniform corrosion was evident, the hypereutectic Si was seen to protrude slightly from the surrounding Al. Some pitting was seen to occur at the side of hypereutectic Si.

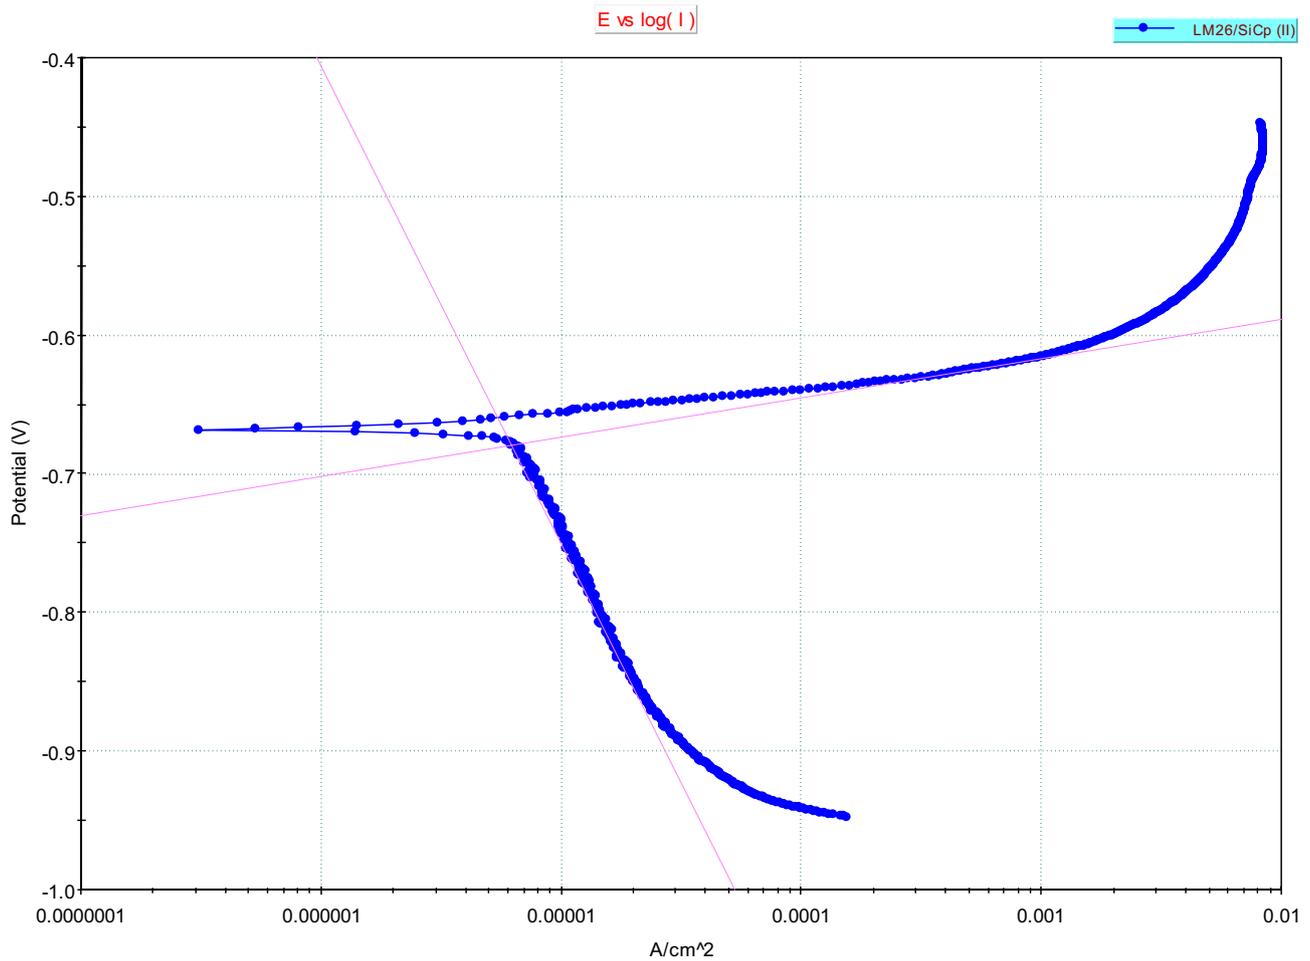
Fig. 7 Electrochemical behaviour of LM30 5% aerated NaCl solution

Figure 7 shows the graph of electrochemical test. The results of electrochemical test in aerated 5.0% NaCl solution with the corrosion potentials (E_{corr}) of - 680 mV, corrosion current (i_{corr}) of 6.28 A/cm² and the corrosion rate (CR) of 3.93×10^{-2} mm/year are presented in Table 3. Corrosion rate measured in electrochemical test was lower than immersion test. These results were expected because of the lesser concentration of oxygen ions in the solution. Thus, measure corrosion rate from the immersion test was taken after 4 weeks and the corrosion rate from electrochemical testing is only for the period of the electrochemical test.

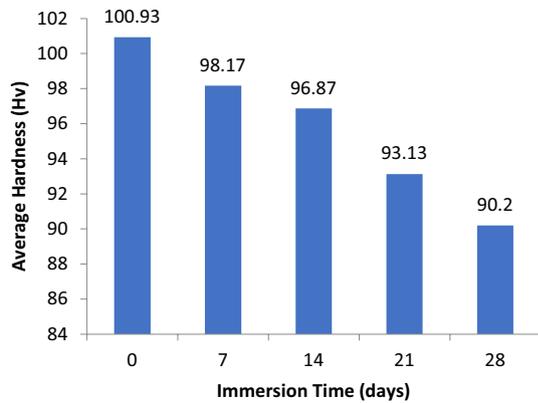
Fig. 8 Average hardness (Hv) of LM30 before and after immersion corrosion test in 5.0% NaCl solution from 0 to 28 days

Hardness measurement was taken before and after immersion corrosion test. The sample preparation and hardness measurement were carried out in accordance with [10]. Figure 8 presents the hardness of LM30 immersed in 5% NaCl. The hardness of LM30 decreased as immersion time increased. This was due to the change in microstructure of the material and pitting that occurred in the surface of specimen.
