**FAILURE ANALYSIS OF STEEL REINFORCEMENT IN COLLAPSED  
BUILDING IN NIGERIA**

**A THESIS SUBMITTED TO THE POSTGRADUATE SCHOOL, FEDERAL  
UNIVERSITY OF TECHNOLOGY, MINNA, NIGERIA IN PARTIAL  
FULFILLMENT OF THE REQUIREMENTS FOR THE AWARD  
OF THE MASTER OF ENGINEERING (MEng) DEGREE IN  
MECHANICAL ENGINEERING (MATERIALS AND  
METALLURGY ENGINEERING OPTION)**

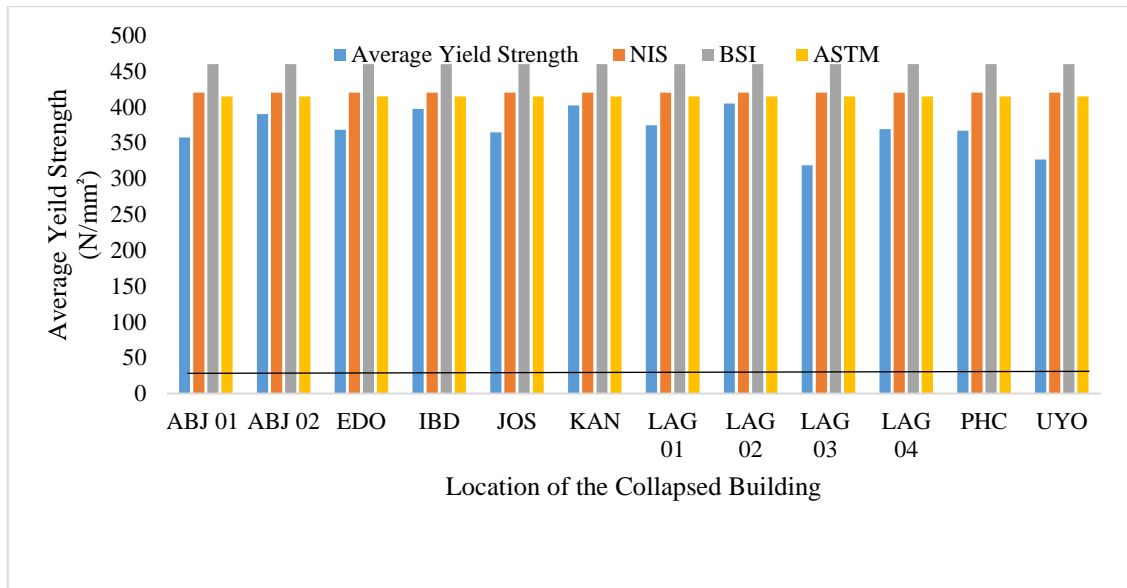
**Figure 4.1:** Average Yield Strength against the Standards for the Reinforced Steel

The average yield strength observed for all the 12 collapsed building locations as indicated in Figure 4.1 were not in points with the standard. This showed that the sampled steels were failed. This could be proved that the use of these mild steels in respective of dimensions as composites reinforcement into cement will probably generate greater building and other structural failure as being shown above. It is possible to note the presence of variations in the yield strength which characterize the material behaviour. Meanwhile, the validation procedure could be in studying the effect of hardness and microstructure examination of reinforced mild steel in comparison to yield strength analysis as presented in subsequent test analyses.

The Table 4.1 above showed that the results generated according to the relevant theory applied and through the experiment performed have attributed the yield strength values range from 318.95 to 405.13 ( $\text{N/mm}^2$ ) of all the reinforced steel samples were characterized with structural failure even with all the parameters concerned as against the NIS117 code of 420  $\text{N/mm}^2$ , BS4449:1997 code of 460  $\text{N/mm}^2$  and ASTM code of 415  $\text{N/mm}^2$ . Therefore, the results are in negative agreement with all the standard codes, and 100 % failed data specification.

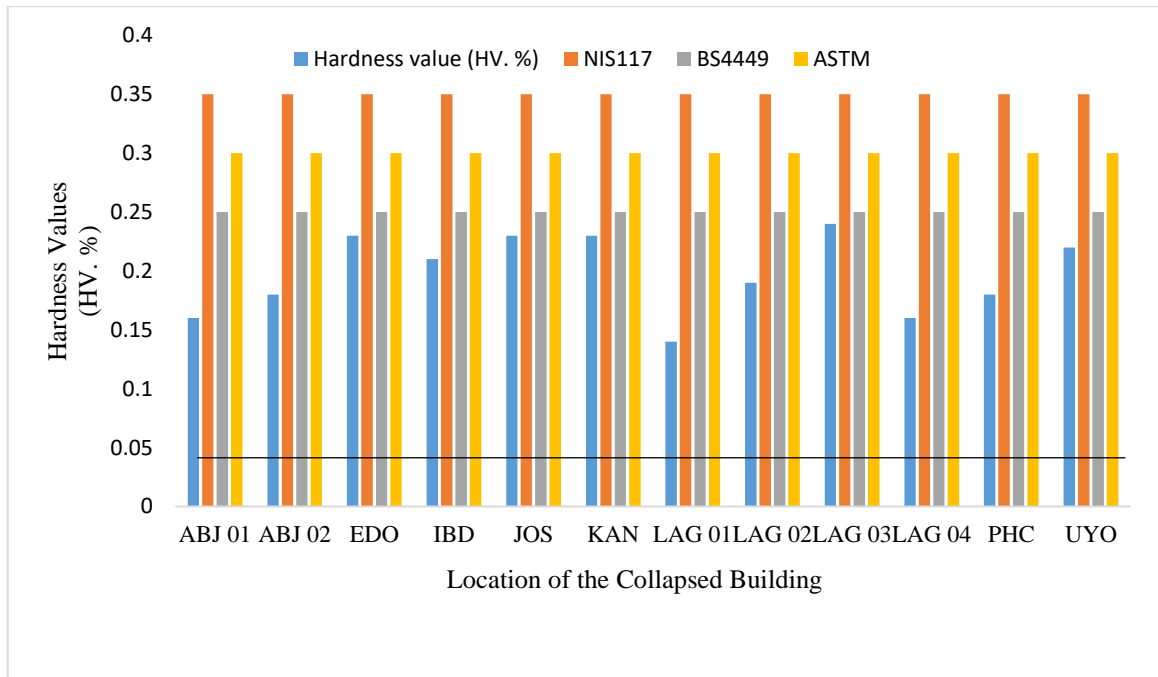
**Figure 4.2:** Hardness Values versus the Standards for the Reinforced Steel

However, from the Figure 4.2, the ramifications of the hardness test for this situation could not measure up to others in which the sample is completely fizzled. In any case, the way that a sample is not totally satisfied the guideline code does not disparages the standard codes. This conduct verifies the burst system of breaks that spread specially in the middle of the compaction of the steel synthesis because of the low interfacial strength. The more prominent break region will be identified with the lower or higher carbon weight fixation (wt. % C), legitimize the underlying disappointment of the inspected steel.

From the results presented in Table 4.2, the hardness test values by EDS shows that the distribution of hardness of the sampled materials made of the steel ranged from 0.14 wt. % to 0.24 wt %, for the sited collapsed buildings. It can be deduced from the analysis of the results that all the hardness values of the 12 sampled steel such as ABJ01, ABJ02, EDO, IBD, KAN, JOS, LAG01, LAG02, LAG03, LAG04, PHC, and UYO were all below the standards considered. The hardness of the steel is absurd, one revealed the areas of a higher (0.24 wt %) not reaching 0.25 wt %, which is a prerequisite for the minimum standard application of the steel according to BS4449:1997. The analysis of the above hardness tests can thus be presented thus;

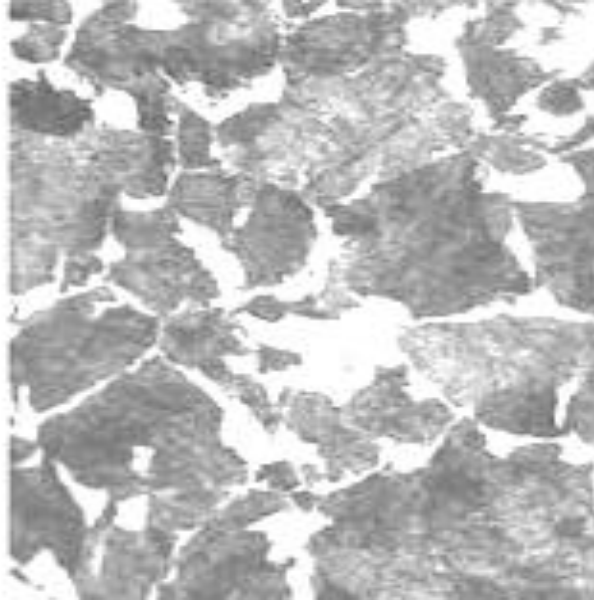
**Plate VI:** Metallographic Image of KAN:

The steel shows fine and good equiaxed grain structure but it appears with dimples grains that so much be taken over by a dominated iron sulphite ( $\text{FeSO}_3$ ) (black). This present due to the excess oxygen concentration lead to the corroded areas (black) in the structure. The microstructure reveals the chemical composition in which Iron (85.98 wt. %) as the main element, but the content reveals a severe phosphorus (0.42 wt. %) and sulphur (0.52 wt. %) as much as carbon (0.38 wt. %). Thereby makes the steel to be brittle which may make it experience fatigue aberration easily at a constant loading, thereby causing unexpected failure in practice. The illustration from the microstructure also indicates the presence of the two particle size of coarse grain structure as pearlite (black) in the matrix of ferrite (white). This is very abnormal in the steel product of structural steel products.

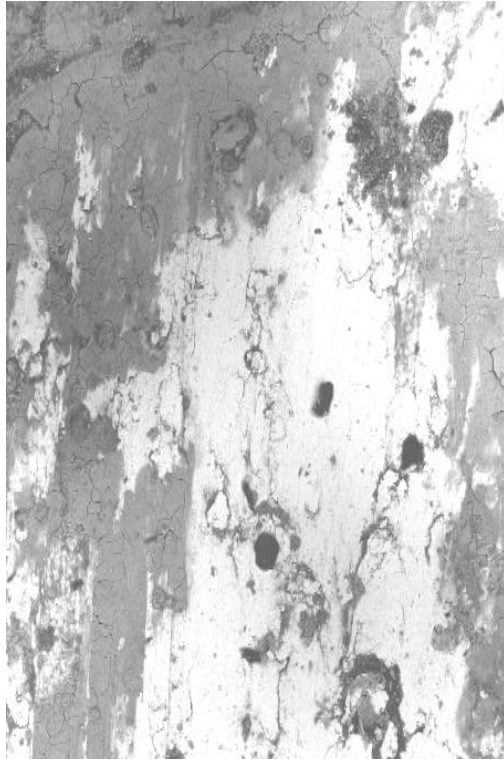
Plate I: Metallographic image of ABJ 01

Element Name	Element Number	Element Symbol	Atomic Conc.	Weight Conc.
Iron	26	Fe	86.53	85.17
Chlorine	17	Cl	1.92	1.27
Sodium	11	Na	1.57	0.67
Silicon	14	Si	1.52	0.80
Sulfur	16	S	1.25	0.75
Potassium	19 <sup>2</sup>	K	1.13	0.82
Phosphorus	15	P	1.06	0.62
Aluminium	13	Al	0.95	0.48
Calcium	20	Ca	0.82	0.61
Carbon	6	C	0.63	0.14
Silver	47	Ag	0.63	1.27
Titanium	22	Ti	0.57	0.51
Chromium	24	Cr	0.54	0.52
Tin	50	Sn	0.37	0.82

Vanadium	23	V	0.32	0.31
Oxygen	8	O	0.20	5.31
Nickel	28	Ni	0.00	0.00
Copper	29	Cu	0.00	0.00
Zinc	30	Zn	0.00	0.00

FOV: 537µm, Mode: 15kV-Image, Detector: BSD Full, Time: FEB 28 2020 14:05

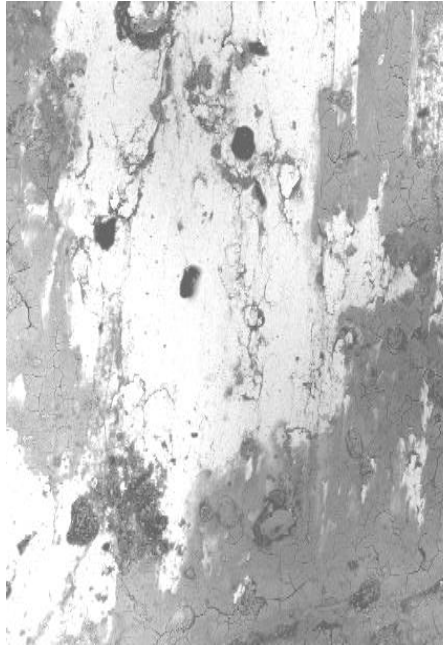
**Plate III: Metallographic image of EDO**

Element Name	Element Number	Element Symbol	Atomic Conc.	Weight Conc.
Iron	26	Fe	81.75	82.47
Sodium	11	Na	5.84	2.58
Potassium	19	K	3.49	2.62
Silicon	14	Si	1.68	0.91
Phosphorus	15	P	1.19	0.71
Calcium	20	Ca	1.11	0.87
Carbon	6	C	1.10	0.25
Sulfur	16	S	1.06	0.65
Silver	47	Ag	0.84	1.74
Aluminium	13	Al	0.80	0.42
Tin	50	Sn	0.50	1.13
Oxygen	8	O	0.34	5.37
Titanium	22	Ti	0.31	0.28
Chromium	24	Cr	0.00	0.00
Nickel	28	Ni	0.00	0.00
Copper	29	Cu	0.00	0.00

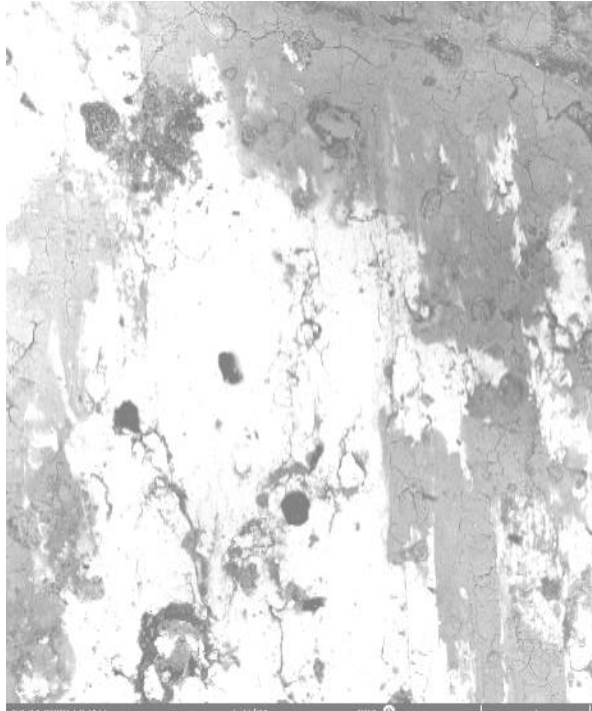
**Plate IV: Metallographic image of IBD**

Iron	26	Fe	78.01	79.32
Sodium	11	Na	6.75	3.00
Potassium	19	K	3.07	2.32
Silicon	14	Si	2.10	1.14
Aluminium	13	Al	1.47	0.77
Calcium	20	Ca	1.39	1.06
Sulfur	16	S	1.38	0.86
Phosphorus	15	P	1.04	0.62
Tin	50	Sn	0.89	2.04
Silver	47	Ag	0.84	1.76
Carbon	6	C	0.83	0.19
Titanium	22	Ti	0.72	0.66
Vanadium	23	V	0.59	0.58
Chromium	24	Cr	0.56	0.57
Oxygen	8	O	0.36	5.11
Cobalt	27	Co	0.00	0.00
Nickel	28	Ni	0.00	0.00
Copper	29	Cu	0.00	0.00

FOV: 537  $\mu\text{m}$ , Mode: 15kV - Image, Detector: BSDFull, Time: FEB 28 2020 14:02

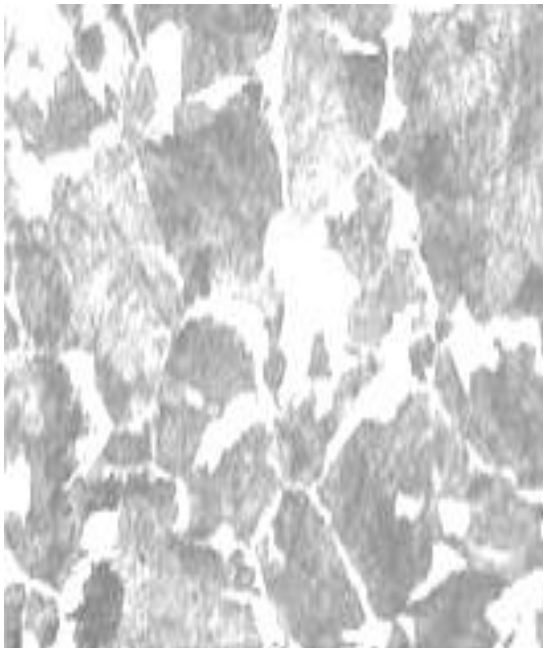
**Plate XII: Metallographic image ofUYO:**

Element Name	Element Number	Element Symbol	Atomic Conc.	Weight Conc.
Iron	26	Fe	81.75	87.27
Sodium	11	Na	3.96	2.57
Potassium	19	K	3.26	2.58
Silicon	14	Si	1.54	0.37
Phosphorus	15	P	0.15	0.06
Calcium	20	Ca	0.41	0.86
Carbon	6	C	1.11	0.42
Sulfur	16	S	0.16	0.03
Silver	47	Ag	0.69	0.51
Aluminium	13	Al	0.71	0.22
Tin	50	Sn	0.00	0.00
Oxygen	8	O	0.24	4.31
Manganese	25	Mn	0.26	0.80
Chromium	24	Cr	0.00	0.00
Nickel	28	Ni	0.00	0.00
Copper	29	Cu	0.00	0.00

FOV: 537  $\mu\text{m}$ , Mode: 15kV - Image, Detector: BSDFull, Time: FEB 28 2020 14:35
