STRUCTURAL HEALTH MONITORING OF A LATTICE TOWER

**DEPARTMENT OF CIVIL ENGINEERING
FEDERAL UNIVERSITY OF TECHNOLOGY, MINNA**

**A THESIS SUBMITTED TO THE POSTGRADUATE SCHOOL, FEDERAL
UNIVERSITY OF TECHNOLOGY, MINNA, NIGERIA
IN PARTIAL FULFILLMENT OF THE REQUIREMENTS FOR THE AWARD OF
THE DEGREE OF MASTER OF ENGINEERING IN CIVIL ENGINEERING
(STRUCTURAL ENGINEERING)**

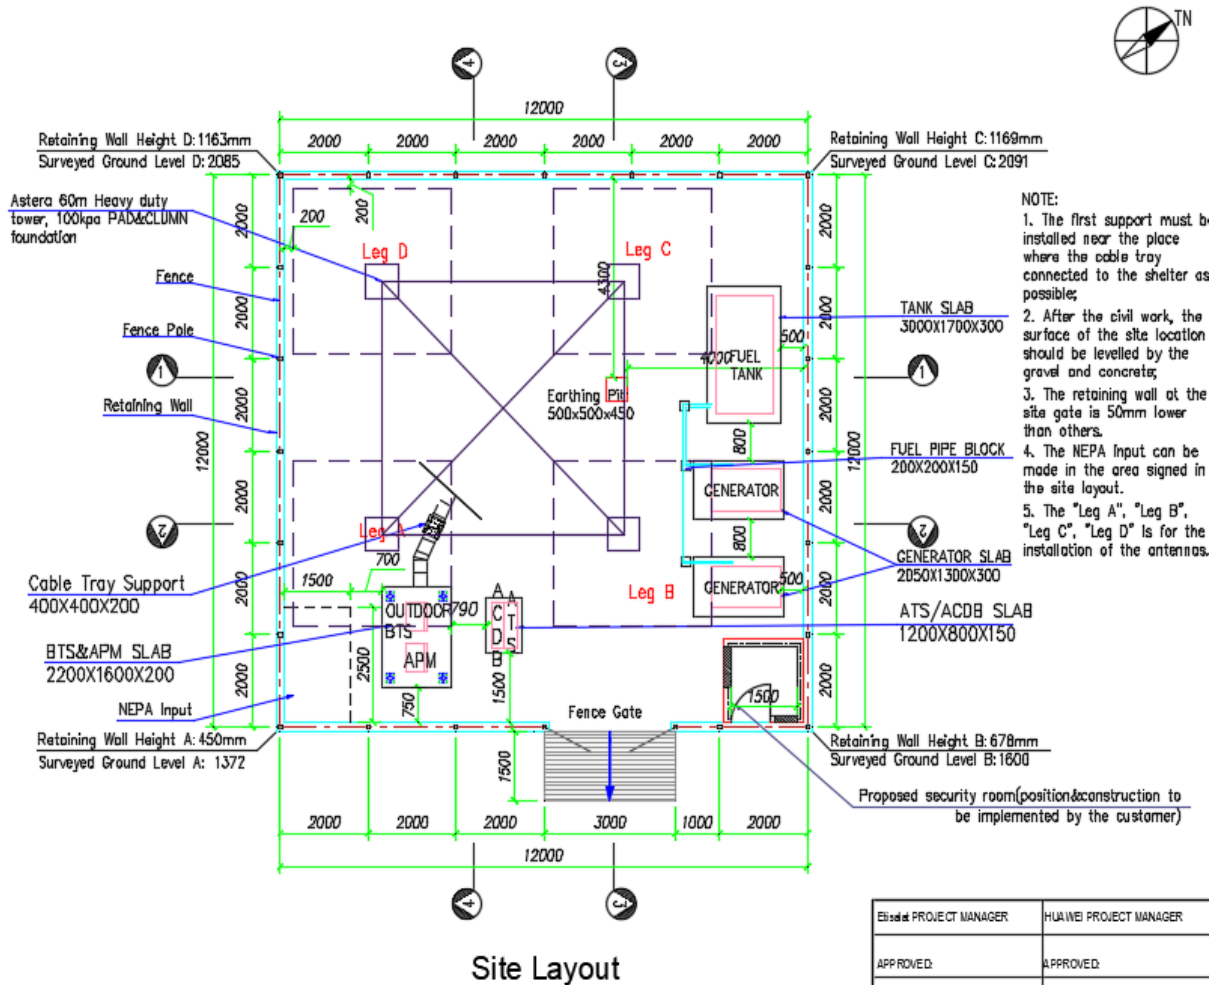
Figure 2.1: Layout of a typical telecommunication site (Source: Etisalat Tower Specification, 2012)

A telecommunication tower is housed in a cell site or base station site. A cell site is a cellular-enabled mobile device site where electronic communications equipment and antennas are placed on a radio mast, tower, or other raised structure to create a cell in a cellular network. Figure 2.1 shows the site layout of a typical telecommunications site.

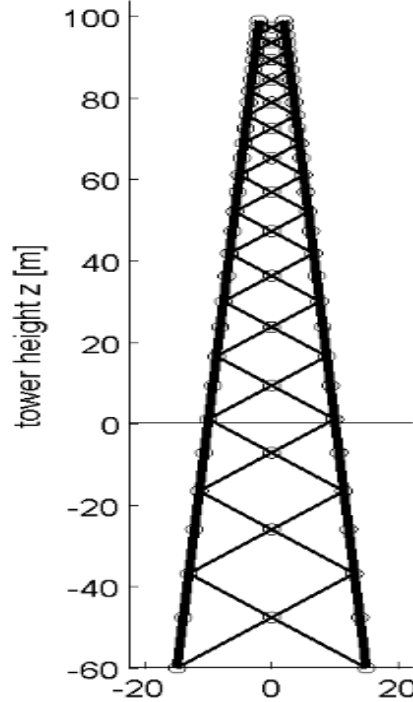
Figure 2.2: Self-supporting tower (Source: Etisalat Tower Specification, 2012)

Self-supporting towers are supported on ground or on buildings. Though the weight of these towers is more, they require less base area and are suitable in many situations.

Most of the television microwave power transmission and flood light towers are self-supporting towers as

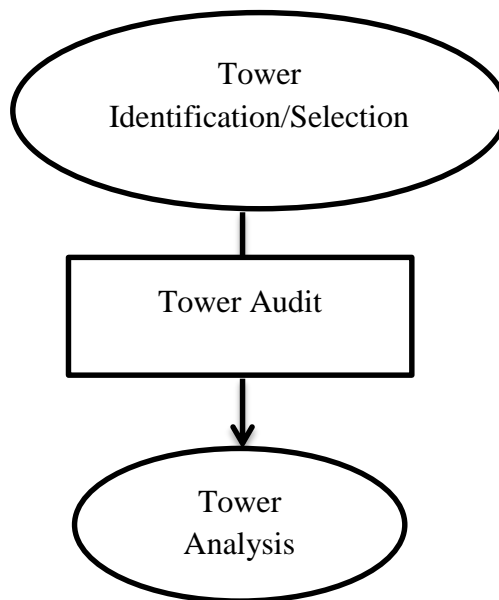
Figure 3.1: Research methodology Chart

Thereafter, the tower was thoroughly inspected to ascertain the structural integrity of its members and accessories. Subsequently, the tower loading was analysed to determine its stability and percentage utilization. The steps undertaken are presented in Figure 3.1.

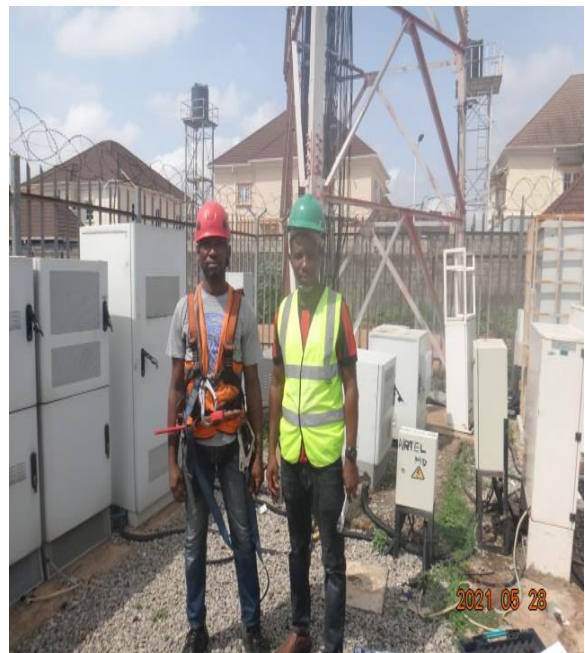
Plate X: On Site with a Rigger

The tower audit was done with the support of a professional tower installer called Rigger. A Rigger is a person specialized in erecting towers as well as carrying out maintenance works on the tower. The tower audit involves the thorough inspection of the tower members and bracings, the bolts and nuts conditions at the connections, the state of other tower accessories like the access ladder, rest platforms, paints, aviation warning lights and earth cables. Any defect noted on the tower and recommended for correction. During the tower audit, records of all the telecoms equipment (antennas) installed on the tower are also recorded for use in structural analyses of the tower.

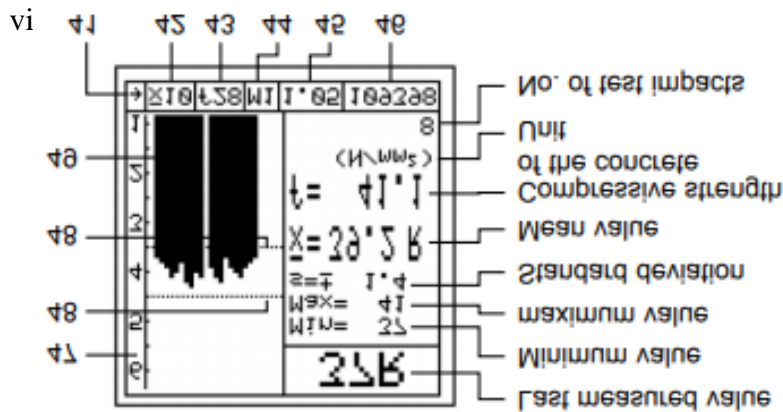
Figure 3.2: Digital Schmidt hammer display screen. (Source: Proceq digital Schmidt instruction manual, 2000)

- i. Mark up the test points which are at least 200mm apart
- ii. Use a grindstone to smoothen the test surface.
- iii. Position the concrete test hammer perpendicular to the test surface.
- iv. Deploy the impact plunger of the Schmidt hammer by pushing the rebound hammer towards the test surface until the push button springs out.
- v. Perform the non-destructive test by pushing rebound hammer against the test surface at moderate speed until the impact is triggered (a loud beep acknowledge impact registration).
- vi. The values of the rebound number (R) and the corresponding compressive strength (N/mm²) are displaced on the digital Schmidt hammer screen.
- vii. Repeat the test at seven more points and click “end button” on the display panel of the Schmidt hammer to obtain the average compressive strength in N/mm². (See figure 3.2).

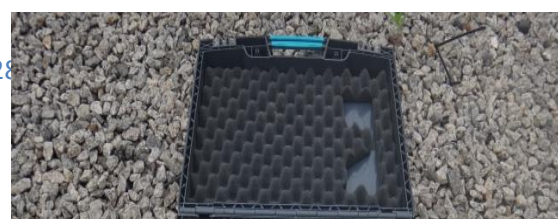
The test was carried out using a digital Schmidt hammer (Proceq). The Schmidt hammer or rebound hammer is a mechanical device used to perform quick, non-destructive quality test on concrete. The tower legs were labelled alphabetically from A-C in anticlockwise direction for easy referencing. Also, the exposed stub columns are also checked for the presence of cracks and surface blisters.

Plate XI: Proceq Digi-Schmidt 2000

Plate XII: Hammer and Display Unit

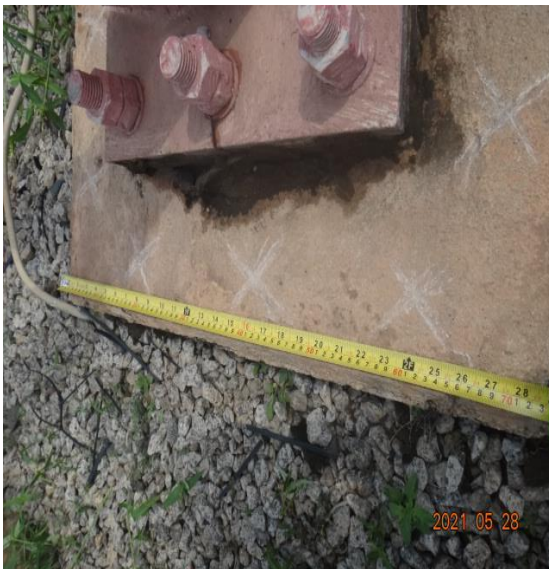
Plate XIII: Marking of test points. as "X"

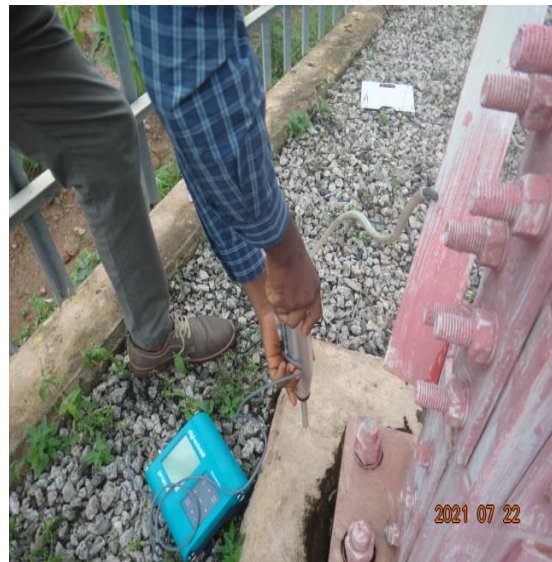
A non-destructive test was carried out on the tower stub columns. The stub column is the vertical member which forms part of the tower foundation. It is a reinforced concrete footing through which the tower is anchored. The tower legs are held to the foundation by galvanized hold down bolts.

Plate XIV: Testing of the foundation

The mean compressive strength of the stub columns obtained using the Schmidt hammer are 25.1, 25.9 and 25.9 N/mm² for legs A, B and C respectively. These values meet the recommended concrete strength of the foundation (25/19 MPa) as stated in the foundation drawing in Appendix B2. The physical conditions of the stubs are also okay as there was no visible cracks or blisters on them. Furthermore, there were no visible compaction failure around the foundation.

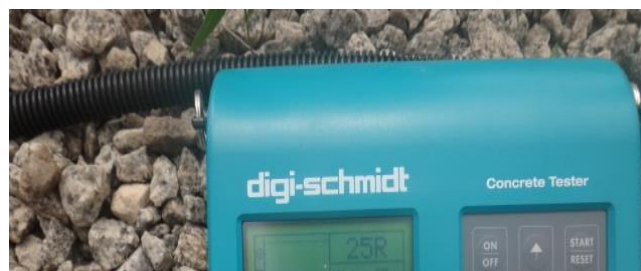
Plate XV: Display unit showing readings.

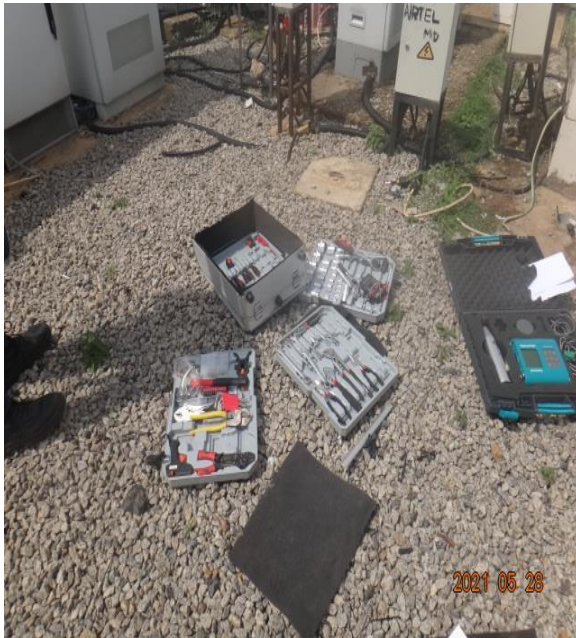
Plate XVI: Toolbox

These activities provide cognizance on the state of the tower and the maintenance history of the tower. The data obtained after the audit are compared with the industry laid-down specifications to ascertain the state of the tower. Table 3.2 below shows the tower accessories description while Plates XVI-XXIII show some of the tools and members' audit procedures used.

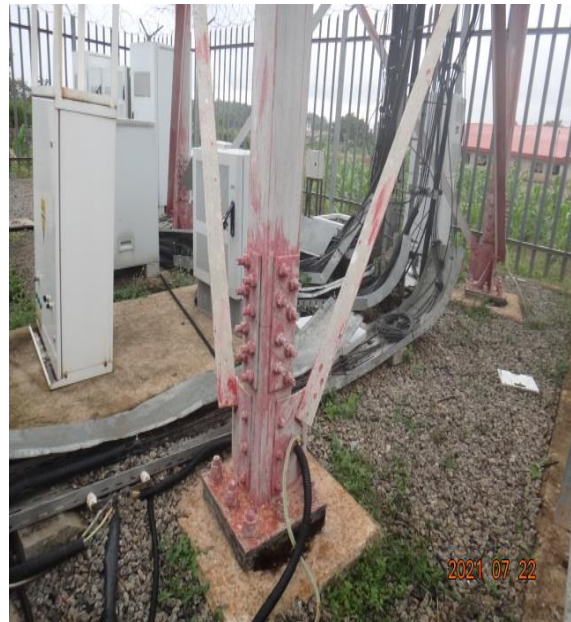
Plate XVII: Tower legs A, B and C

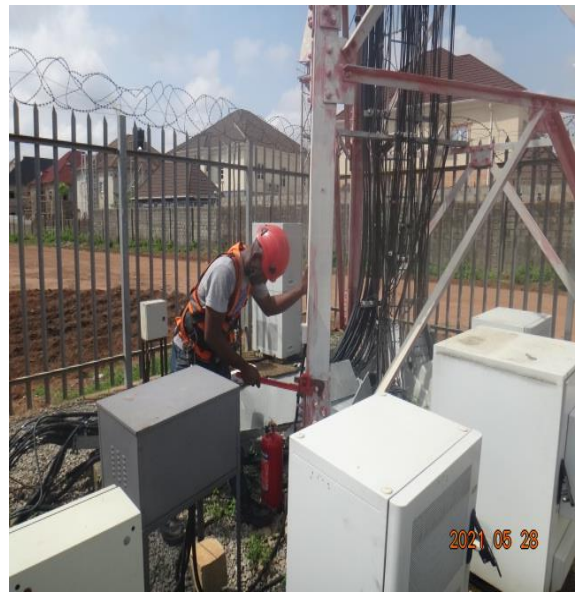
Plate XIX: Bolt torquing

| Item | Description |
|---|---|
| Bolts and Nuts | No missing bolts and nuts were observed. Bolts and nuts are properly tightened. |

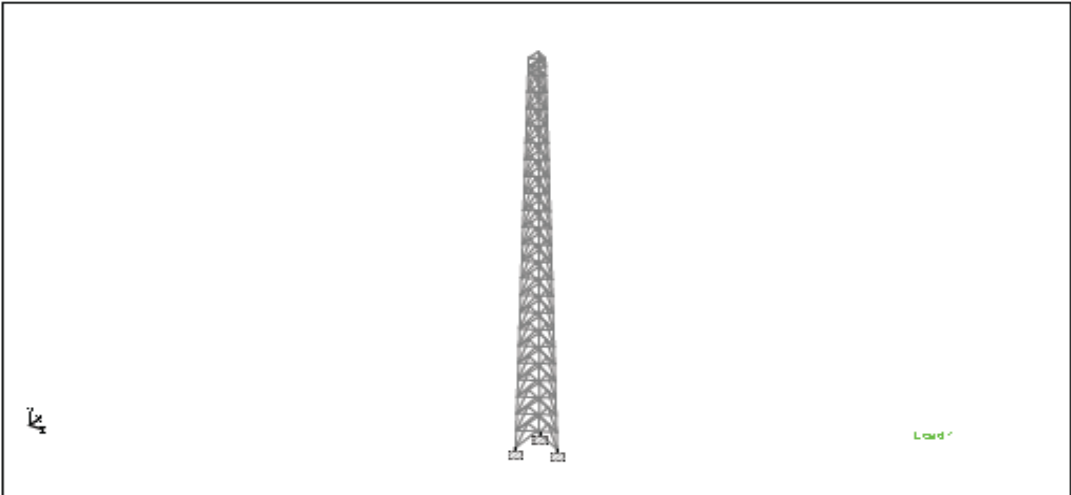
| 45m Tower Model | | | |

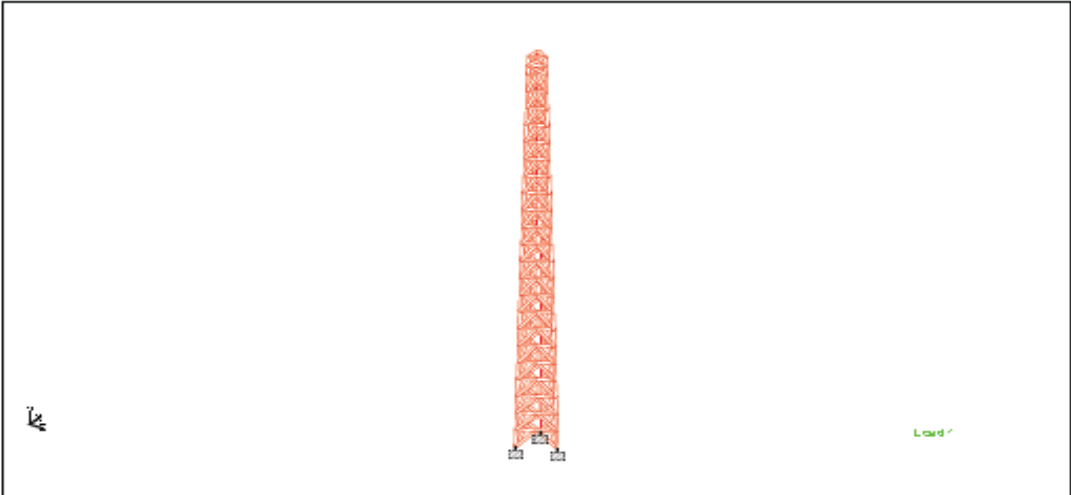
| Dead Load_Tower Self Weight | | | |
