**ENVIRONMENTAL IMPACT
ASSESSMENT OF FOUR VILLAGES
LOCATED DOWNSTREAM OF
SHIRORO DAM IN NIGER STATE**

**A thesis submitted to the Postgraduate School, Federal University of
Technology, Minna, in partial fulfilment of the requirement for the award of
the degree of Master of Technology in Remote Sensing Applications.**

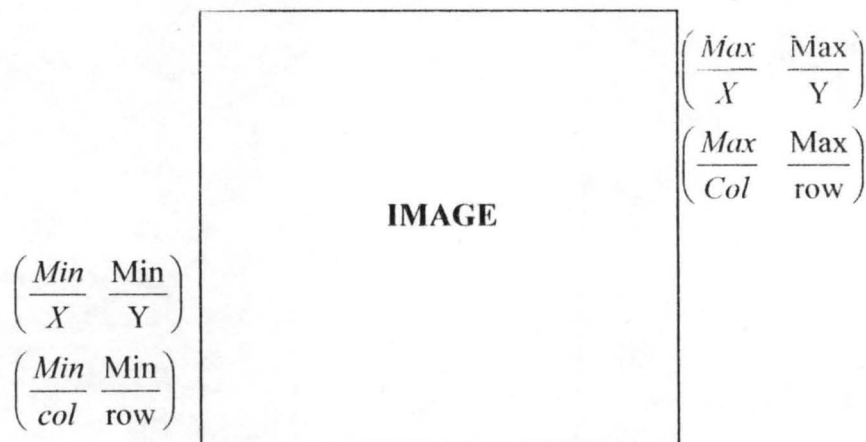
Fig. 3.1 Georeferencing Bounding Corners

The procedure involved the registration of the minimum and maximum X and Y ground coordinates of the corresponding minimum and maximum rows and column of the image corner points using IDRISI 32 software. The UTM rectangular coordinates system in zone 32 was used as the reference surface and system for the study of the three Bands (Blue, Green and Red) which were georeferenced separately with the same documentation coordinate data. A georeferenced 24-colour bit of these bands were created as single image for the classification process. The original 3 bands images were stored in Tagged Image Format (TIF), which were imported into Idrisi format 'band-by-band' during the georeferencing exercise. Example of the georeferencing corner coordinates is as shown in Fig. 3.1.

The purpose of this exercise is to establish the real world coordinates of the study area analogous to that of the Land sat TM data of 2001, which bears direct resemblance with the ground points in the study area.

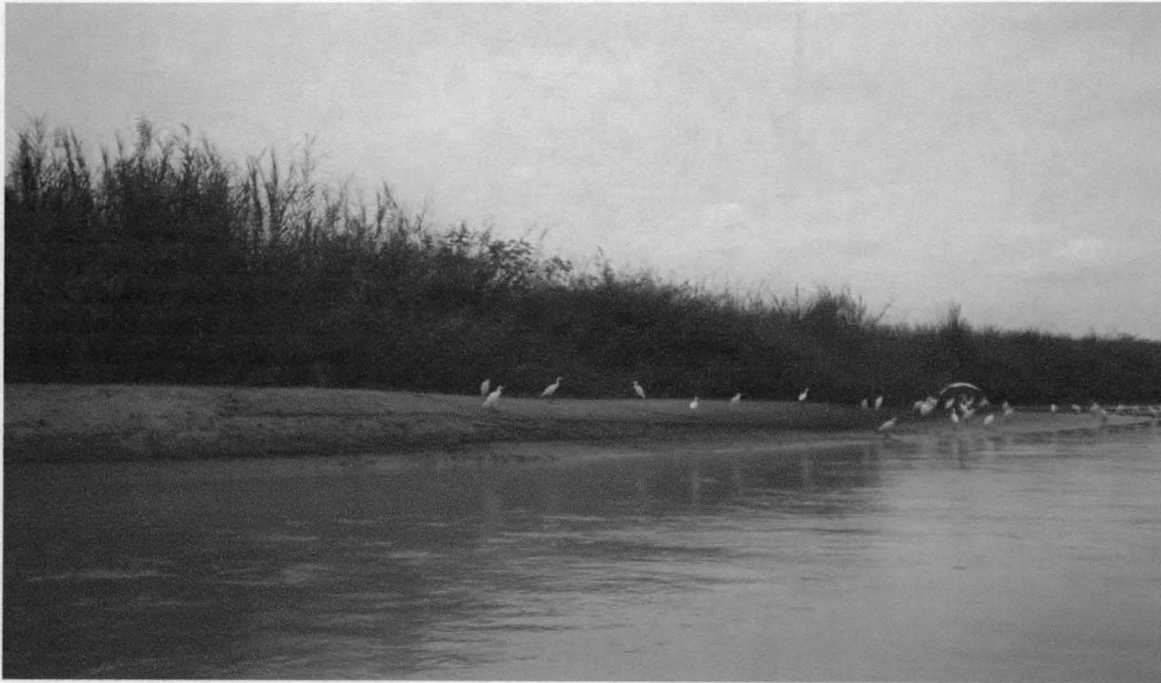
Plate 1: Sand Deposited at the Bank of the River

The result analysis of the land cover changes of Shiroro down stream using multi-temporal images (land sat-TM, 2001 and Nigeria sat, 2003) has shown that, there is tremendous change in the pattern of land use. It is observed that shrubs and weeds in the study area between 2001 and 2003 have reduced drastically. The trend shows reduction of 61.91% (about 1007.11 hectares covered with shrubs and weeds in 2001, which was reduced to 4272.17 hectares in 2003). This reduction may be due to increase in the volume of sand deposited (Plates 1 and 2) as a result of the yearly flood.

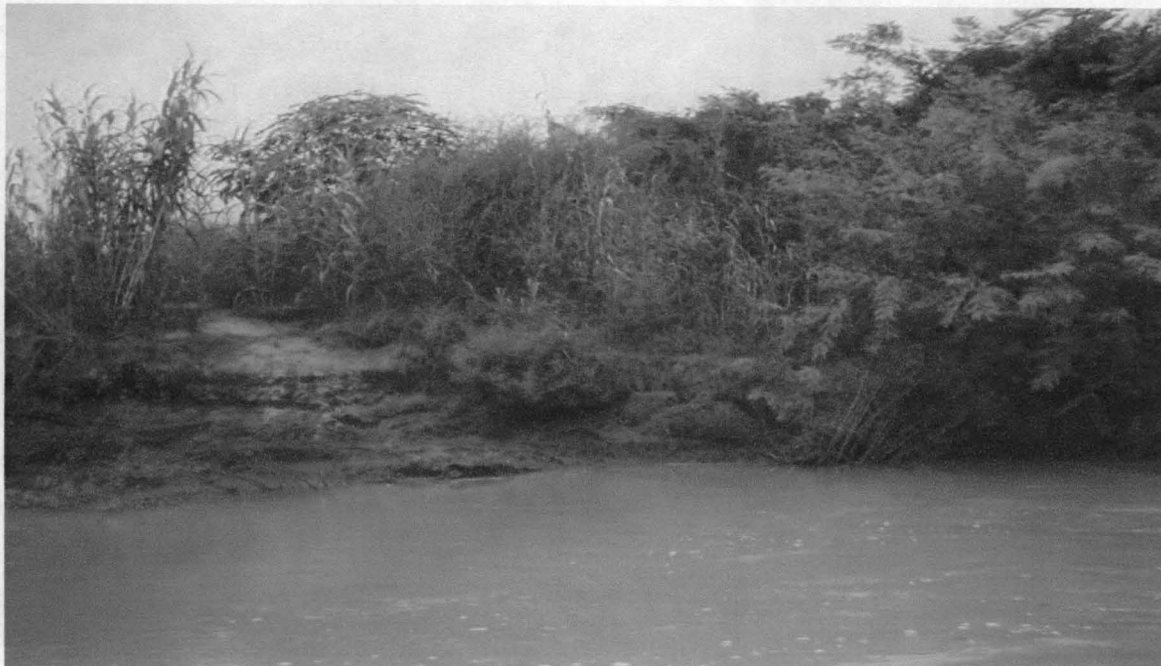
Plate 2: Part of the island in Layi Village where the villagers cultivate their crops, washed away. October 2004.

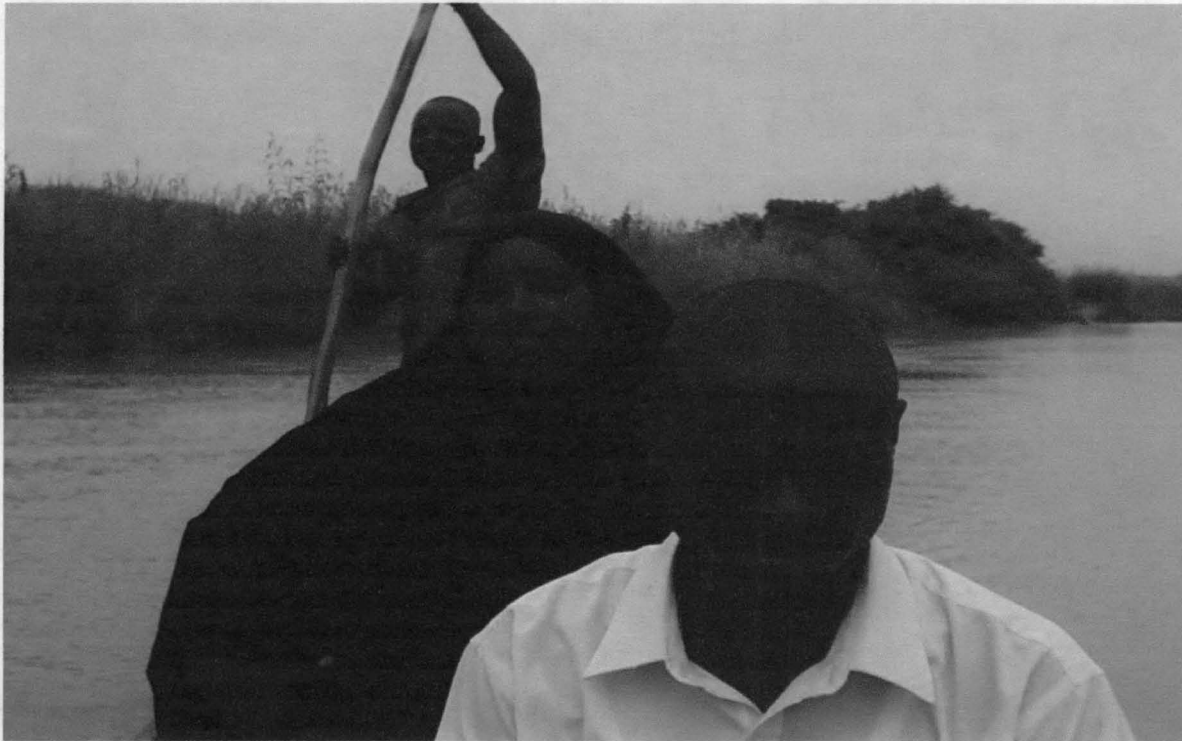
In assessing the pattern of change of degraded area /soil between these years, the result shows decrease in the total land cover by bare soil 13.41%.It is confirmed that some of the islands (Plate 3) at the middle of the water have been washed away by the effect of flood. Hence reduced by replacement the total number of area that was formally degraded

Plate 3: The Author and others on board a canoe on the River Kaduna. See the island at the background in October 2004

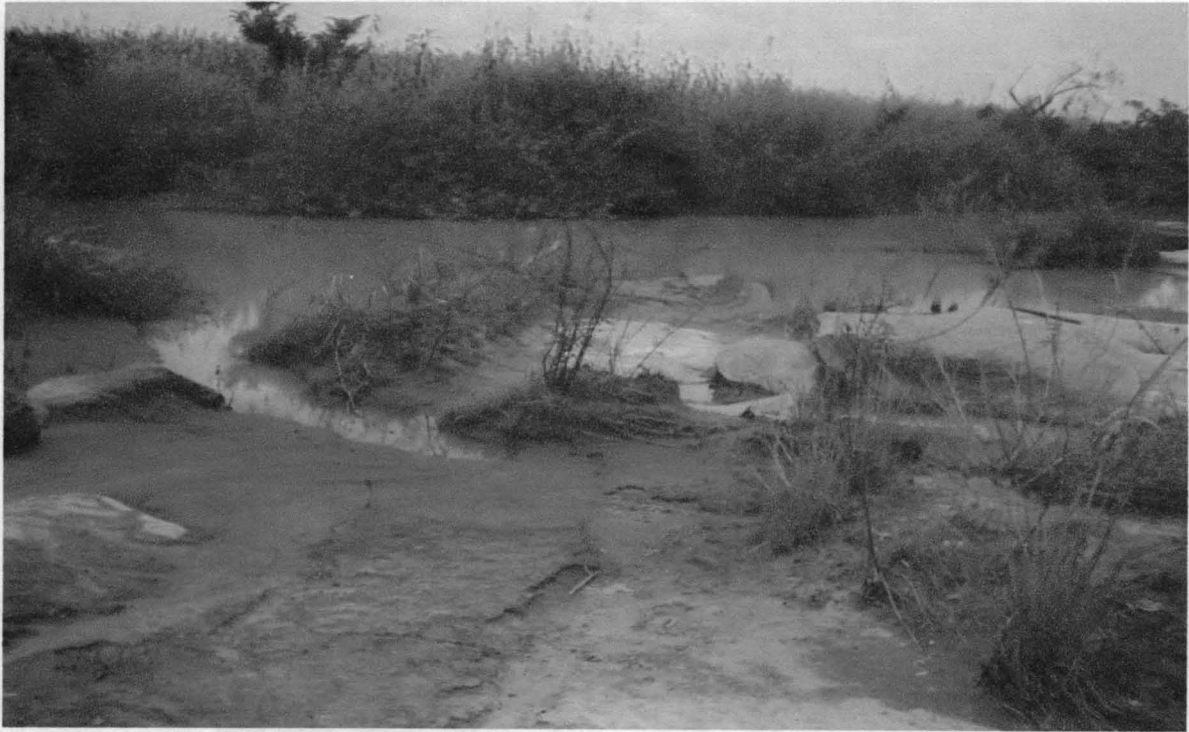
Plate 4: Previous farmland washed away by flood. Surveyed in October 2004

With the adverse effect of the rain and flood, some of the rocks (basement rocks are exposed hence the increasing number of rock outcrop found in this area. The trend in the pattern of erosion is shown in Plates 4, 5 and 6.

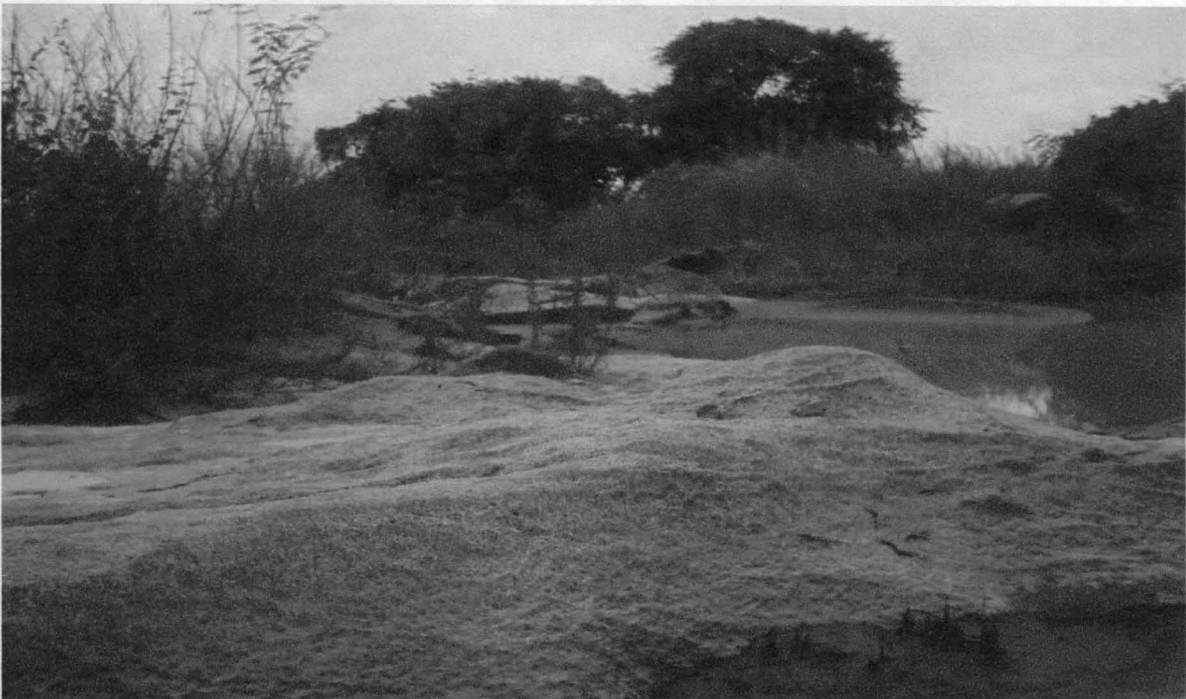
Plate 5: Partially exposed rock after the sand was washed, October 2004

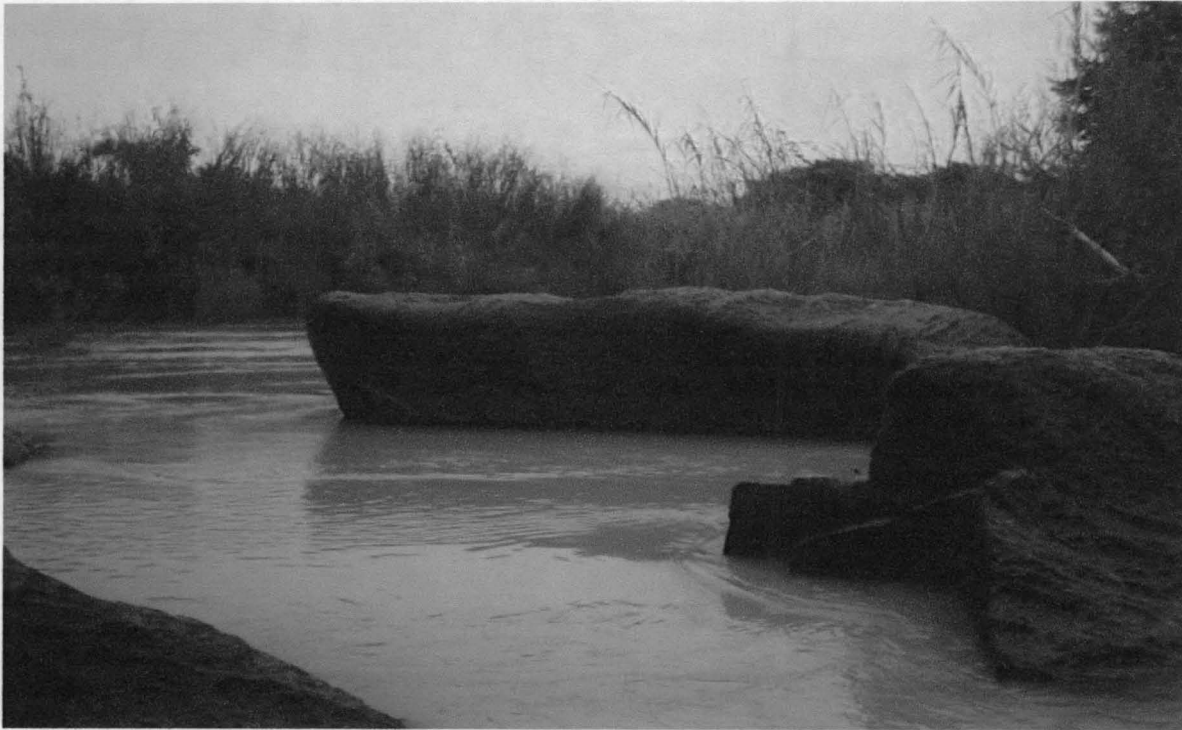
Plate 6: Once a farmland but the rock now exposed as a result of erosion, October 2004.

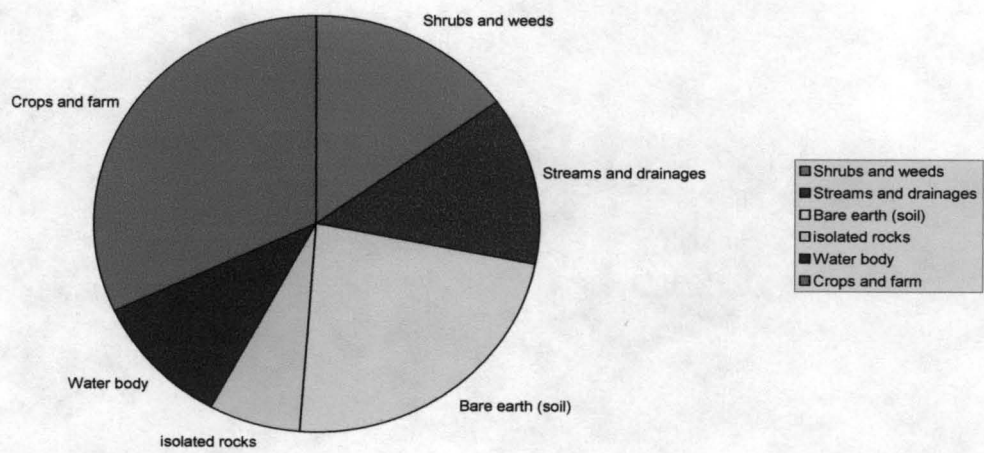
Assessing the activities (Fig.4.4) of the people (basically farming) the result shows a reduction in farm land. The result of analysis reveals that in 2001, there were about 2155.47 hectares of farm land. This has reduced to about 787.66 hectares of farm land in 2003. This is because more fertile land available for cultivation was washed away by flood effect (see Plate 7, 8 and 9) and more rocks exposed (see Plate 4, 5 and 6 above) as a resultant of erosion effect from flood. Hence, the total land area available for effective cultivation is therefore reduced by this effect since most of the farming is done at the bank of the river. Beside, the entire study area is characterised with isolated rocks which made the land unfit for cultivation.

Fig.4.4: Summary of the changes in land use

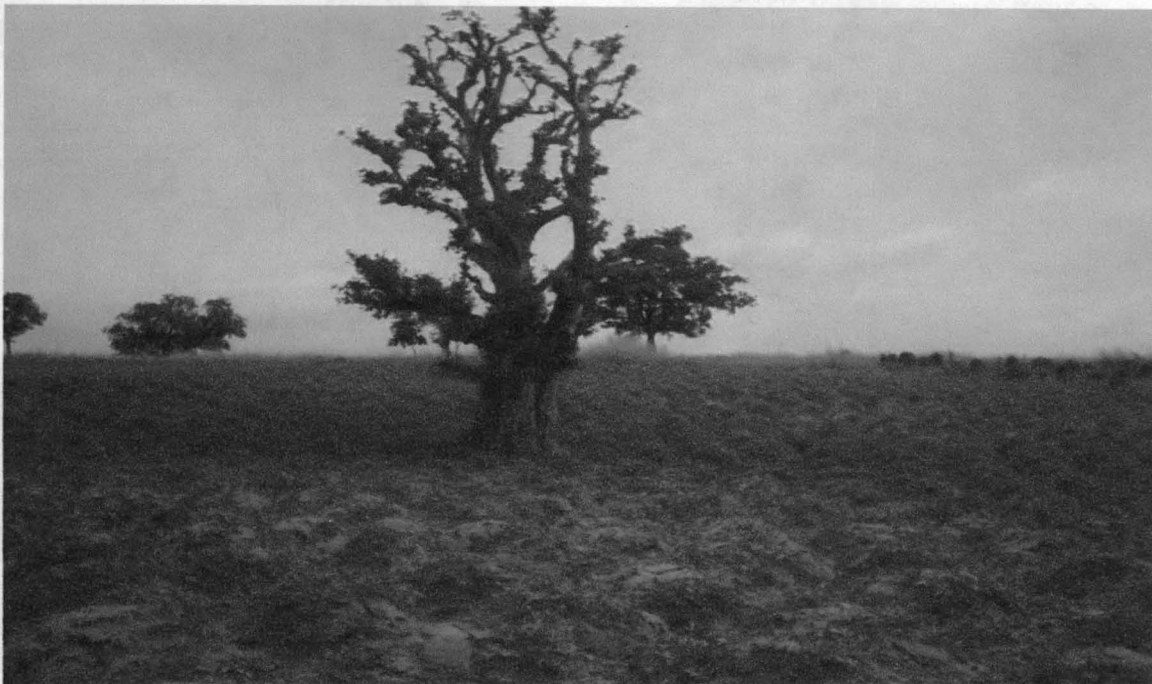
Plate 7: Farmland about 150m from the river, but over flow went up to the Baoba tree in the picture.

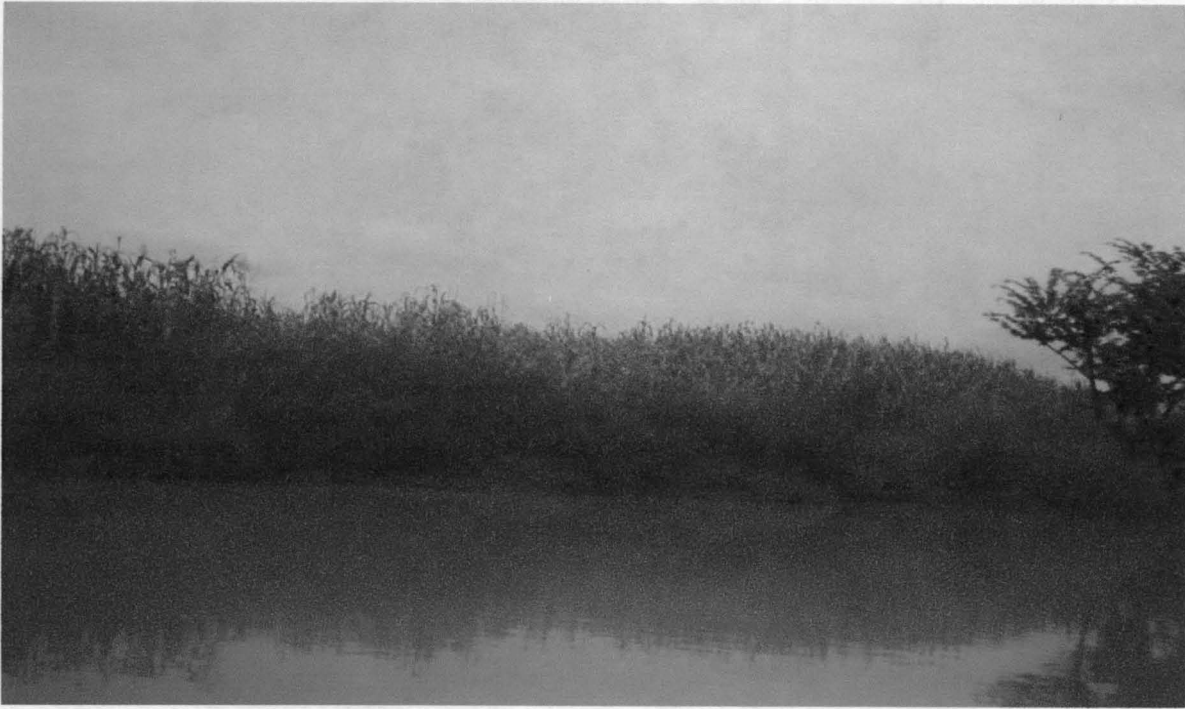
Plate 8: Farmland about to be washed away. October 2004

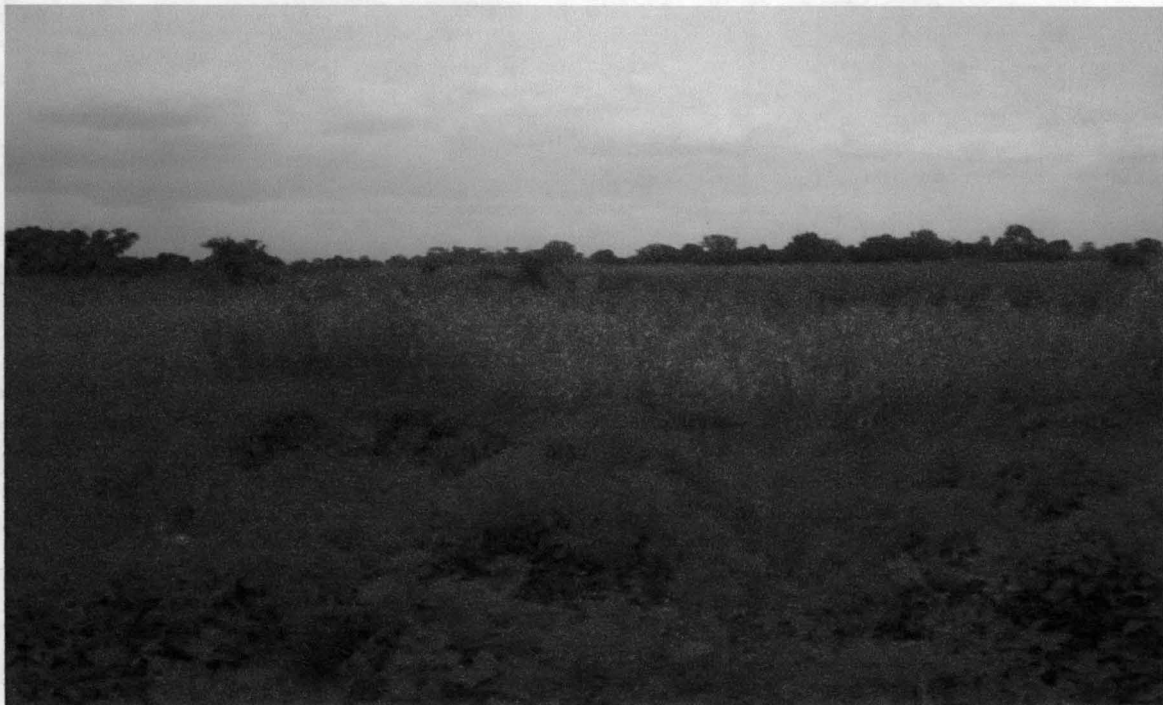
Plate 9: Farmland of the settlers about 300m from the river. October 2004
