**AN ASSESSMENT OF THE EFFECTS OF  
LANDUSE PRACTICES  
ON  
AGBA DAM IN ILORIN  
USING A REMOTE SENSING TECHNIQUE**

BEING A THESIS SUBMITTED TO THE DEPARTMENT OF  
GEOGRAPHY IN PARTIAL FULFILMENT OF THE  
REQUIREMENTS FOR THE AWARD OF THE DEGREE OF  
MASTERS IN TECHNOLOGY (REMOTE SENSING) SCHOOL OF  
SCIENCE AND SCIENCE EDUCATION  
FEDERAL UNIVERSITY OF TECHNOLOGY, MINNA.

NOV., 2003

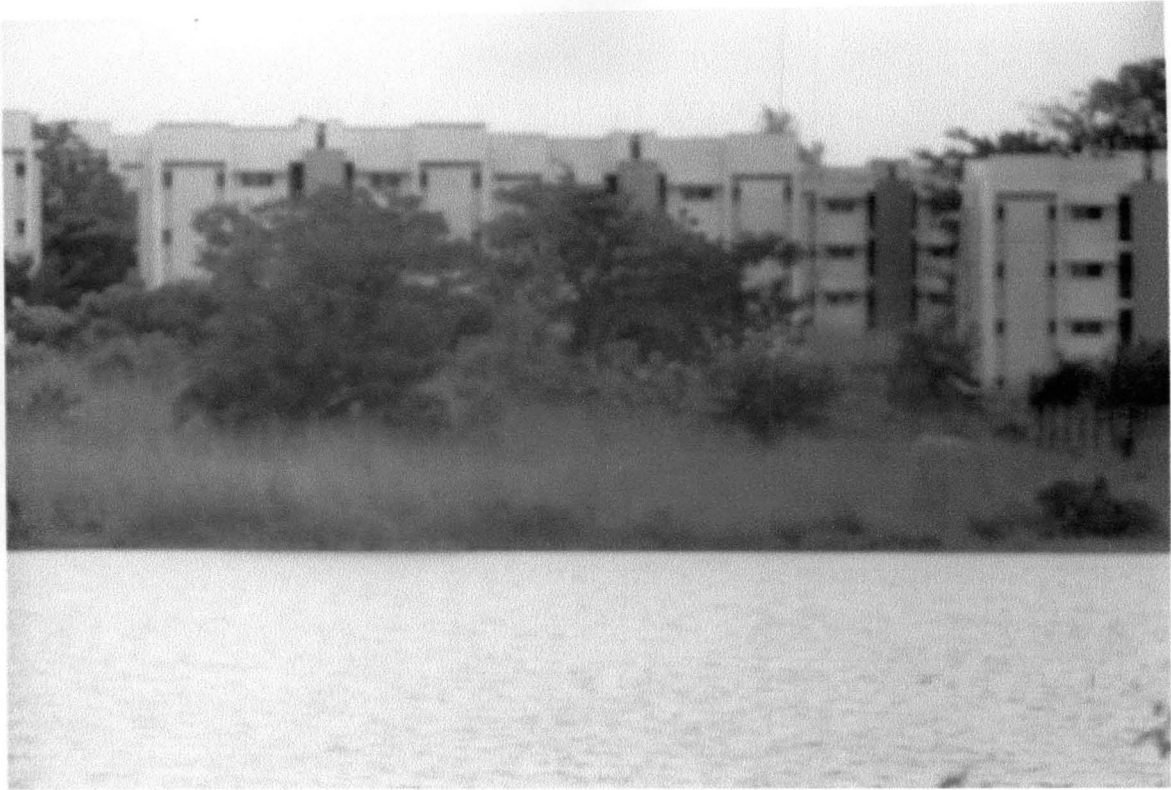
**Plate 1:- Residential Building Close to the Dam**

Household detergent that contains phosphates flows into water bodies and also lead to eutrophication of the water. This domestic sewage from buildings around the dam includes all wastewater from bath sinks, basins and similar appliances in the home.

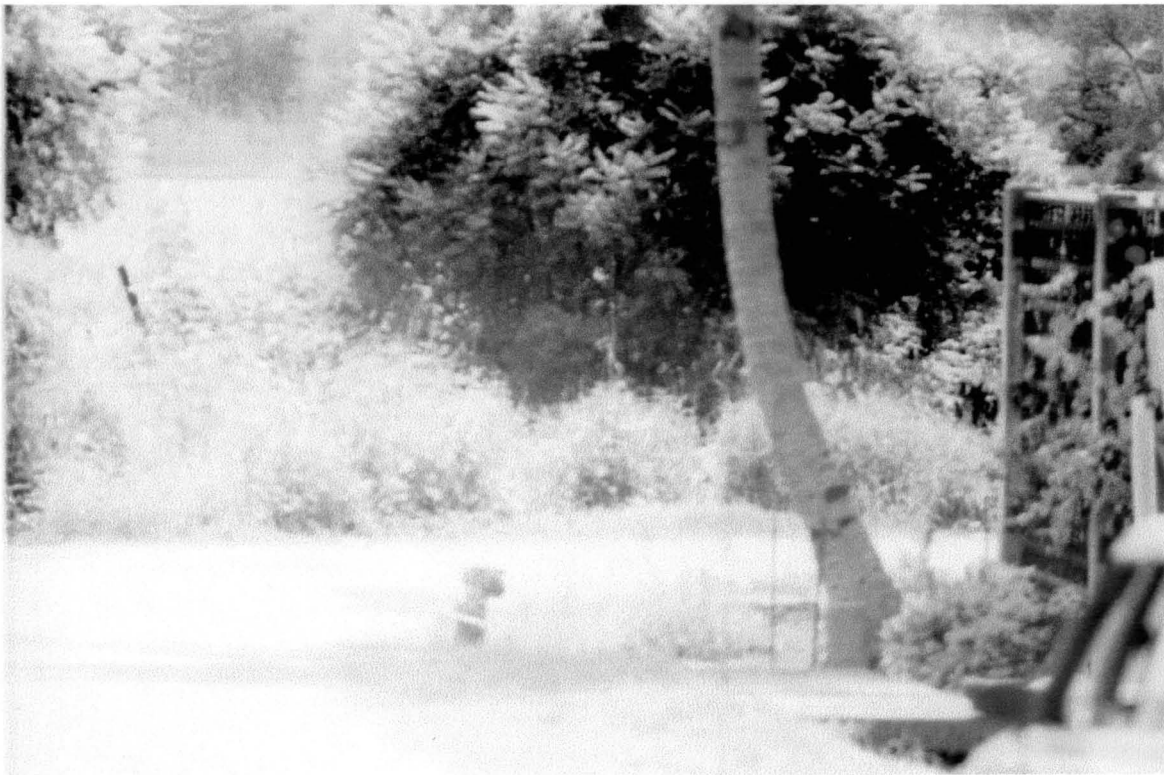
**Plate 2:- Tarred Road round the Dam**

Tarred road are seen detouring round the dam and also leading to the dam and out. Since erosion between tarred and untarred road are not the same so the tarred roads are prone to surface wash and this all have serious impact on the dam.

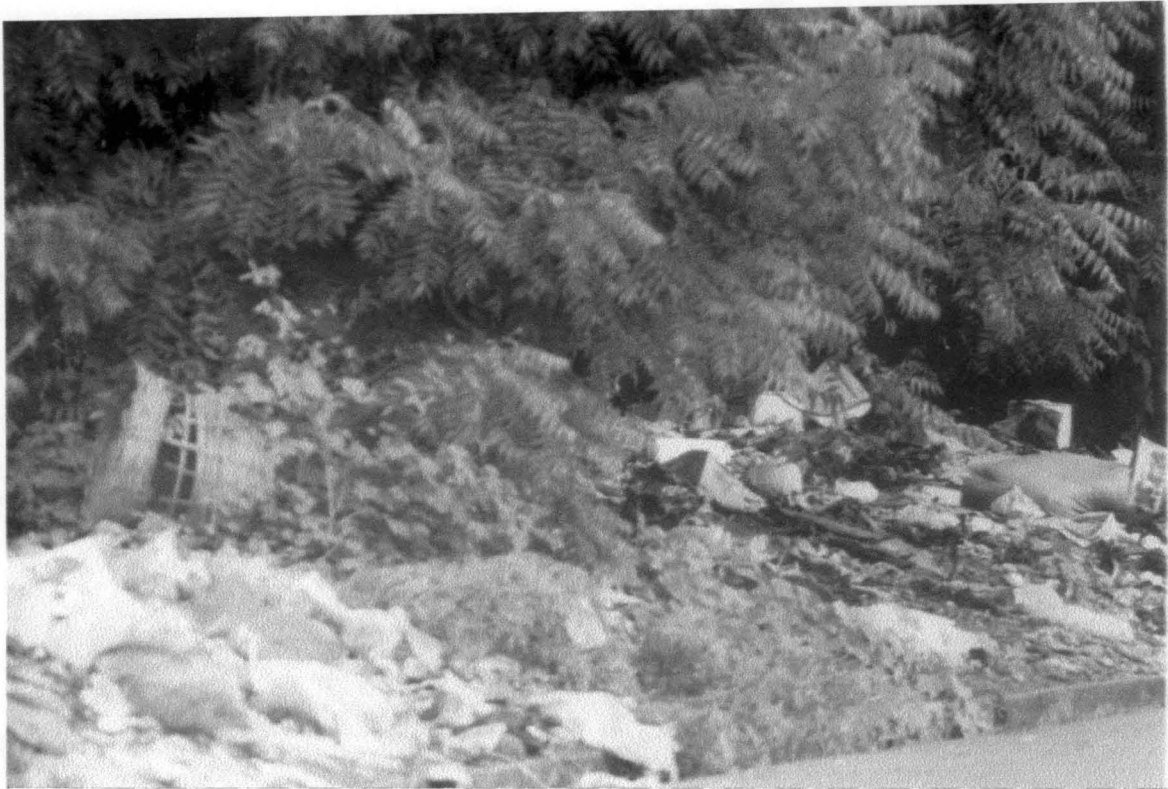
**Plate 3:- Domestic Waste Disposal very close to the Dam**

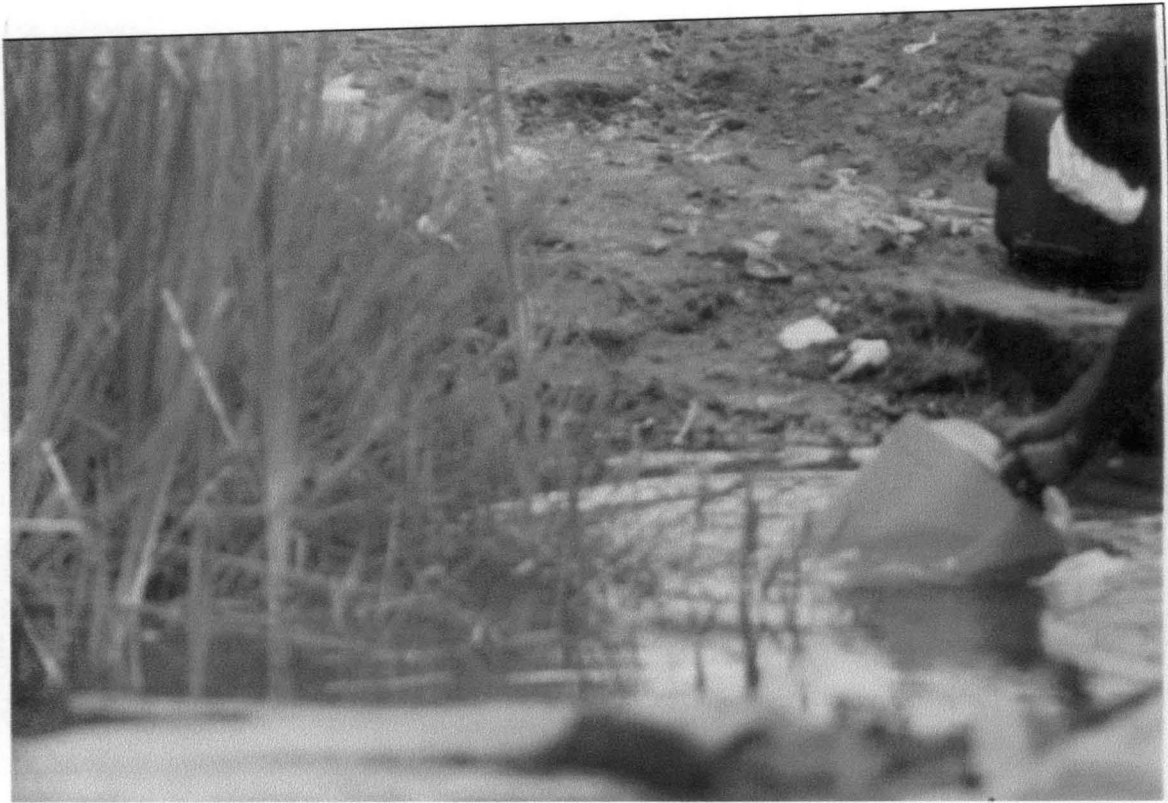
**Plate 4:- Picture Showing Irrigation Farming**

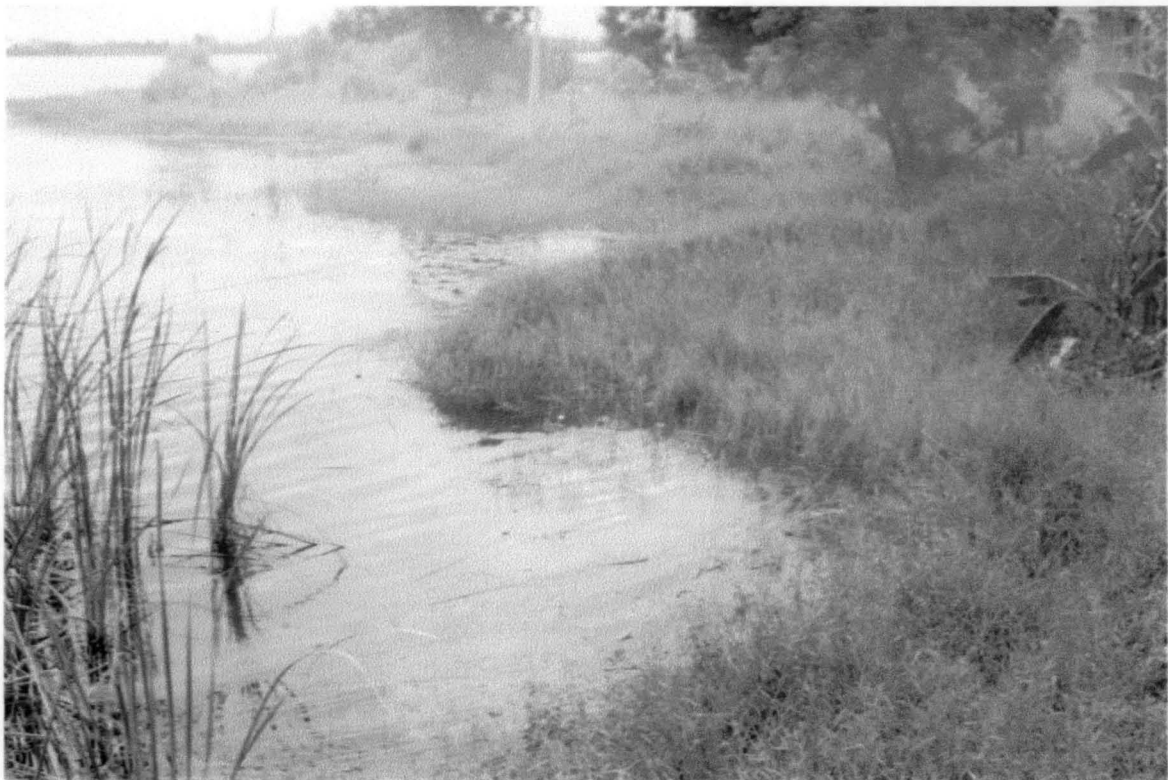
**Plate 5:- Banana Cultivation and Sedimentation**

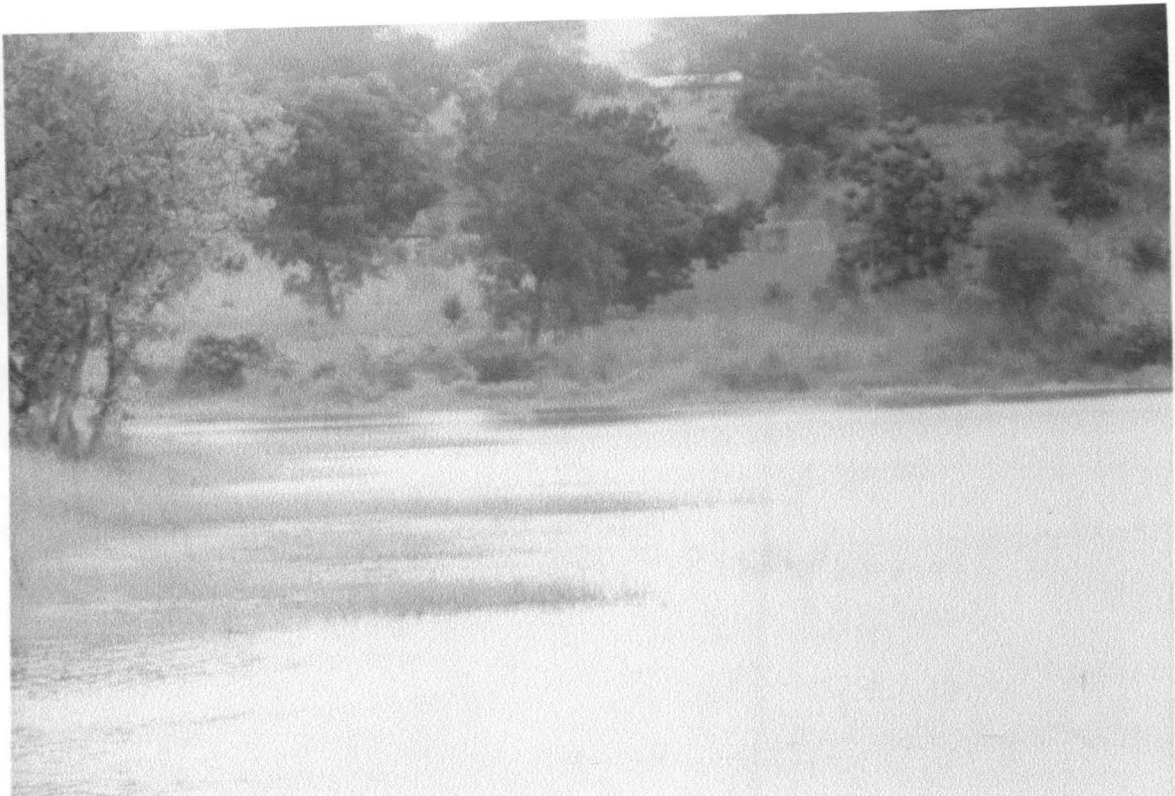
**Plate 6:- A Picture Showing Sedimentation**

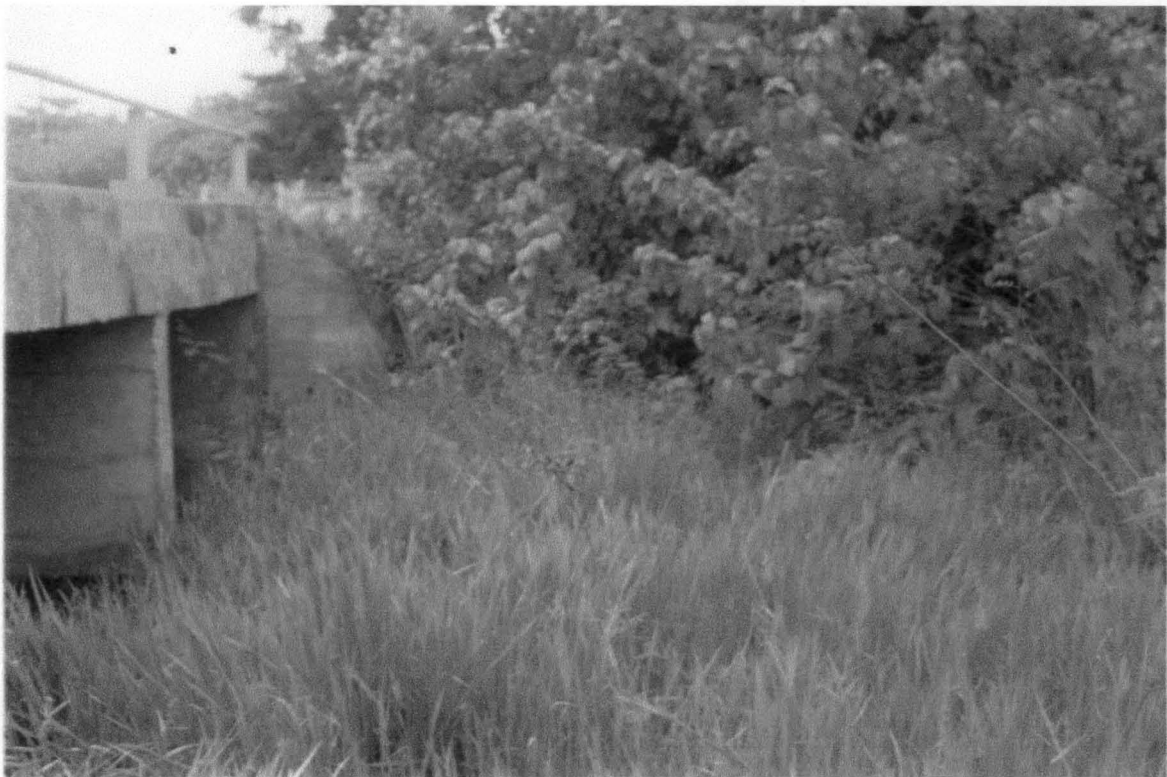
**Plate 7:- Another Source of Water into the Dam**

A pilot survey was undertaken round the dam. This is to identify the upstream and downstream of the dam, it was observed that the water enter the dam via two-source .The two sources to the dam is from Agba stream and the second source can be seen in Fig 4.4.
