**URBAN EROSION CONTROL AS PANACEA FOR
ENVIRONMENTAL DEGRADATION**

**A CASE STUDY OF FEDERAL GOVERNMENT OF NIGERIA –
SULEJA TOWNSHIP EROSION CONTROL PROJECT**

**DEPARTMENT OF GEOGRAPHY
SCHOOL OF SCIENCE AND SCIENCE EDUCATION
FEDERAL UNIVERSITY OF TECHNOLOGY, MINNA.**

**IN PARTIAL FULFILLMENT OF THE REQUIREMENT
FOR THE AWARD OF POST GRADUATE DIPLOMA IN
ENVIRONMENTAL MANAGEMENT OF THE FEDERAL
UNIVERSITY OF TECHNOLOGY,
MINNA, NIGER STATE.**

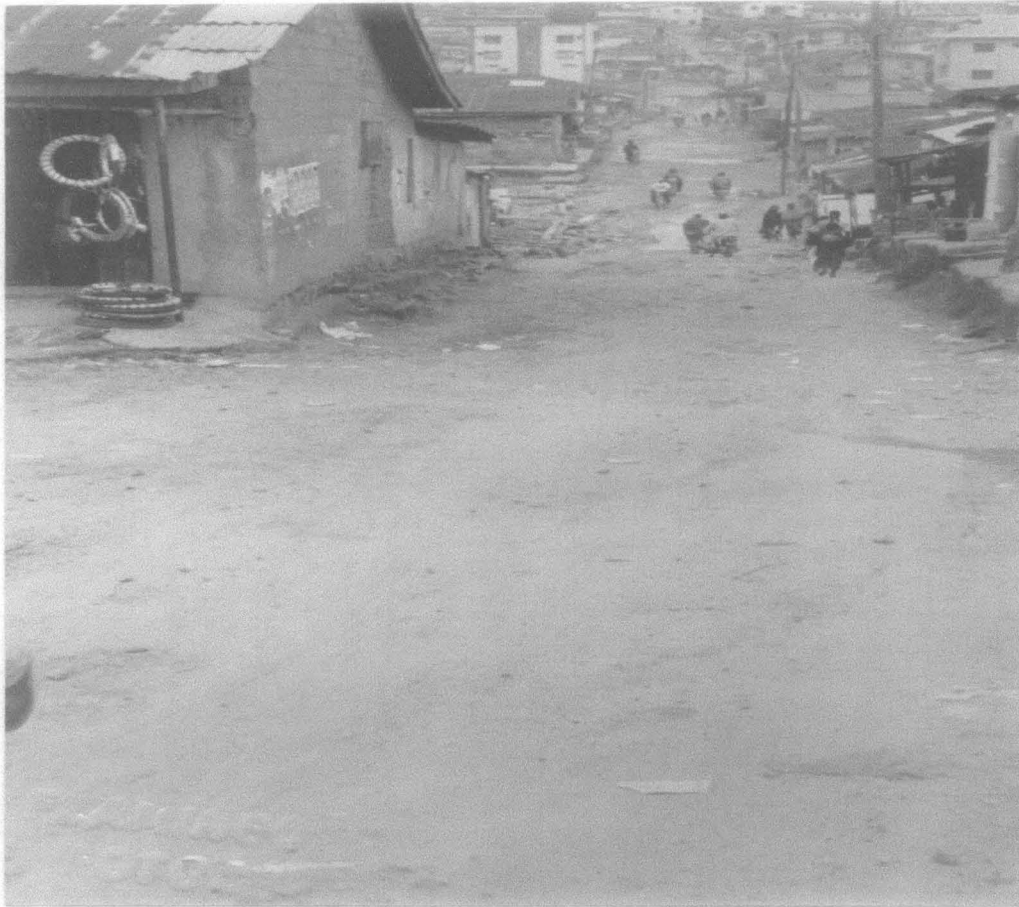
Plate 4.1b: Part of Victory Road in deplorable condition

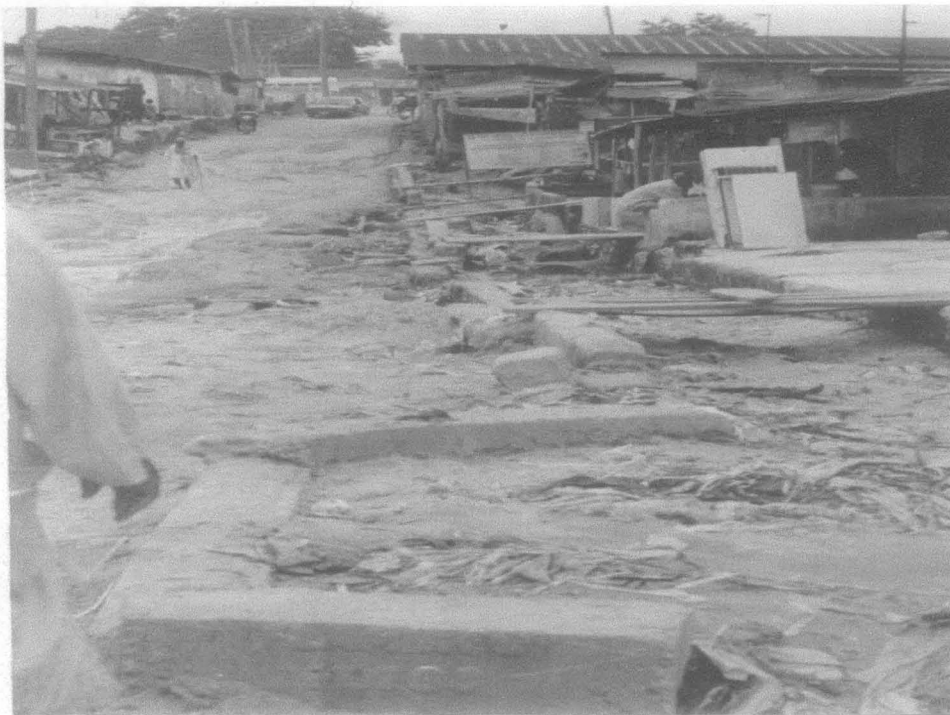
Plate 4.1c: Another Part of Victory Road completely devastated by erosion no longer motorable and road culvert blocked by deposits from unconstructed rainwater run off.

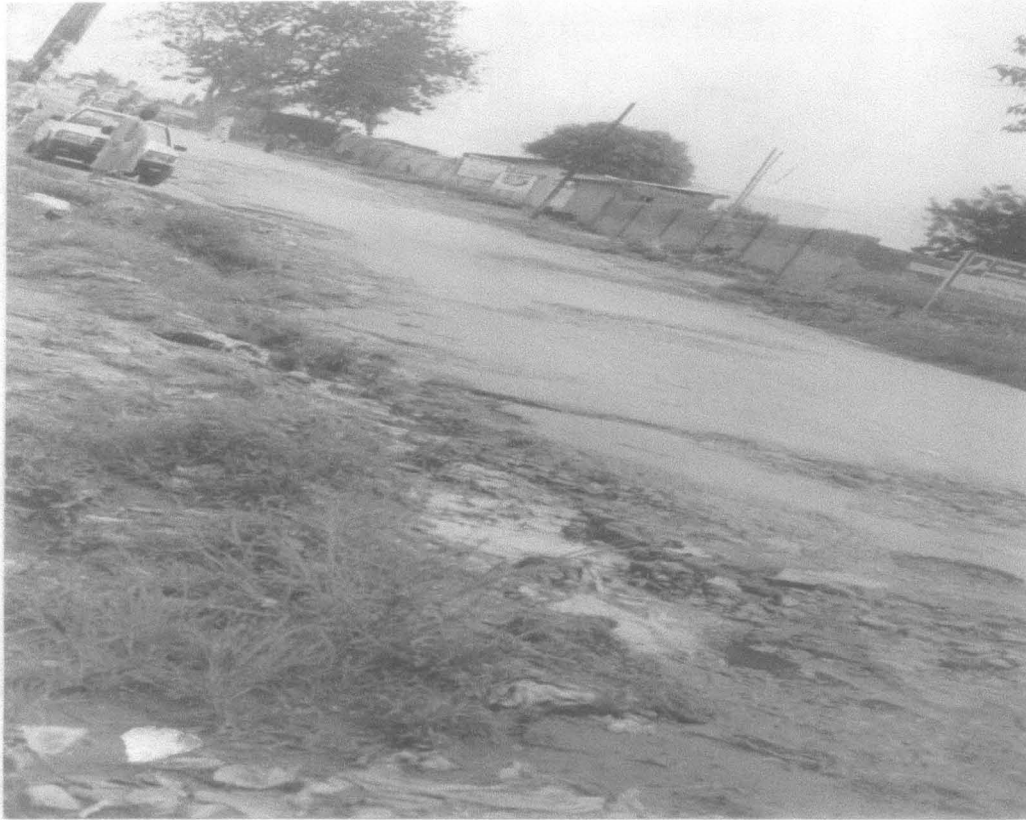
Plate 4.1d: GRA / Union Bank Road, washed away by Erosion, water storm channel not in existence

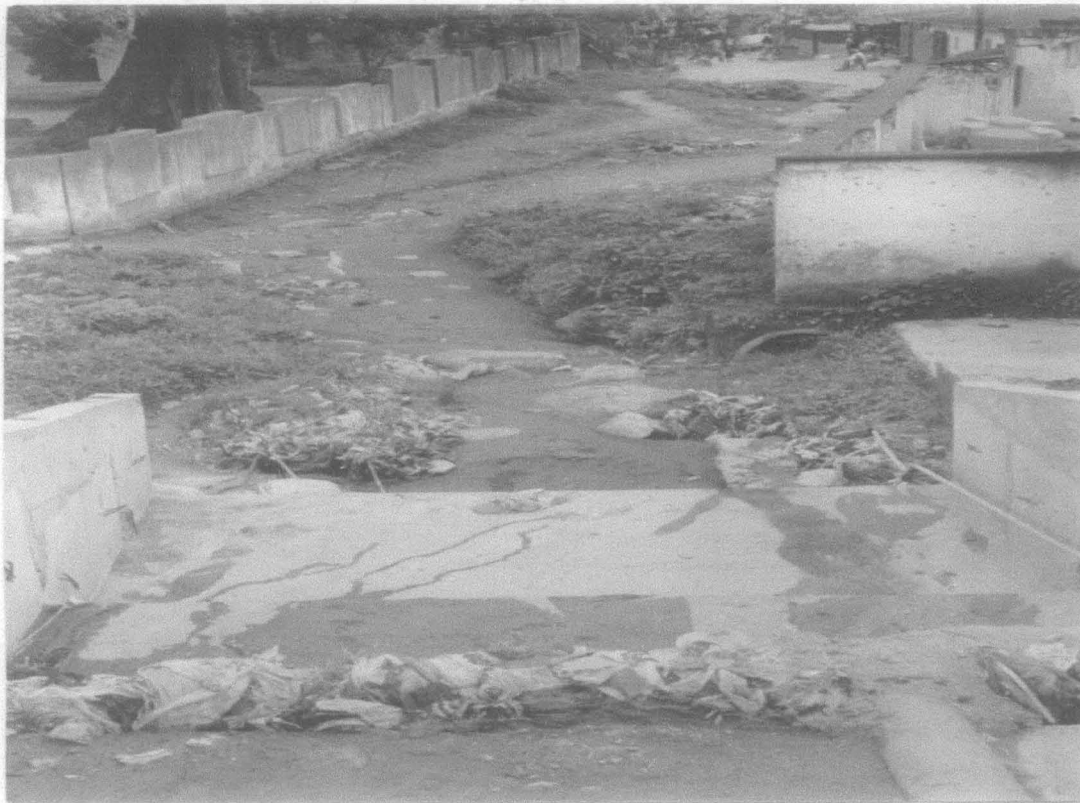
Plate 4.1e: 'B.Division', water channel, drainage not connected to the main township drainage.

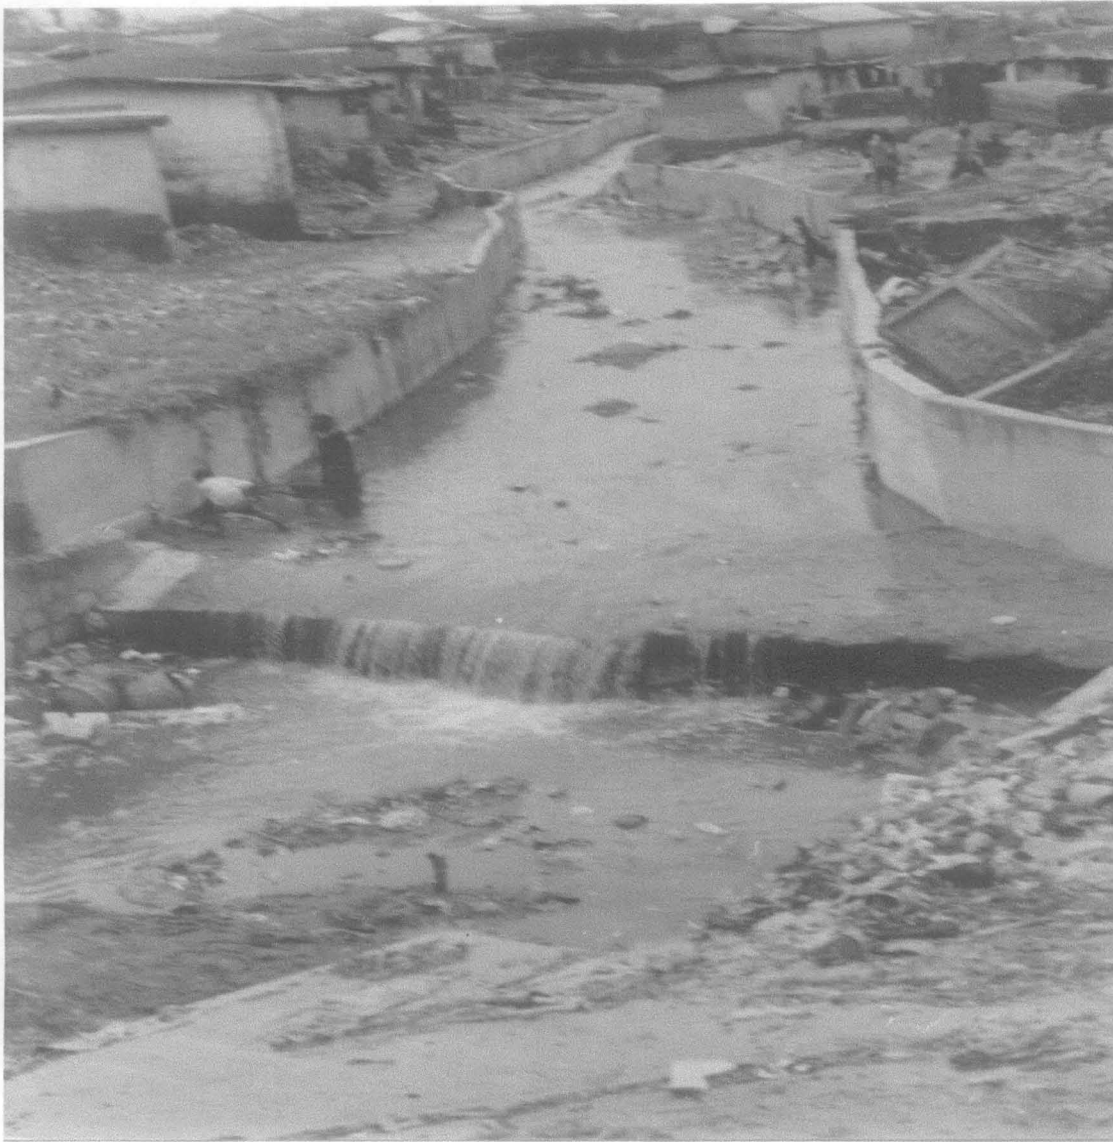
Plate 4.1f: Dawak Junction / U.B.A Road Water Channel, Drainage Banks not fully sandfill creating another vacuum for water pool.

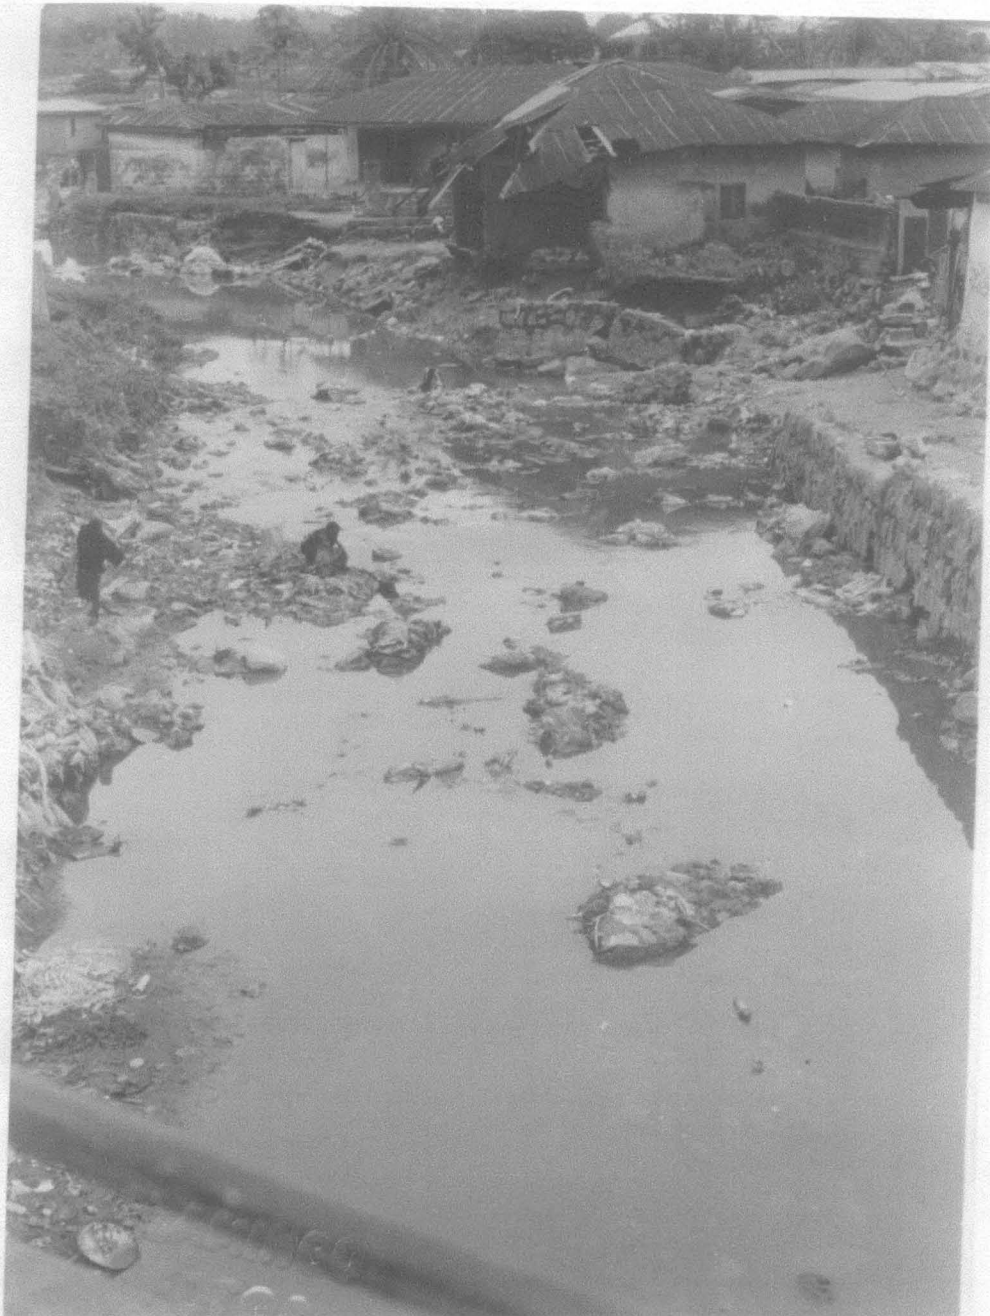
4.1g: Dawaki Junction – Kantoma – Channel uncovered by Township Erosion Control Project. Showing Diverstating effect on building and other structures.
