**DISTRIBUTION, CONTROL AND
MEASUREMENT OF IRRIGATION
WATER ON THE FARM: A CASE STUDY
OF TUNGAN KAWO IRRIGATION SCHEME**

***A PROJECT REPORT SUBMITTED TO THE SCHOOL OF POSTGRADUATE
STUDIES, FEDERAL UNIVERSITY OF TECHNOLOGY MINNA, IN PARTIAL
FULFILMENT OF THE REQUIREMENT FOR THE AWARD OF
POSTGRADUATE DIPLOMA (PGD) IN AGRICULTURAL ENGINEERING
(AND WATER OPTION)***

FEBRUARY, 1999

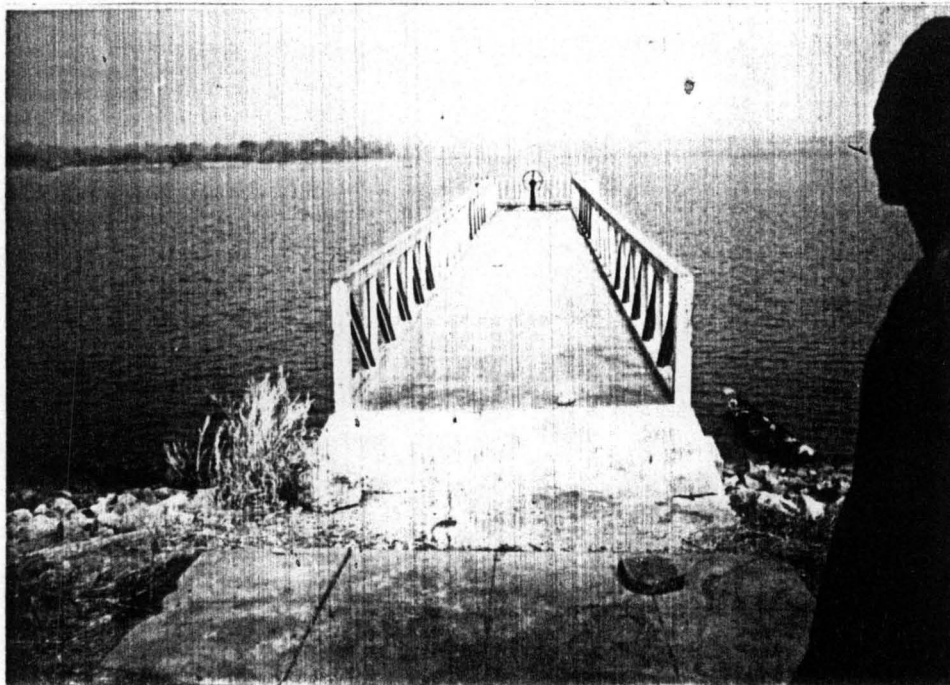
Fig. 3: Upstream view of Tunga Kawo Dam with slide gate.

- i) Intake structure:- For supplying water from the reservoir to the main canal, the outlet works was provided. These include intake structure of internal diameter dimensions of 3.0m by 3.0m with the provision of trash rack and grooves for stop logs to be dropped in emergency. For supply to the main canal, are cast in situ reinforced concrete conduit pipe of 120 cm internal diameter was provided. The upstream inert of the pipe was kept at El. 105.00 and the down stream at 105.25m giving a longitudinal slope of 0.01 with the above mentioned arrangement the water way of the conduit pipe passes a discharge of $3.44\text{m}^3/\text{sec}$ with a minimum water level of 107.5m on the up stream side. The flow through the pipe is being controlled by vertical lifting sliding gate.

6. Nearly all the control gates are in various stages of disrepair. The main intake gate is only being managed at the moment. The sliding gate spindle and gear accessories for the bifurcation, escape and off take structures at the tertiary canals are worn out making them extremely difficult to operate. The wooden logs used as turnout gates also serve very little purpose of water control.

6. The intake, bifurcation, escape and tertiary canal gates require serious rehabilitation. It will also be necessary to provide spares of their accessories for replacement any time the need arises.

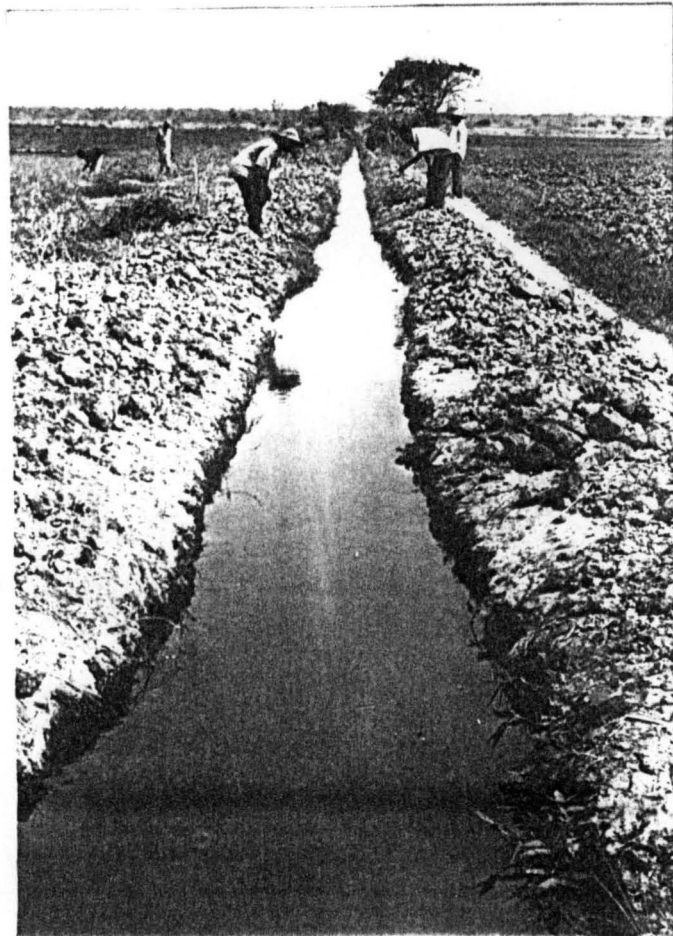
Fig. 6: A field channel being disilted by farmers

- iv) Field channels:- There are a total of 63 field channels taking off from secondary or Tertiary canals. The lengths of the field channels vary from a minimum of 280m to a maximum of 720m. The sizes of blocks served by the channels also vary from a minimum of 5.5ha to a maximum of 20 hectares. Most of the blocks sizes were kept within the range of 11-15ha so that the discharge of the field channels does not exceed $0.06\text{m}^3/\text{sec}$ (2 cusecs).

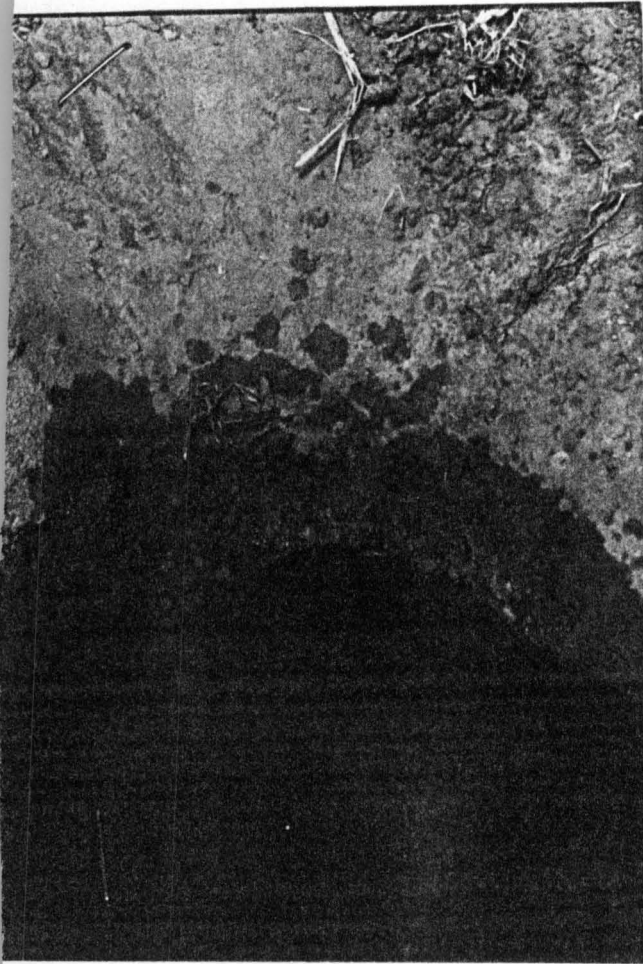
Fig. 7a. Upstream view of Pipe Outlet installed on field channel.

Estimating flow in an open channel is done in the same manner as that through pipe to the field since there are no measuring structures on the field channel. It should be noted that most field channels have submerged outlets and in estimating flow, the head difference between the water level in the canal and that of the field channel is determined and the equation of the pipe flow applied to estimate flow

4. The existing pipe sizes used in some of the turnouts produced low discharges relative to the field demand. Such pipe should be replaced with those of bigger diameters to match up the field demand with the supply.

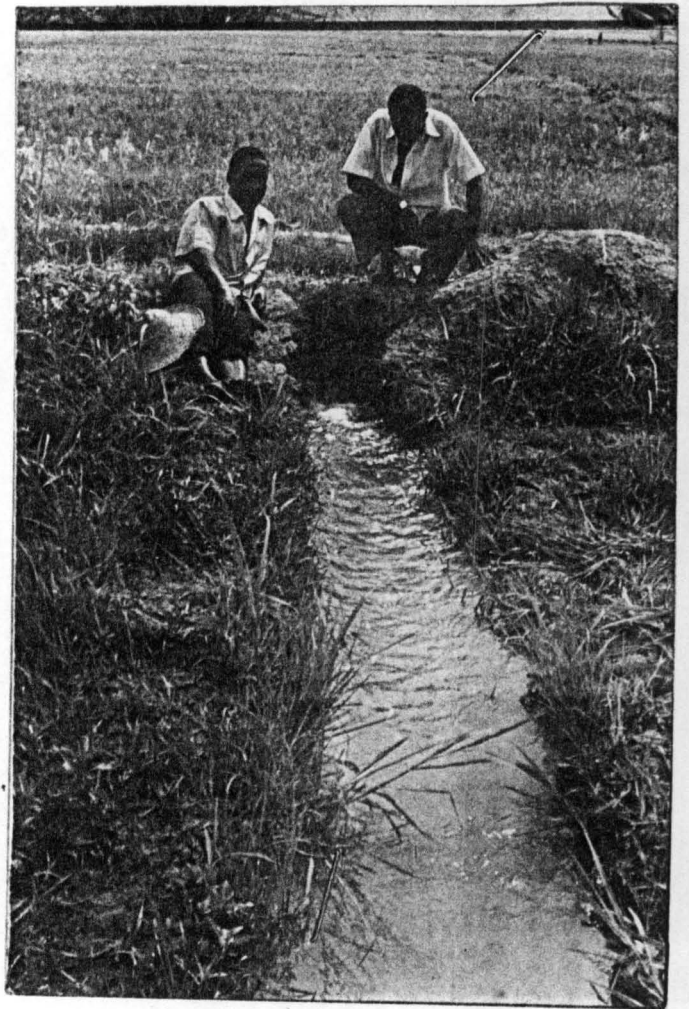
Fig. 7b. Downstream view of the Pipe Outlet.
