SEDIMENTATION AND POLLUTION PROBLEMS IN BOSSO RESERVOIR:

AN INTEGRATED STUDY INVOLVING SPOT XS, GROUND AND

LABORATORY DATA

IN PARTIAL FULFILMENT OF THE REQUIREMENT FOR THE AWARD OF MASTERS OF TECHNOLOGY IN REMOTE SENSING APPLICATIONS

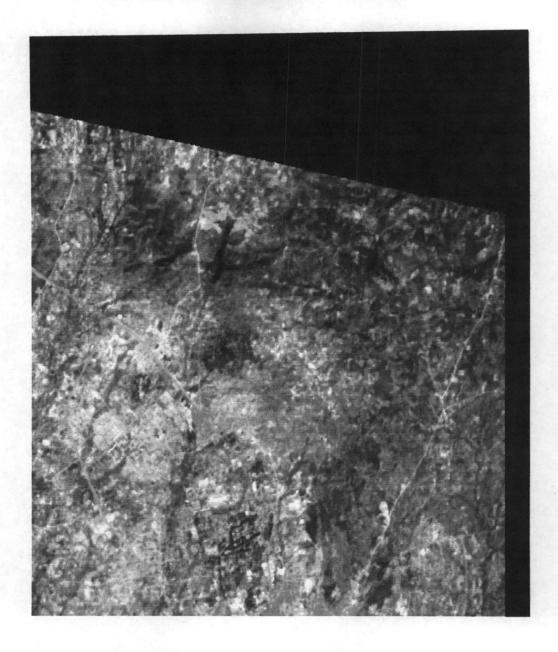
FIGURE: 3.2 GEO-REFERENCE IMAGE OF MINNA, 1994

The Georefenced image is seen as fig. 3.2

The mountainous areas of Minna seen on georenference image on fig 3.2 provide a vast land for the mountainous vegetation type. This class is sometimes seen to be associated with or coexisting with the woodland/forest and are often, riparian vegetation type.

The carved area shows Bosso dam to the north of the SPOT Georeferenced image on Fig. 3.2 The mountain ranges to the east, center and at the fringes of Minna township. Other features will be classified for the purpose of this research later. The orthographic view of the image is shown on figure 3.4

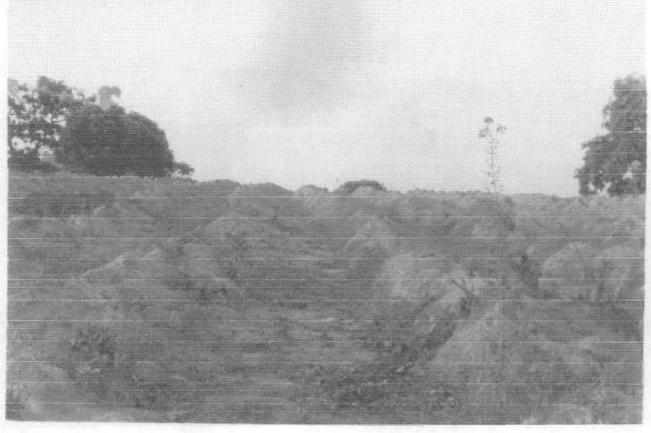
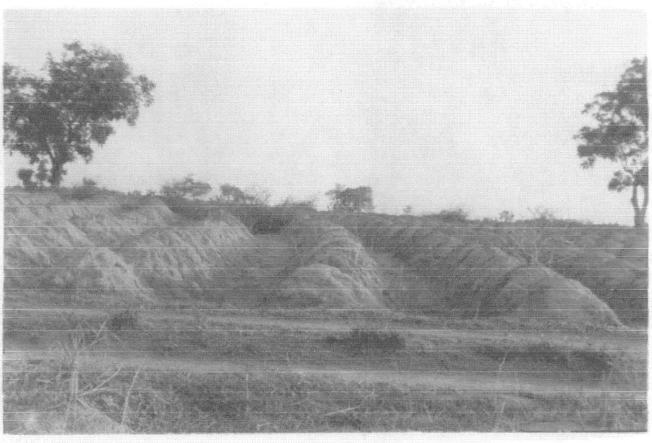
Plate 1 & 2:- Showing the agricultural activities on Cultivated slope.

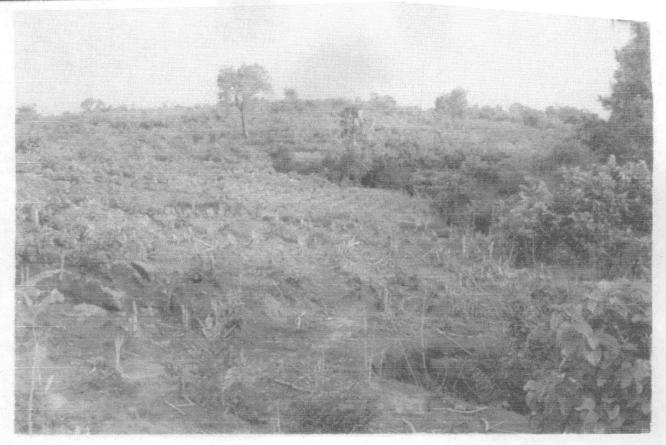
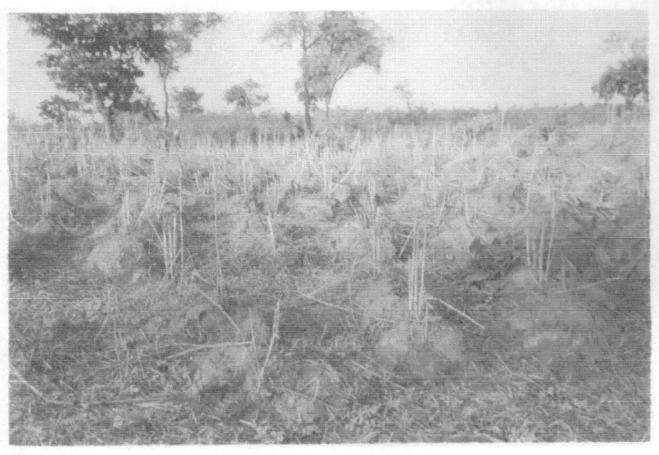
Plate 3 & 4:- Showing indiscriminate agricultural activities just upstream the reservoir.

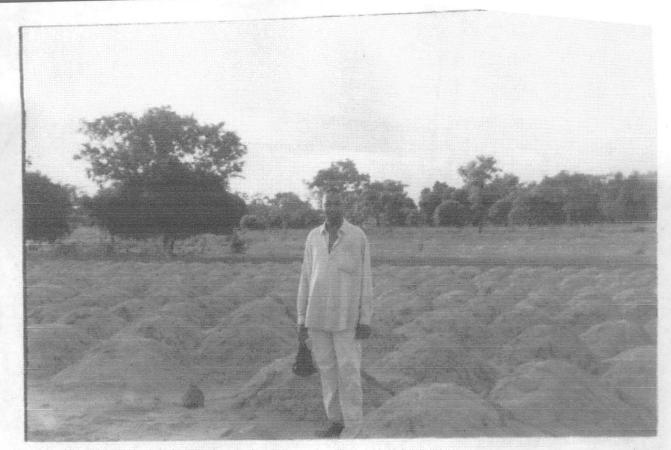
Plate 5:- Showing a boundary between the cultivated area and Densely vegetated area during ground truthing.

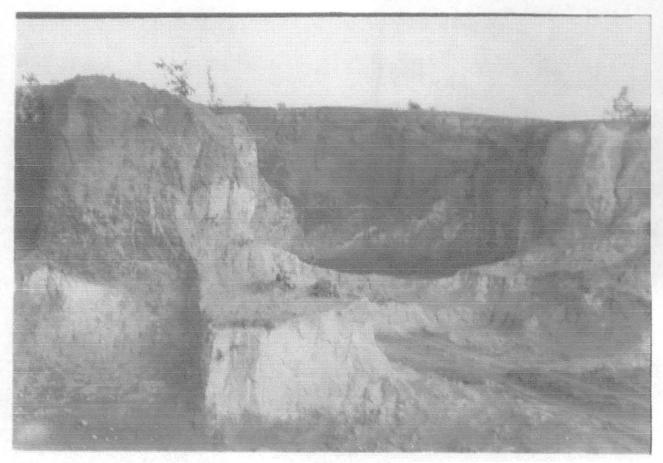
Plate 8:- Showing laterite excavation activities around the Dam

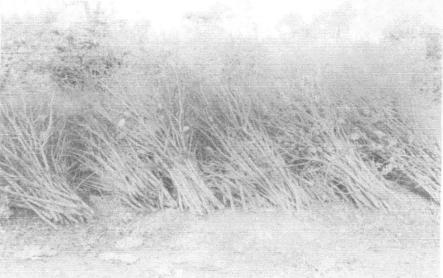
Plate 11. Plate 9, 10 & 11:- Showing degradation of the environment by felling of trees and cutting of shrubs at the banks of the reservoir.

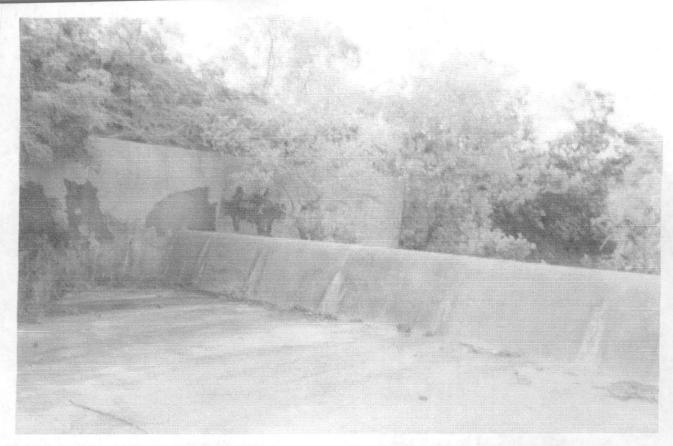
Plate 12:- Showing Eroded fringes of the reservoir at the Spillway.

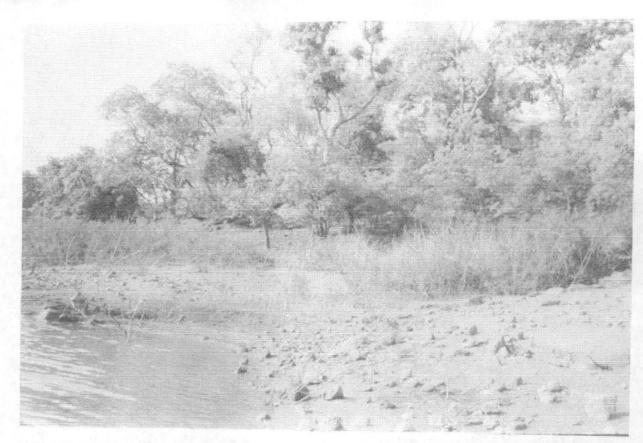
Plate 14:- Moved rock debris and vegetation growing on sediments.
