# RECLAMATION OF DERELICT PONDS OF BIRNIN KEBBI URBAN ENVIRONMENT

A DISSERTATION SUBMITTED IN PARTIAL FULFILMENT OF THE REQUIREMENT FOR THE AWARD OF MASTER OF TECHNOLOGY DEGREE IN REMOTE SENSING APPLICATIONS

DEPARTMENT OF GEOGRAPHY
FEDERAL UNIVERSITY OF TECHNOLOGY

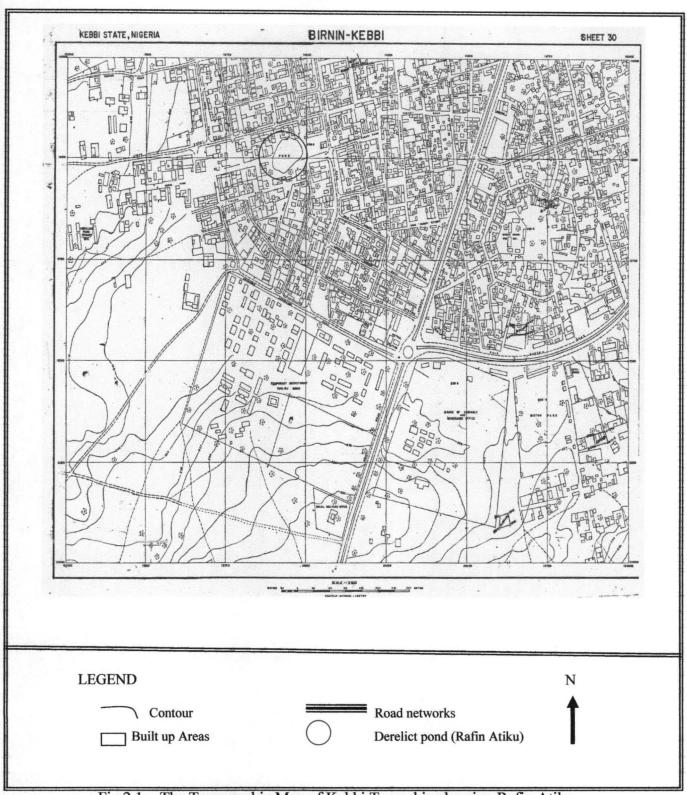
Fig.2.1: The Topographic Map of Kebbi Township showing Rafin Atiku

The master plan of Birnin Kebbi, 1980-2000 reveals that the soil condition in the Birnin Kebbi urban area would normally allow rain fall to percolate into the ground without causing flooding. However, as the town continue to expand and develop, the original area becomes covered with impermeable materials such as zinc, roofing concrete and tarred roads. The capacity for the remaining area to absorb the rainfall is greatly reduced; consequently, flooding is unavoidable year in year out around tpond areas making homes to be flooded floors and furniture are ruined and the roads underwater while some are washed down causing erosion at the banks. The concerned present administration had to embark on reclamation exercise which consequently, had brought a lot of positive physical development in the state capital. Although, a lot more needs to be done because many more still exist in other areas of the town that requires urgent attention.

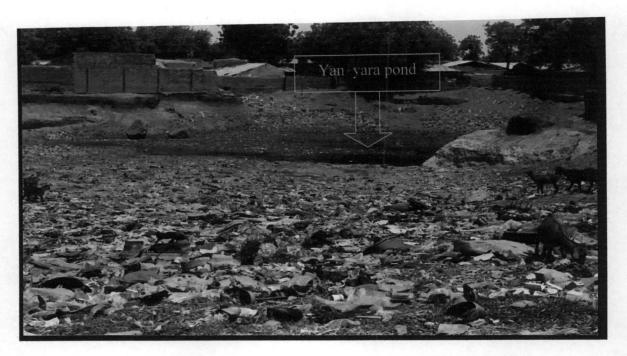
Plate 1: Solid Waste dumped in one of the ponds (Yan yara pond)

volume of water. Photographs of the refuse dumped at the pond an area is shown on plate 1.

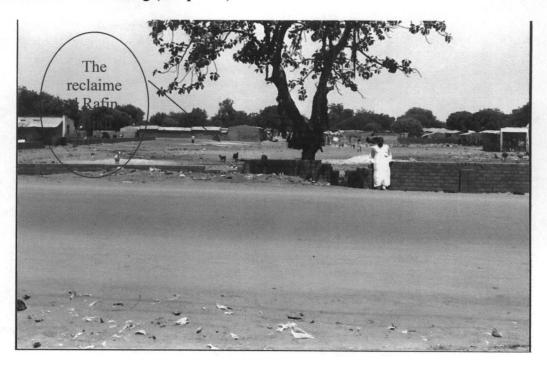
Plate 2: At the reclaimed Rafin Atiku derelict pond by Kebbi State Government

Apart from the construction of drainage, the pond that formerly received its run-off from three cardinal slops from Dukku Hill Area, Dukku Barracks, and Haliru Abdul Secretariat, has also been reclaimed into children's park through emptying the pond of all its content and sand filling (See plate2).

The Kebbi State Government in 2003 awarded the construction of a 4 Kilometre drainage system that emptied the Rafin Atiku Pond that was like a monster to the neighbourhood. The drainage system empties into the Shella Fadama east of the township.

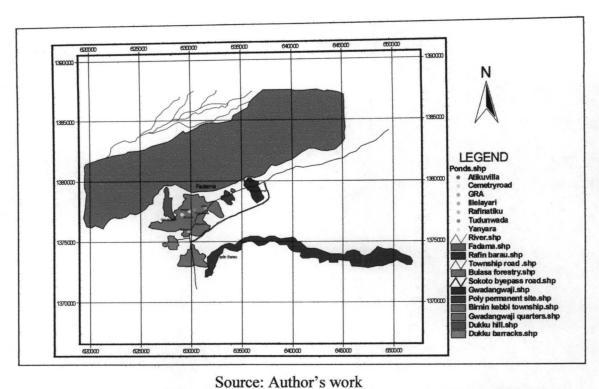
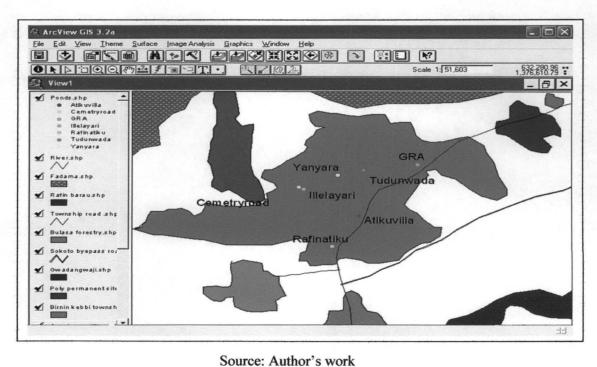
All these details were properly edited after digitization and were subjected to quality connectively and completeness of coverage (See figure 4.1a&b).

Figure 4.1a: Kebbi Township Map showing various landuses and the location of ponds

Figure 4.1b: Land use Map of Kebbi State Township in GIS environment

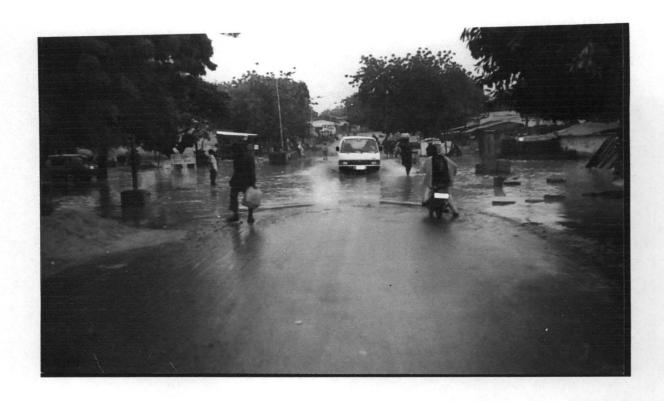
These photographs reveal the environmental degradation resulting from the direct effect of the ponds. For example, the flood how the overflow of the pond submerged the road and houses as shown in plate 3. The overflow was all over the streets and obstructed free flow of tropic and the environment was littered with solid waste materials. Also noted from the photograph are the areas of the ponds that have turned into refuse dumps both inside and the surrounding (refer to plate 2). The photographs also reveal the abandoned borrow pits it contain water lilies growing inside since stagnate water in some of the pond remain all year round(See plate 4). The effect of erosion at the edges of the pond towards residential building is also noted on the plates as indicated in plates 5.

Plate 3: Flood effect resulting from overfill of Rafin Atiku pond in 2004

At the dawn of every year, a fraction of land around the pond areas suffers physical degradation due to the activities of material mining. The areas degraded reduce the potential capability to provide sanitary and recreational uses. This degradation is largely human-induced and this includes a strong socio-cultural component. Consequently, land conservation and rehabilitation can technically be feasible, but often at high costs. The environmental impact of the mining activity is severe in some regions of the township. For instance, the land behind Illela Yari Old Prisons has been greatly devastated through the clearing and digging. Now, this area is unsuitable for any development activity, the hilly sides even suffer severe erosion and the left out dugged areas collects stagnant water. In such regions, there are no free movement neither are they suitable for further development. This is illustrated in plate 3.

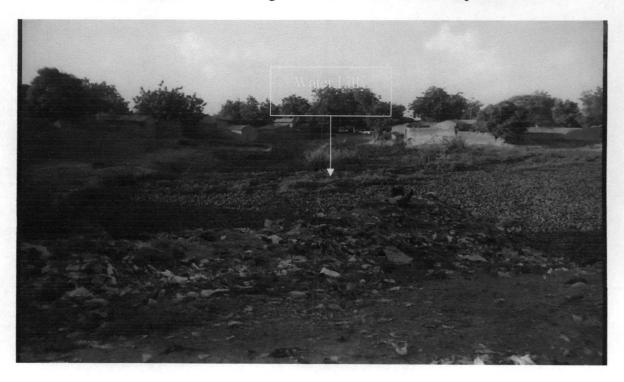
Plate4: A pond covered by water Lilly

The existence of these derelict ponds distributed about the urban environment do not provide aesthetically good quality environment. Overgrown grasses and water lilies are found in most of the abandoned ponds, thus making the site unpleasant since they are located in the midst of residential areas.

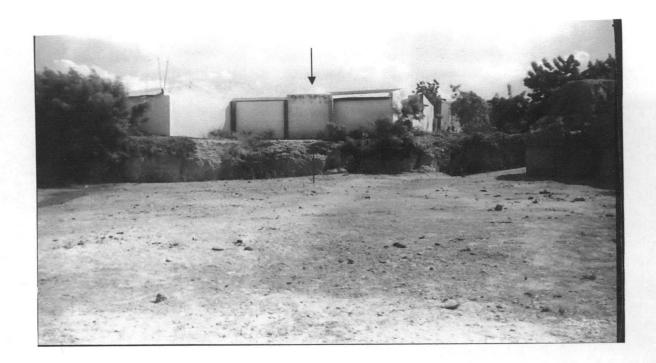
Plate 5: The effect of derelict ponds on the structural development (Expansion of Ponds eroding the foundation of buildings).

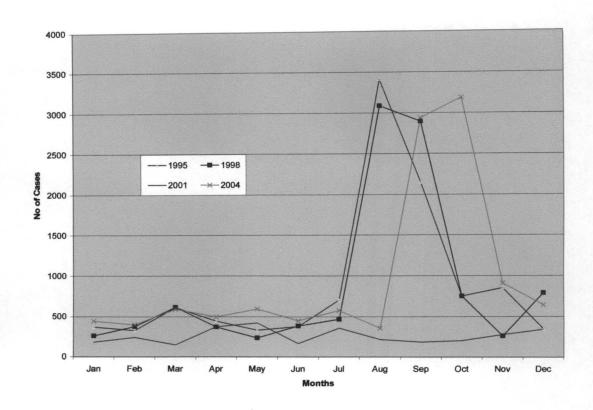
The annual returns of the Sir Yahaya Memorial Specialist Hospital of the cases of malaria and typhoid fever for a period of ten years (1995-2004) the number of patients treated or cases of malaria and typhoid reveals high cases of the diseases between July and

November of every year (see figure 4.2). This coincided with the period of High rainfall which is usually recorded between the month of July and October every year.

Fig.4.2: Cases of Malaria & typhoid treated (1995 - 2004)

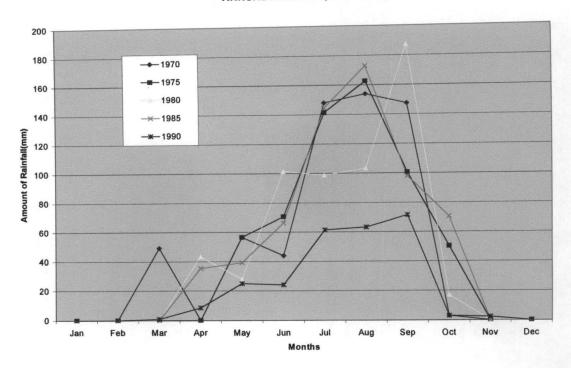
Fig.4.3: Trend of Annual Rainfall (1970–1990)

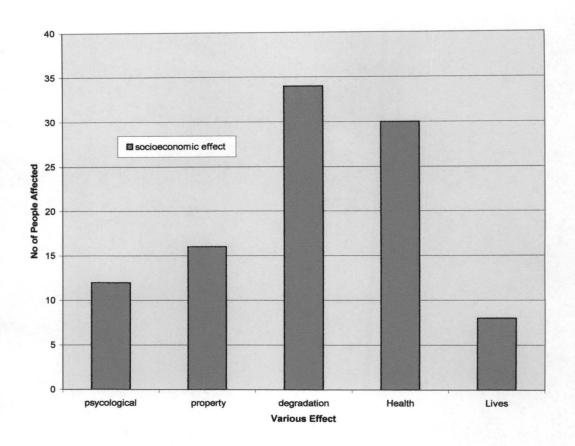
Floods are catastrophic events which put at risk human lives, valued property, homes and businesses. The existence of the derelict ponds(Earth mining ponds) in Birnin Kebbi township as resulted into floods over the years have occurred without warning and with effect of rainfall., Enormous property have been lost and even lives. The town's infrastructure has also been affected severely including the communication and transportation facilities. The result(Fig.4.4) of the field analysis conducted reveals that

effect of these ponds in the township has resulted into environmental degradations (34%), constitute health hazard (30%),lost of valuable properties(16%),psychological trauma(12%) and lost of lives(8%).

Fig.4.4: Socioeconomic Effect of the Derelicts ponds

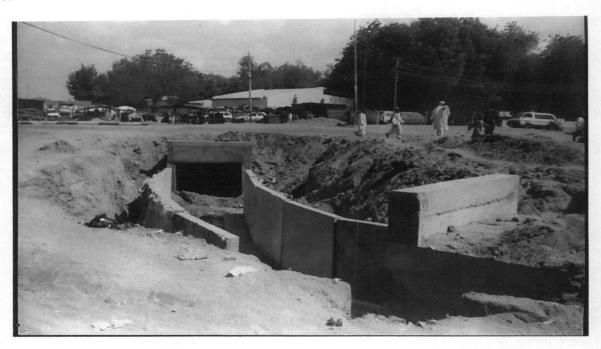
The 4 kilometre drainage system has been constructed from the pond area into shella fadama, the eastern part of the township. The pond itself has been reclaimed and converted the area into children's park, whose construction work has since began see plate 6.

Plate 6: Construction of drainages to discharge water from Rafin Atiku pond

An assessment carried out by Hybrid Design and Associates on the reclaimed pond indicates that, minor works would still be required to properly drain both silages and storm waters emanating from the densely populated areas adjacent to the drainage system. Similarly, in order to protect the park from future destruction there is need to construct perimeter drainage to receive water from the catchments area around the former pond.

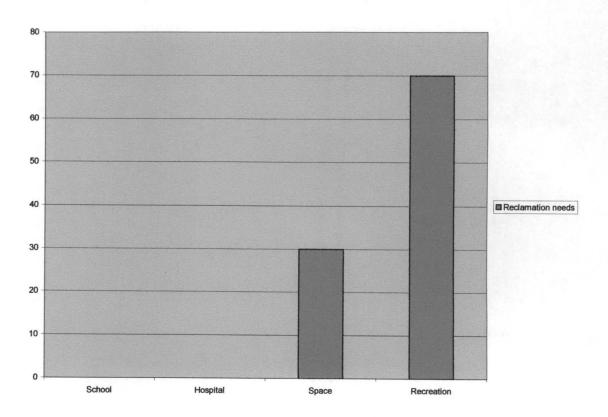
The analysis of field survey(Fig.4.5) has revealed that majority of the respondents(70%) are of the opinion that the derelict ponds be reclaimed for recreational purposes the remaining(30%) suggested that the ponds be reclaimed into open spaces or any useful purposes, most especially building construction i.e. mini markets.

Figure: 4.5. Response to the need for Reclamation
