**THE EFFECTS OF RAINSTORM ON BUILDINGS IN CHANGHAGA
AREA OF NIGER STATE**

**PROJECT SUBMITTED IN PARTIAL FULFILMENT OF THE
REQUIREMENT FOR THE AWARD OF POST GRADUATE DIPLOMA
[PGD] ENVIRONMENTAL MANAGEMENT**

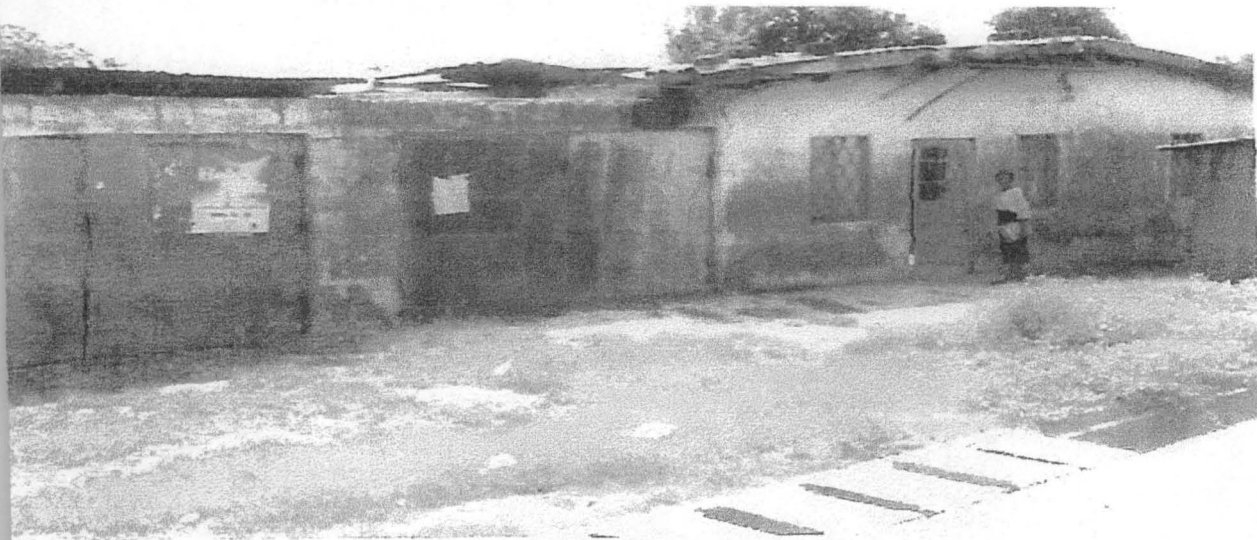
Plate 1: The effect of rainstorm on a house; Wind has blown off Part of the roof, discoloured paint surface, corroded metal gate, roofing timber, fascia, board and ceiling board decayed due to moisture.

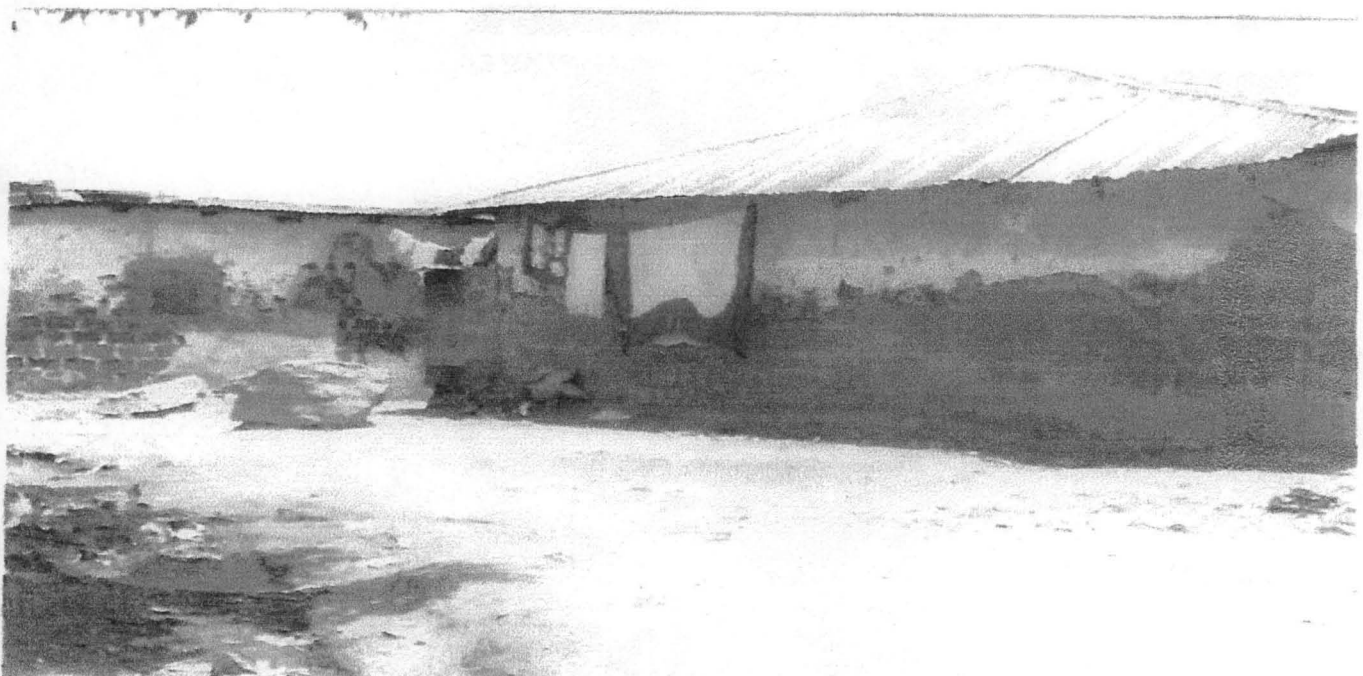
Plate 4: Shows the effect of rain which have wash off the paint and peel of the rendering exposing the mud and sandcrete block in Chanchaga town.

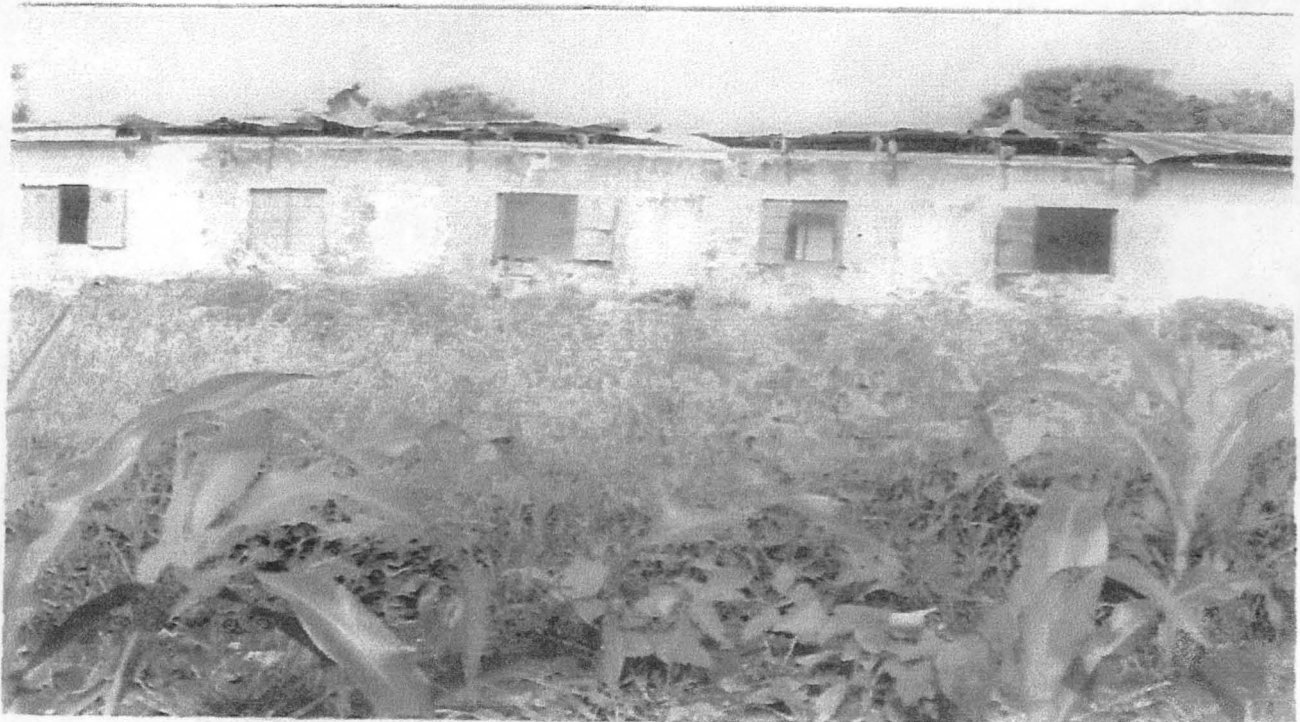
Plate 6: The effect of rain washing away the paint on wall and Wind blowing off part of the roofing sheet. Also part of Fascia board and ceiling board completely falling off in G.T.C. Minna.

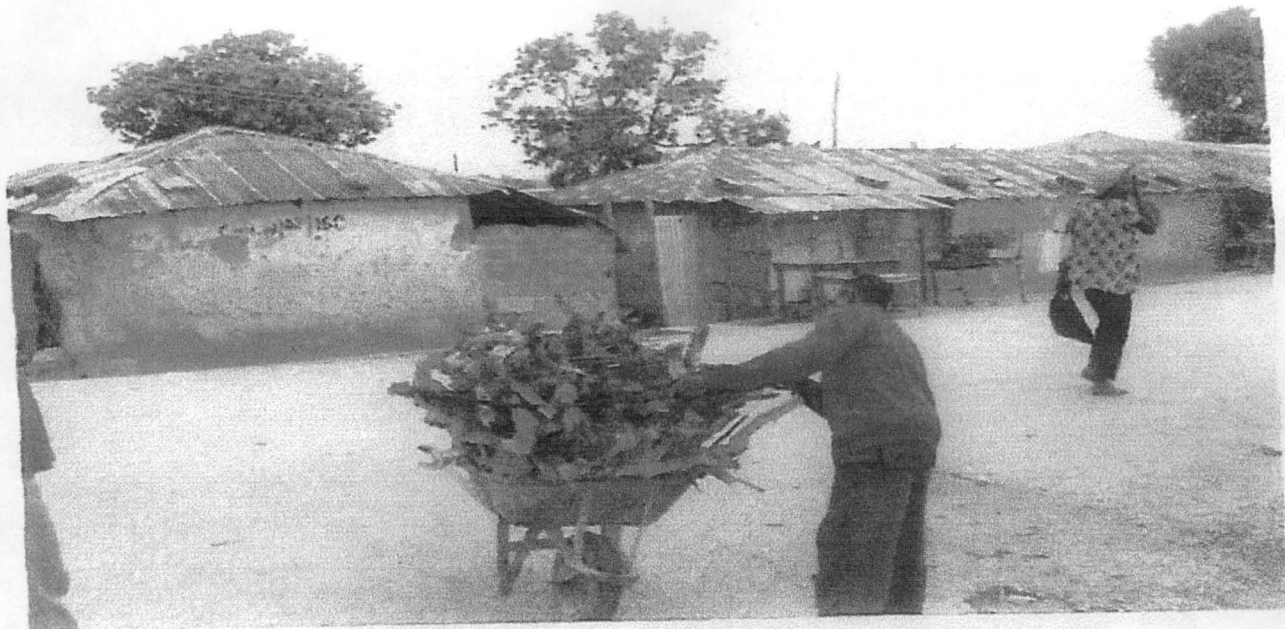
Plate 7: Shows large stone and block placed on roof top to prevent roofing sheet from been blown off by wind. Also shown the effect of rain on wall discolouring and flaking the rendered wall

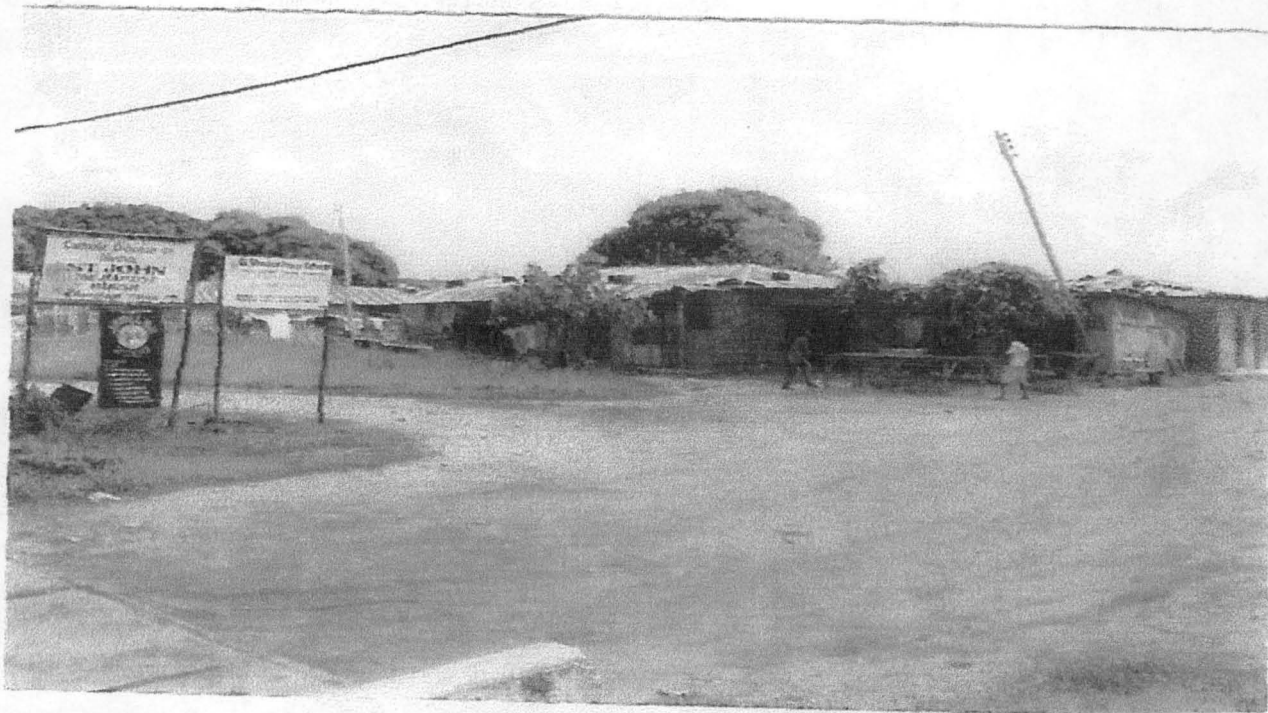
Plate 8: Shows buildings with large stone and block laid on the roofing sheets to prevent lifting in the event of rainstorm within Chanchaga town.

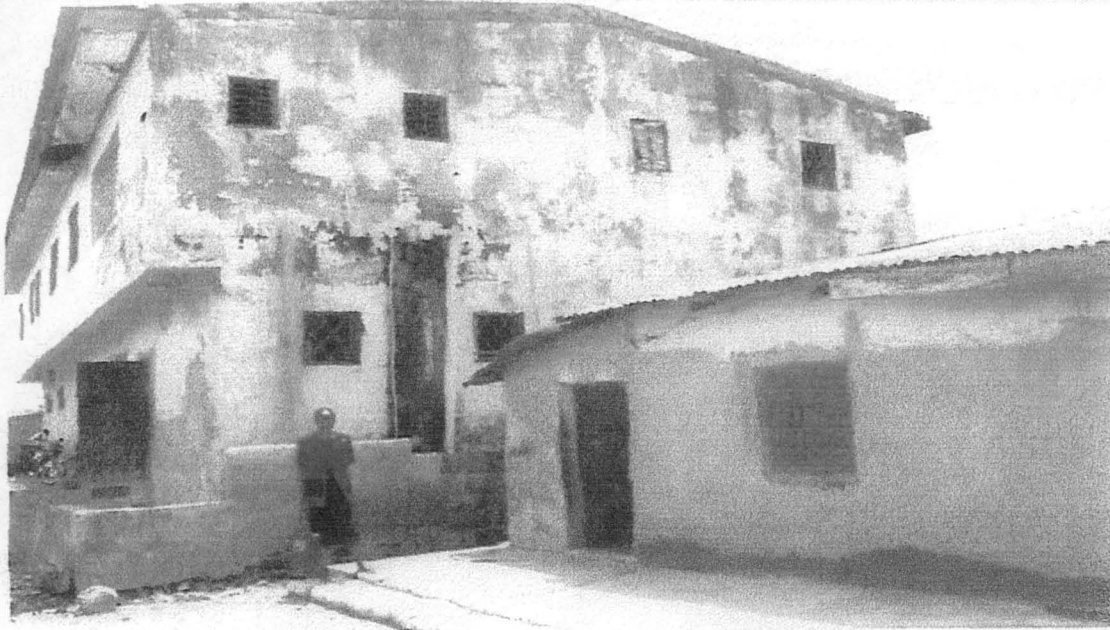
Plate 9: Shows the effect of rain on a storey building washing of the paint and damp penetration at the top part of wall surface.

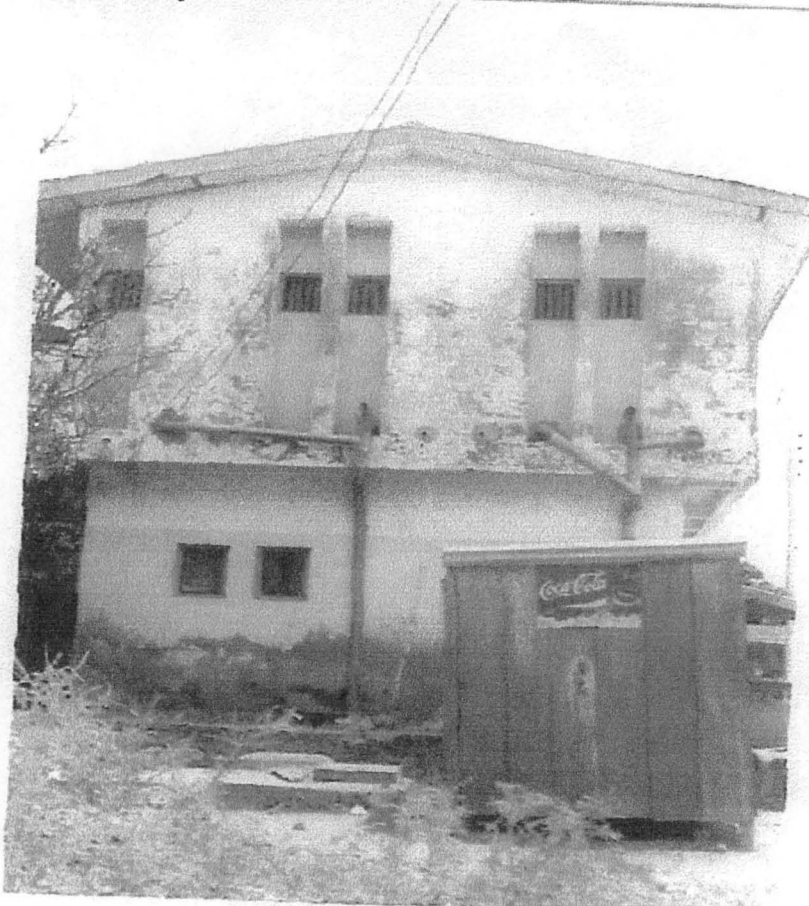
Plate 10: Shows a storey building affected by rainstorm causing discolouration of the wall at the first floor of the building and underground moisture at the ground floor in Chanchaga town.

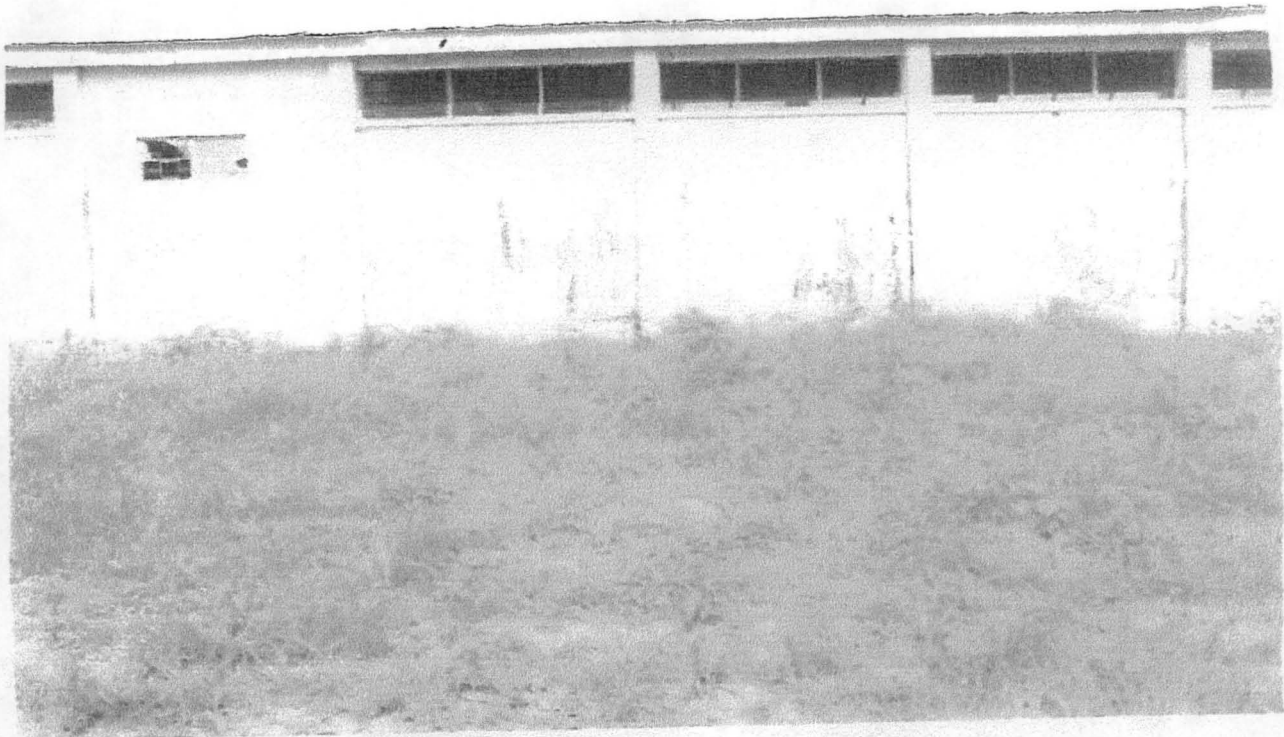
Plate 11: Shows the effect of rain on wall surface washing off the paint on a workshop block in G.T.C. Minna in Chanchaga town.

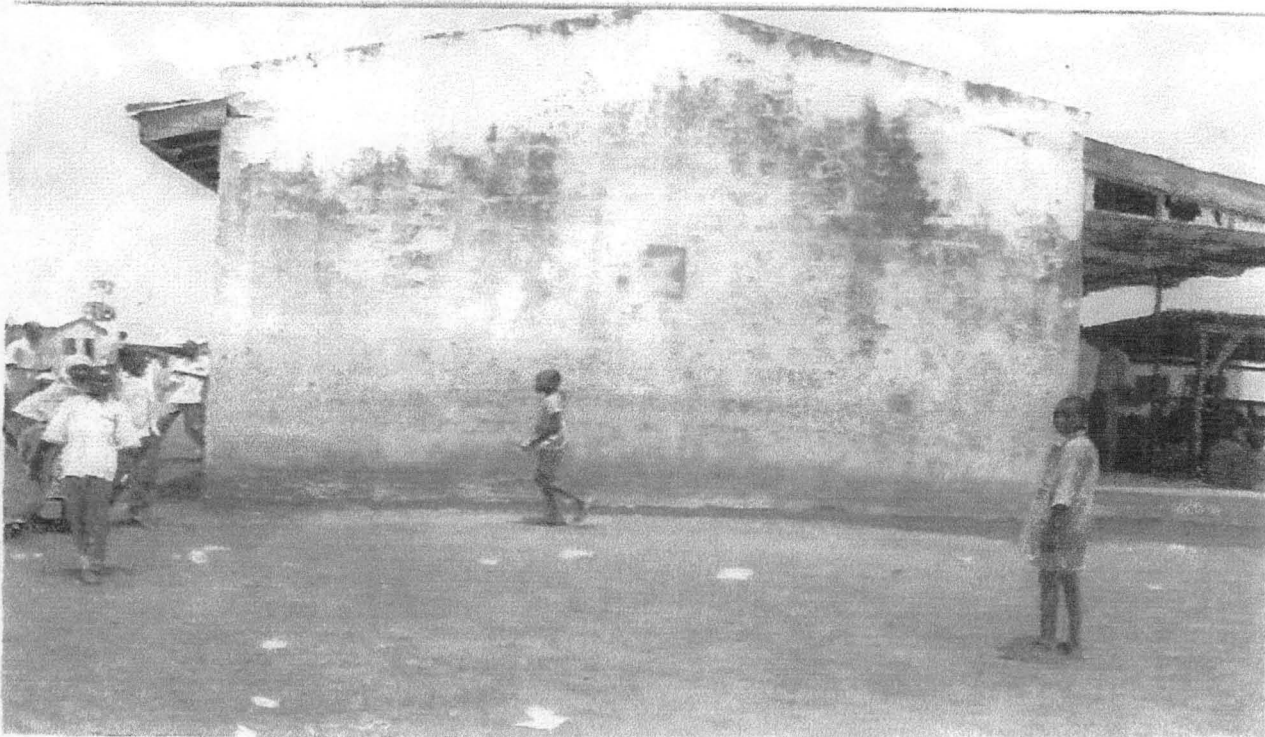
Plate 12: Shows the wall of a Primary School in Chanchaga with washed off paint surface, flaked rendered wall and damped fascia board with decayed ceiling board.
