EROSION PROBLEM IN KONTAGORA

A MENACE TO THE ENVIRONMENT

SALISU AHMED REG. NO: PGD/GEO/2000/2001/141

DEPARTMENT OF GEOGRAPHY. SCHOOL OF SCIENCE AND SCIENCE EDUCATION

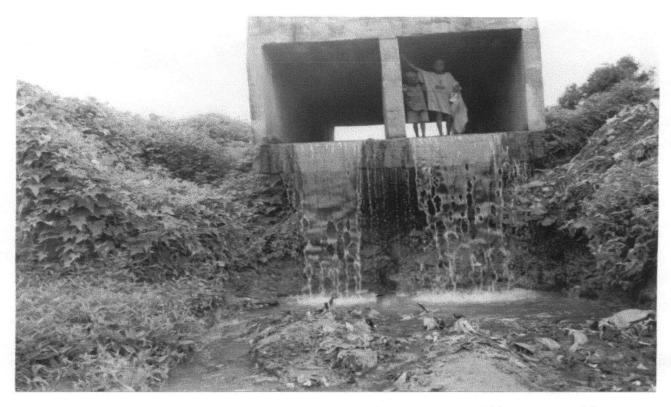
PLATE 5.2: Shows a bridge rendered useless at Unguwar Yamma due to erosion activities SOURCE: Field Survey, 2001

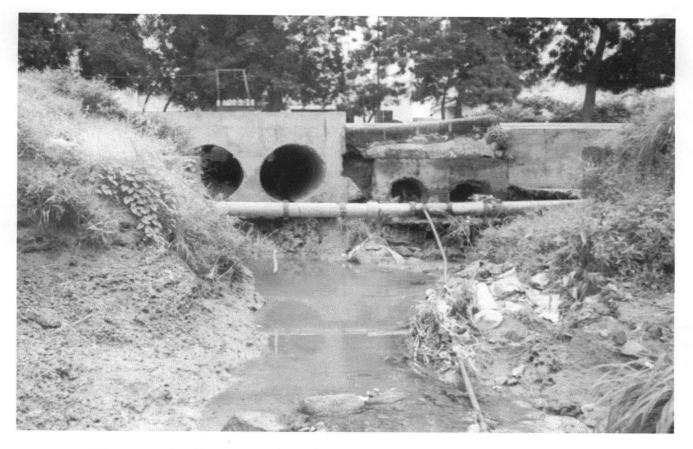
PLATE 5.3: Shows a burried pipe now exposed to the surface as a result of erosion SOURCE: Field Survey, 2001

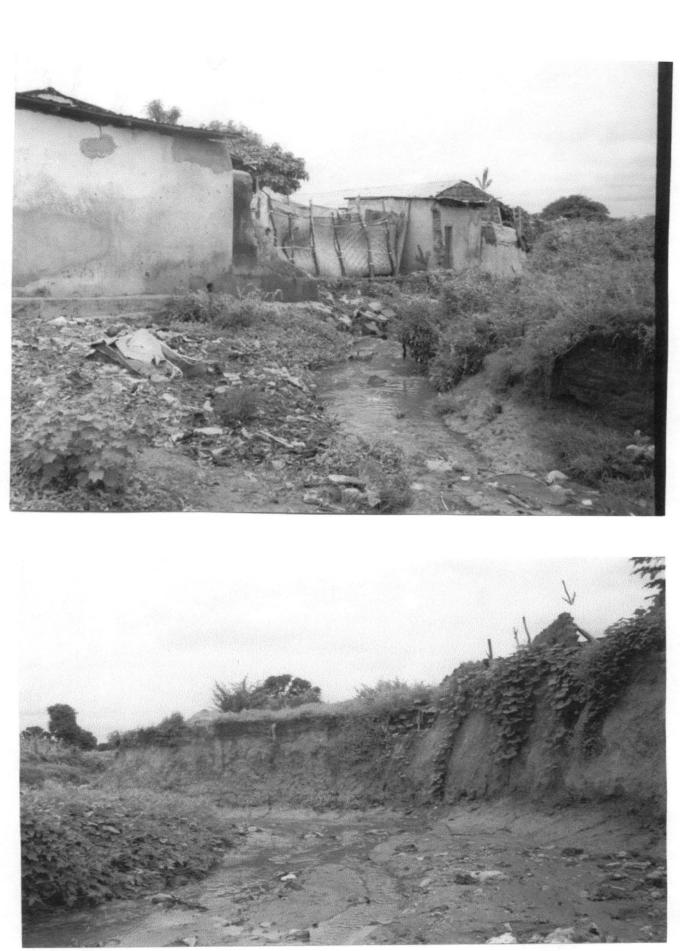
At Kwangwara area, erosion is also a problem to the environment Erosion has contributed to various formation of the land scape. Various houses are being threatened, such that parts of most of the houses are already being chopped off from the main building. Erosion in this environment are of various degree as can be seen in plate 5.5 - 5.8. The arrows in plate 5.5 reveal that part of the fence and room have been rendered useless. Plate 5.6 shows how a road has been rendered useless due to erosion of the land, thus maloing the road un accessible to motorists.

PLATE 5.5 and 5.6: Reveal a part of a house fence and a loom collapsed due to eroded portion of the land surrounding the house at Kwangwara study area SOURCE: Field Survey, 2001

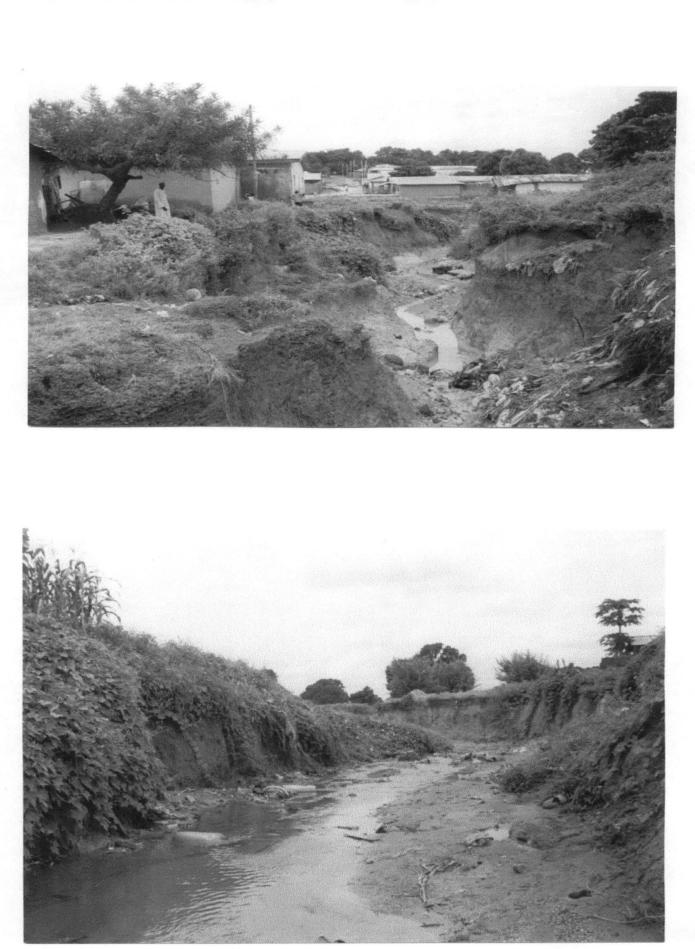
PLATE 5.7 and 5.8: Show a minor drainage in Kwangwara environment which erods backwards and downward thus turning into gully erosion SOURCE: Field Survey, 2001 Plate 5.7 and 5.8 shows a minor drainage in Kwangwara environment. The water channel erods backward and downward, thus producing a gully. The gully as can be seen in plate 5.8 is getting deeper and could be dangerous to the environment.

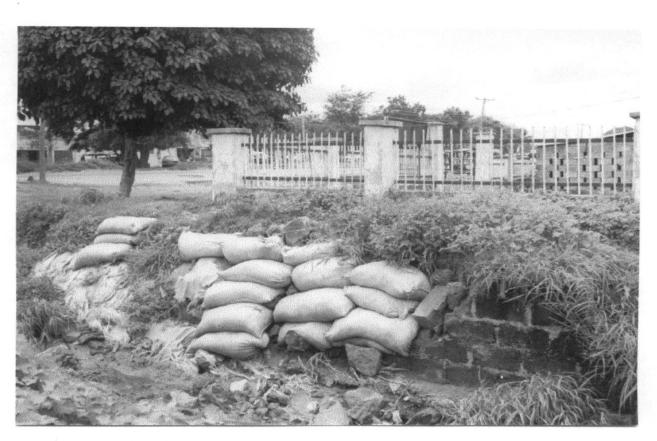
PLATE 5.15: Shows Sand bags were used to present erosion activities SOURCE: Field Survey, 2001

Efforts were made by various people to combat further erosional menance. Plate 5.15 and 5.16 show some attempts made by people to use traditional methods to reduce further damage to their environment. Plate 5.15 shows how sand bags were used to prevent further Erosional activities. Plate 5.16 also reveal the construction of stone pitching embankment to prevent further erosion.

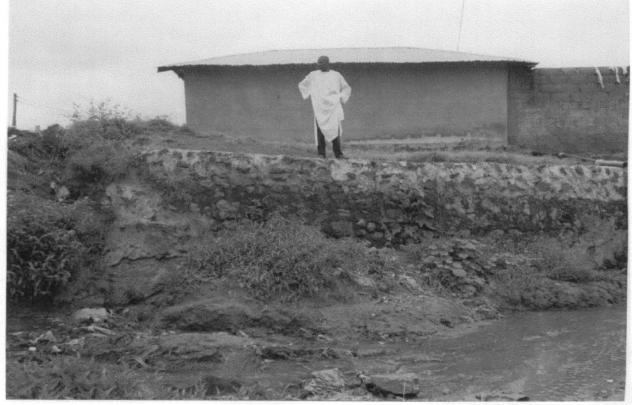
PLATE 5.16: Shows traditonal stone pitching work to present erosion SOURCE: Field Survey, 2001
