**AN INTEGRATED APPLICATION OF REMOTE SENSING, GLOBAL  
POSITIONING SYSTEM AND GEOGRAPHIC INFORMATION  
SYSTEM TECHNIQUES IN ASSESING THE IMPACT OF GULLY  
DEVELOPMENT ON FARMLANDS IN FARIN LAMBA, RIYOM  
LGA, PLATEAU STATE, NIGERIA.**

**A THESIS  
SUBMITTED TO POST GRADUATE SCHOOL OF  
FEDERAL UNIVERSITY OF TECHNOLOGY, MINNA  
IN PARTIAL FULFIIMENT OF THE REQUIREMENTS  
FOR THE AWARD OF MASTER OF TECHNOLOGY  
(M.TECH) IN REMOTE SENSING**

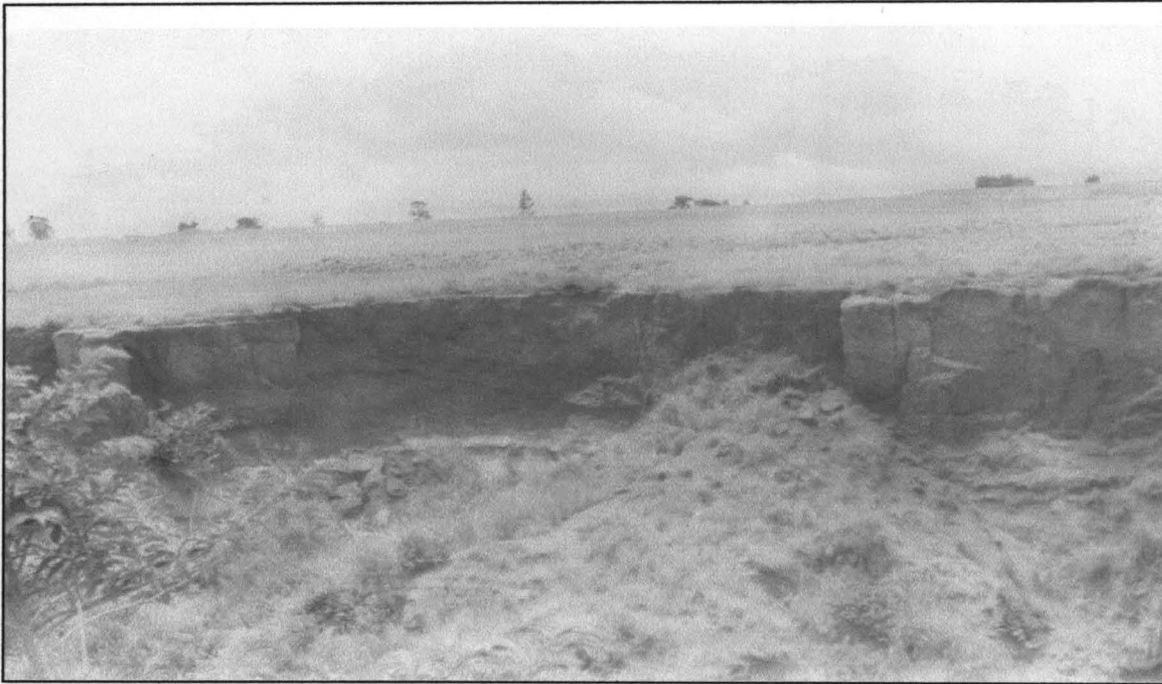
**Plate 1: Erosion destroying farmland in Farin Lamba**

Lack of sufficient information about lost of farmlands as a result of erosion necessitates this study. The study area, an agricultural area for crops like maize, millet, and Irish potatoes that are produced in a large quantity, has been under threat by gully erosion. The cultivation of these crops has favoured accelerated development of water erosion processes. The expansion of gullies can be seen glaringly in the maize and Irish potatoes farms, causing serious problems to farmers in terms of reduction of farm size, bad accessibility, generation of marginal areas and soil loss, among others (plate1: Erosion encroach into farmland).

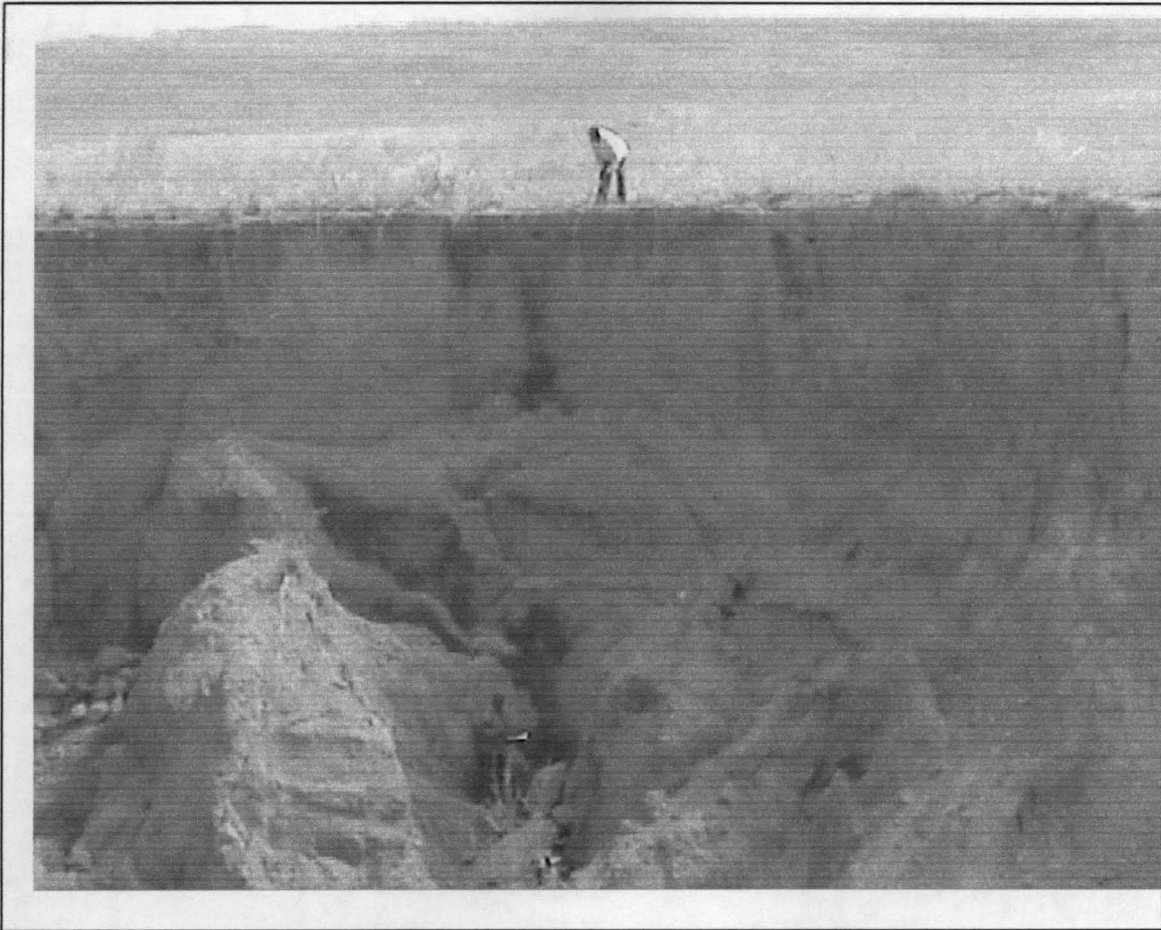
Plate 2.1 Fieldwork at one of the active erosion area

For the data to be presented for final analysis, it is very important to go to the field. This is to confirm the existence and correct locations of the identified gullies and assess the impact of the gullies on the farmlands and the immediate environment (See plate 1.1). At this point, active eroded areas, semi-active and stable areas were noted by taking the GPS points. To locate other gullies within the study area that could not be visible on the image (See plate 2.1).

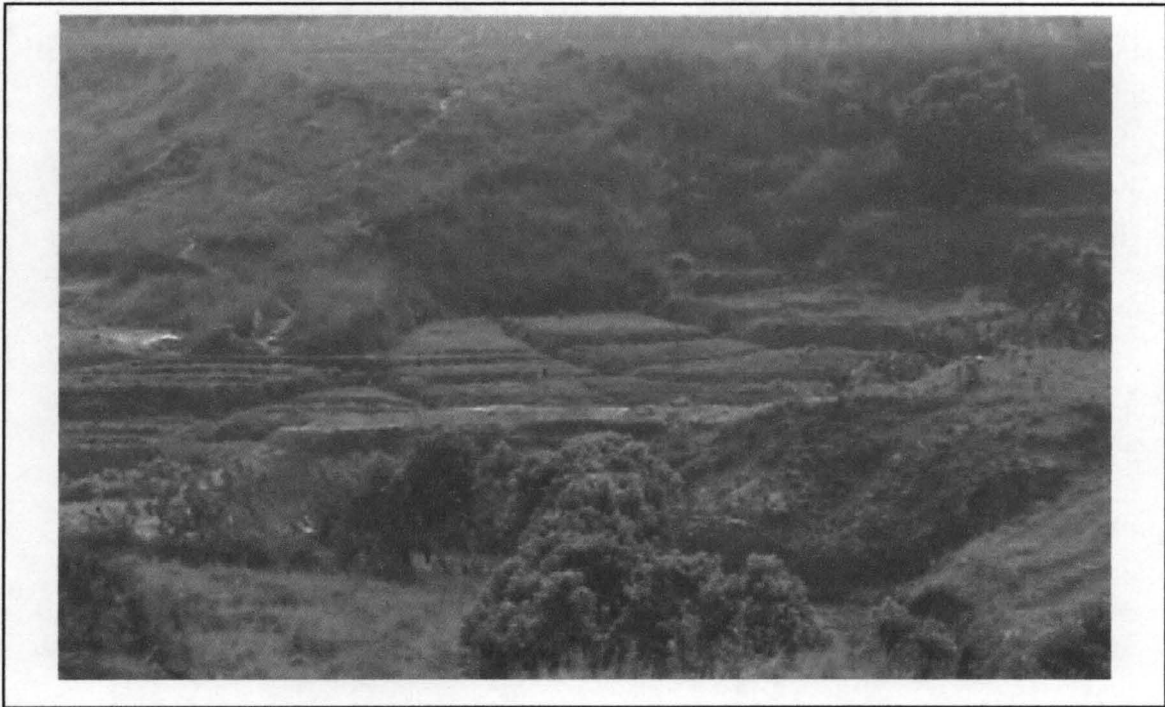
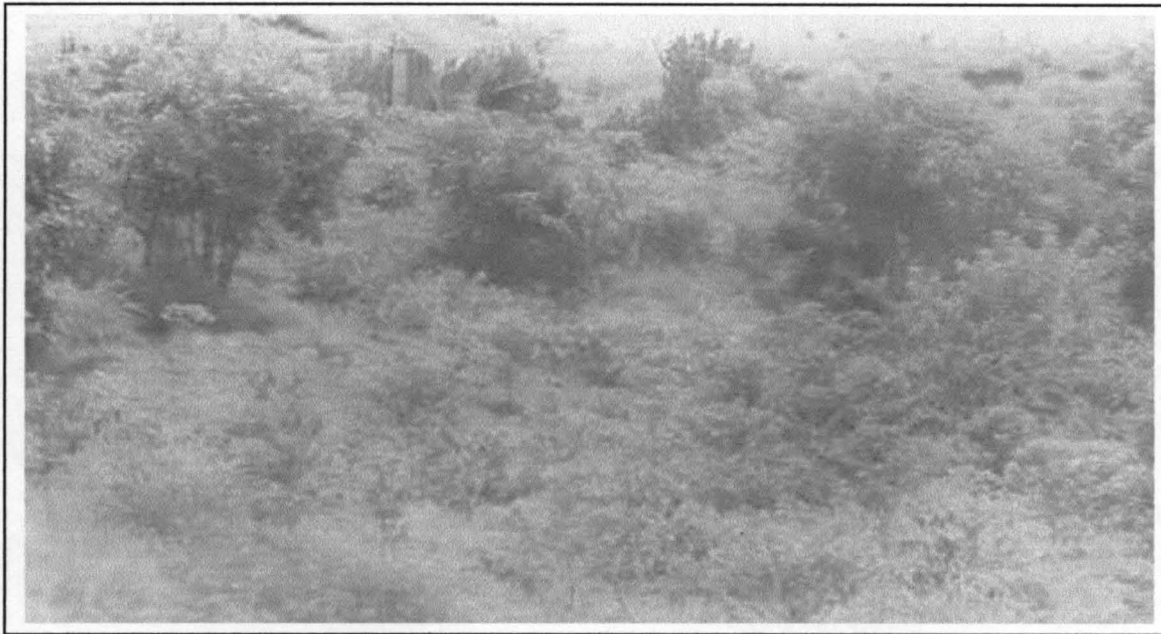
**Plate 4a and b: Cultivation inside the gully**

is that the crops are not looking healthy due to the lost of essential nutrients in the soil  
(plate 4a and b)

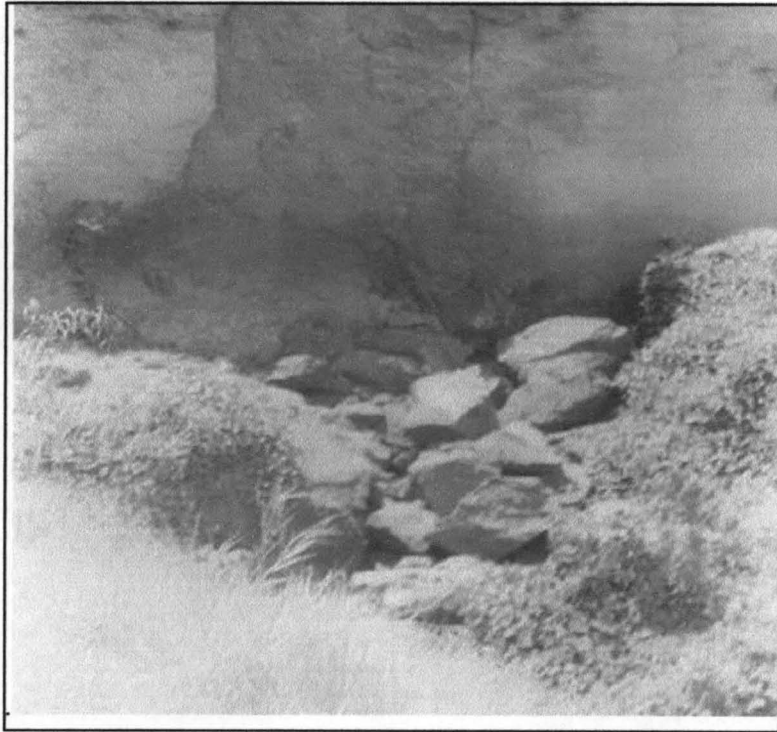
**Plate 4.2: Expansion of sidewall**

The gullied terrain consists basically of relatively deep valley side (usually between 15 - 20m deep). Gullied terrain can be conveniently interpreted on the basis of tone, shape and pattern. Gullies have high reflectance, are irregularly shaped and present recent geomorphic features on depositional area. The areas classified as severely eroded are the actual active areas shown by the processes of wall failure (Plate 2). Lateral expansion of gullies is accelerated by the side wall falling resulting from infiltration or over saturation.

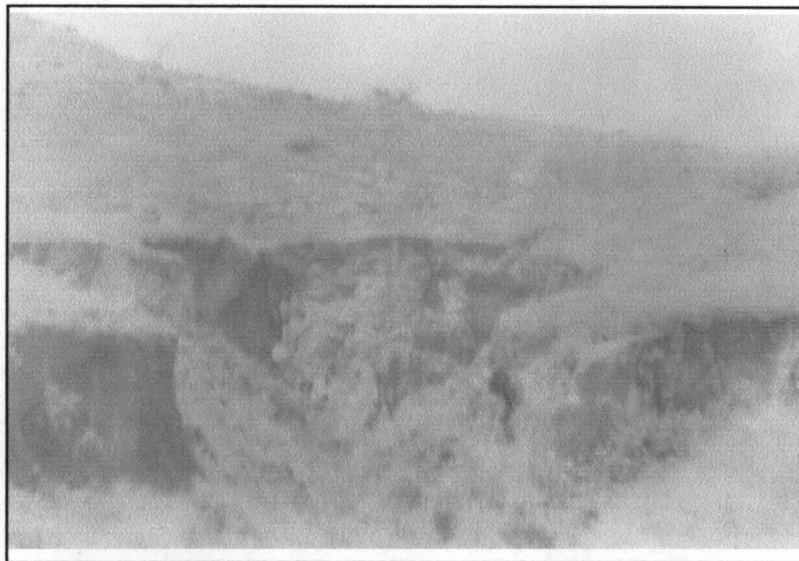
**Plate 4.3: Head scarp recession**

**The drainage system of the parcels concentrates the flow in few outlets. The water flows within the border of the gullies especially during high intensity precipitation. Also the accumulation of runoff at gully bordering areas produces soil saturation.**

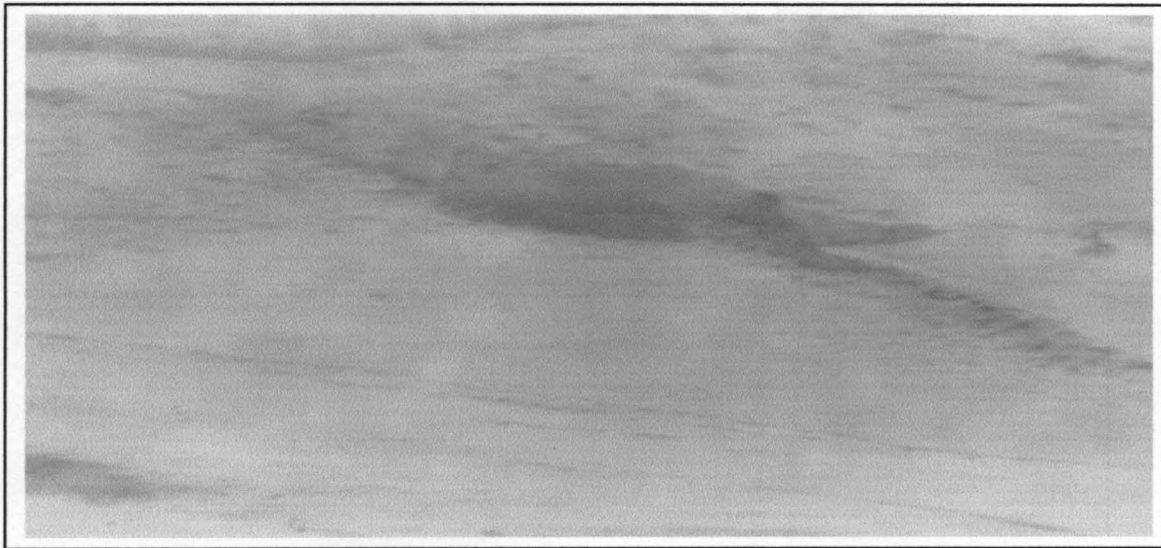
Figure 8: Development of new gullies

The gully initiation risk model developed by Meyer and martinez-Casasnovas 1998) was adopted. The study here reveals significant differences on the risk of new gully development in the deferent landscape units. The difference could be the result of distinct relief characteristic and soil properties. The landscape unit with the highest risk development of new gullies is the gentle slopes. This is where agricultural activities are prominent and covers about 80 percent of the total land. The parent material (the steep slope) of the hilly area is resistant to erosion processes so that water flows at a considerable speed without actually causing friction within the soil structure to loose,

until it gets in contact with the soil on the gentle slope. The landscape with the lowest degree risk is the steep slope that consists of hard parent material. During the rains, the runoff water from the hills disintegrates the soil structure as it moves down the slope carrying materials along resulting in the development of new gullies in agricultural parcels.
