**Environmental Appraisal of Drainage System in Minna, Niger State-Nigeria**

Musa, J. J.

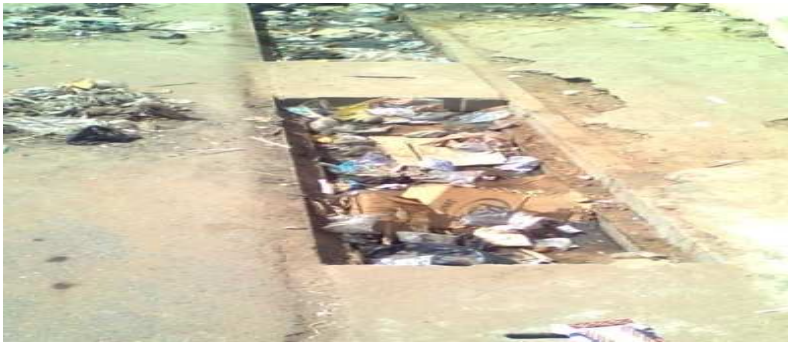
During the reconnaissance, it was observed that most of the drains were converted into dumping grounds where all sorts of waste material can be found. Plat 1 below show

refuse in the channels which is the ingredient of flood disasters within most communities.

Plate i: Showing filled Drainage system along Mypa road

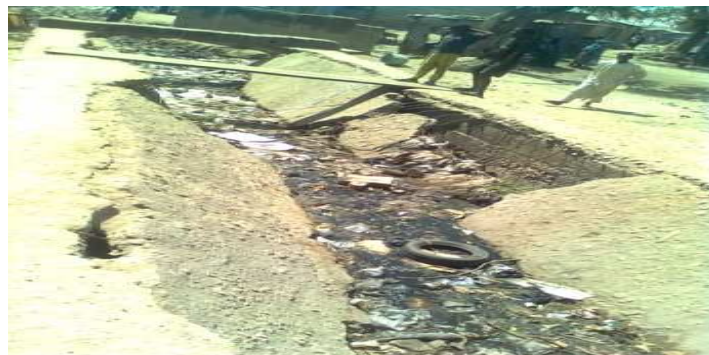
Due to lack of adequate maintenance of the drainage system and provision of refuse dump sites, culverts constructed for easy passage of traffic and human have

collapsed further hindering the free flow of water in the drainage systems, vehicles and human. An example of this is that found at the back of the Emir’s palace in Bosso.

Plate ii: Showing a collapse Drainage system at back of Emir’s house

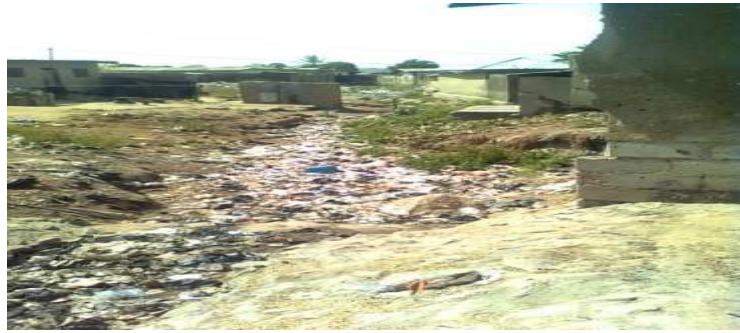
Plate iii: Broken down fence wall along one of the drainage channels

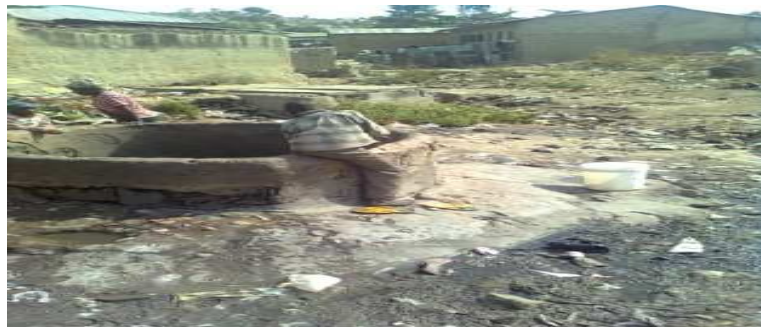
The picture below show an open well sited close to an unconstructed drainage path. The drainage path is filled with different types of waste both human and animal. It was observed that wastewater from nearby houses runs into the drainage path since it

is not well constructed and cleaned, thus such wastewater from the drainage ends up percolating into the nearby open well which contaminates the water inside the well which is being used by the inhabitants of the area.

Plate iv: Drainage system close to an open well in Angwanbiri

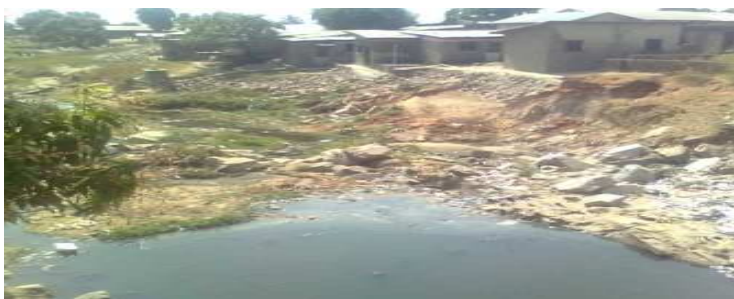
Erosion and flood disasters are of dangerous occurrence that threatens the life and properties of the people living along their paths. The picture below shows the condition of the uncompleted erosion along Mypa Bridge in Bosso Local Government Area. During the months of August and September, flooding in this area is due to the fact that the drainage

path is not constructed. The erosion ends up spreading wider and causing the collapse of many houses and properties around the Mypa road.

Plate v: Showing an erosion site along Mypa Bridge
