**WET SEASON FIELD REPORT ON ENVIRONMENTAL IMPACT ASSESSMENT  
(EIA) OF PART OF BIDA BASIN, NIGERIA**

**KUTIGI TEAM**

**Submitted to  
Project Coordination Team, FUT, Minna**

**September, 2021**

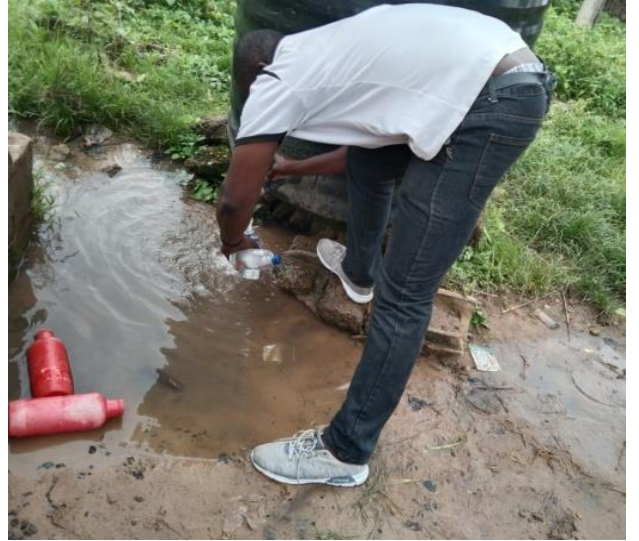
Fig 2: Taking borehole water sample from Wuyako  $9^{\circ} 8' 38''$  N  $5^{\circ} 49' 10''$  E

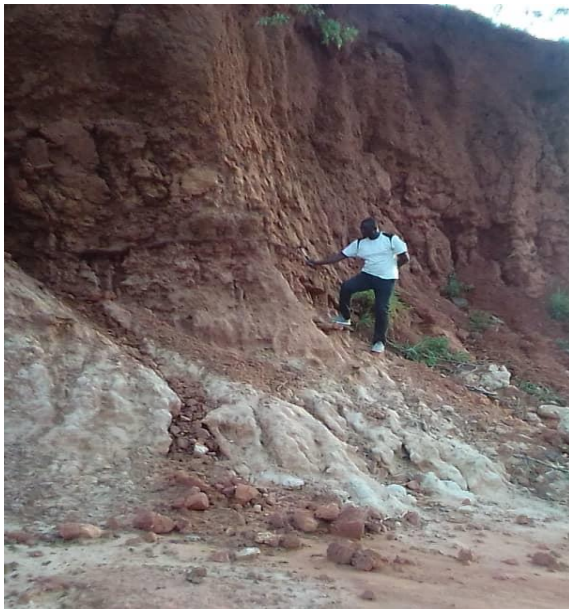
Fig 3: Section of rock at a quarry site (Wuyako Kede)  $9^{\circ} 7' 26''$  N  $5^{\circ} 48' 10''$  E

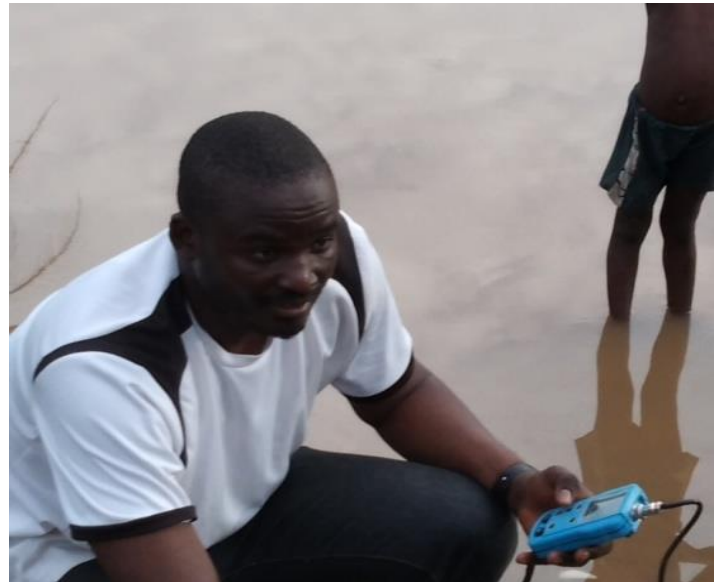
Fig 4: Measuring the parameters of stream water at River Etan, Wuyako  $9^{\circ} 8' 38''$  N  $5^{\circ} 49' 12''$  E

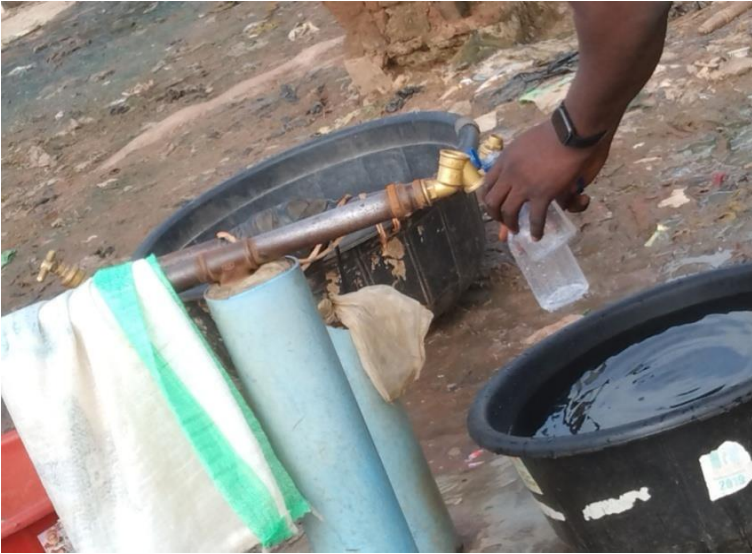
Fig 5: Sampling borehole water at Kudu  
9° 16' 06" N 5° 20' 57" E

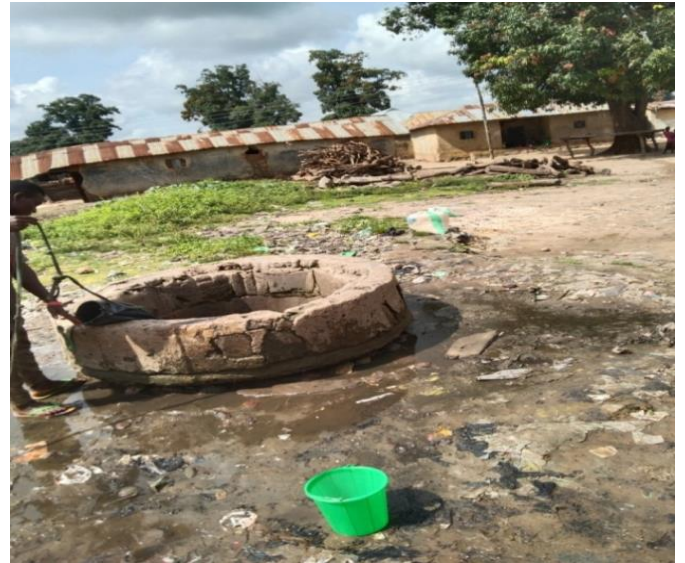
Fig 6: Well from which water was sampled  
9° 16' 56" N 5° 20' 51" E

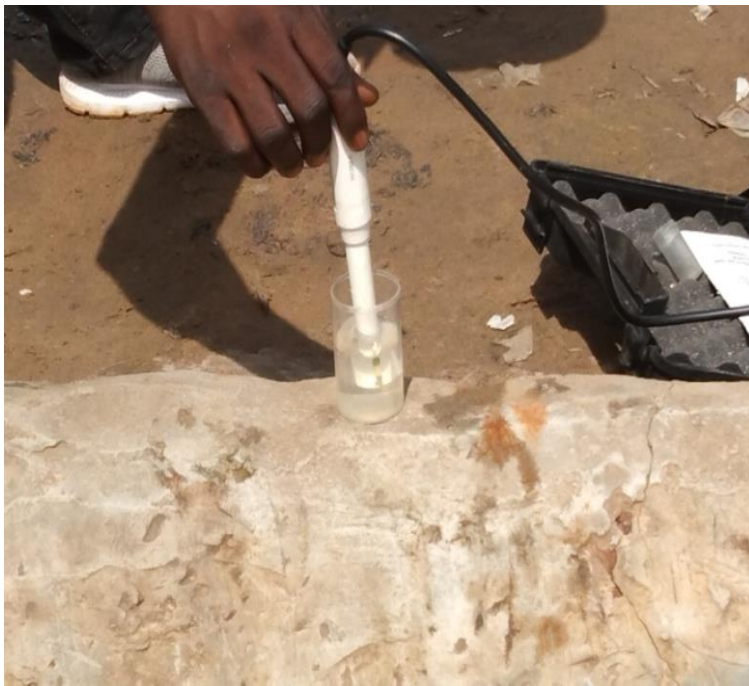
Fig 7: Taking the various parameters of water samples  
with aid of HANNA multimeter

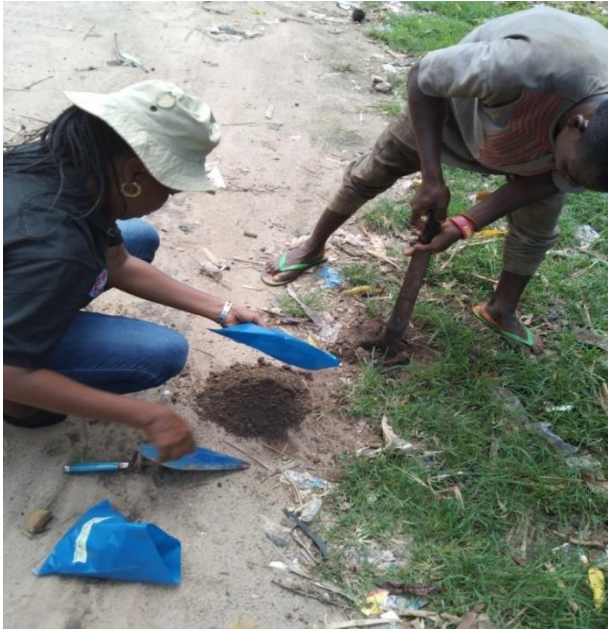
Fig 9: Sampling soil at 0-15 cm and 15-30 cm depth at a farm in Kudu

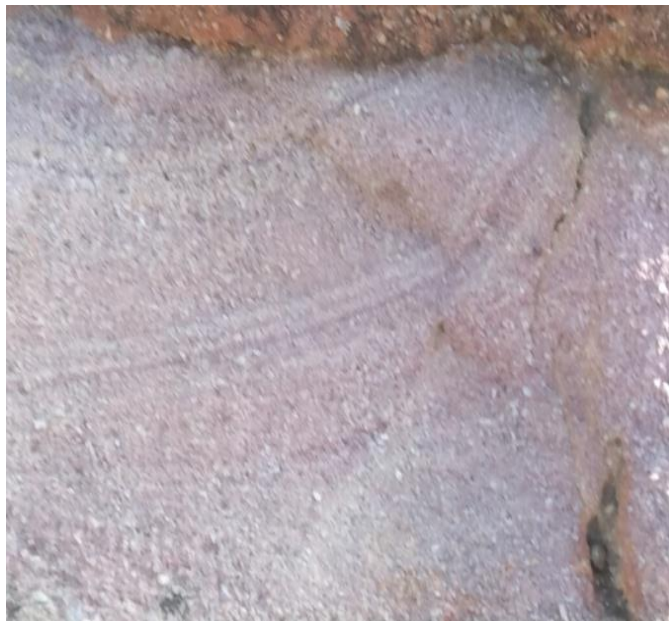
Laminated poorly sorted whitish sandstone at Kutigi

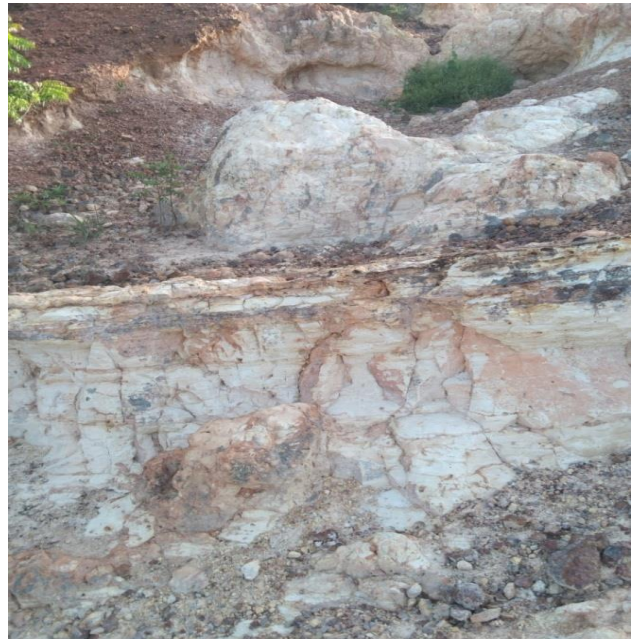
Exposed section of claystone bed at Kutigi 9°11' 59"N5°36'36"E

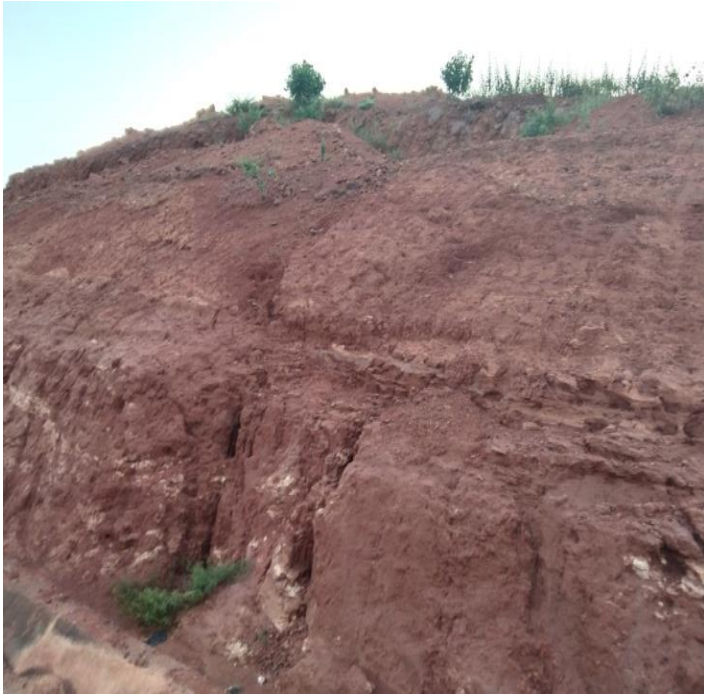
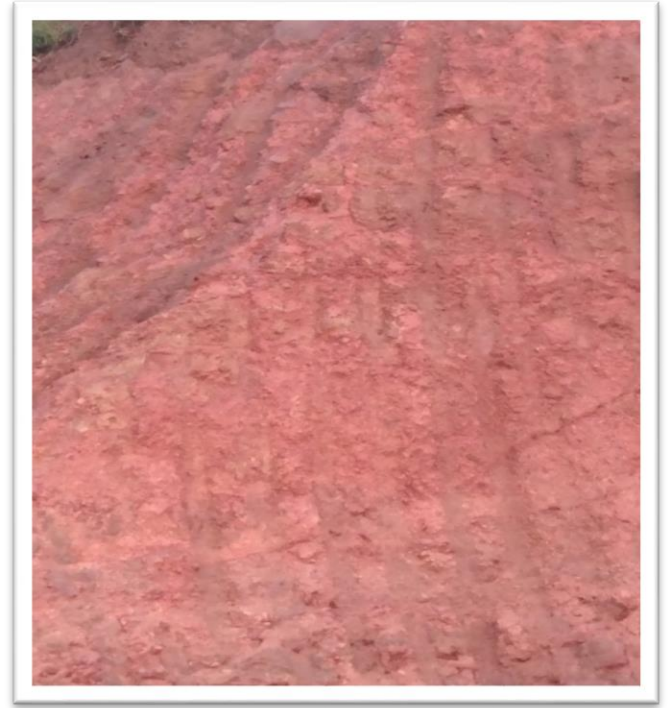
Exposed Section of reddish brown sandstone at a road cut from Kutigi to Tessa Hajia (Ruga road)

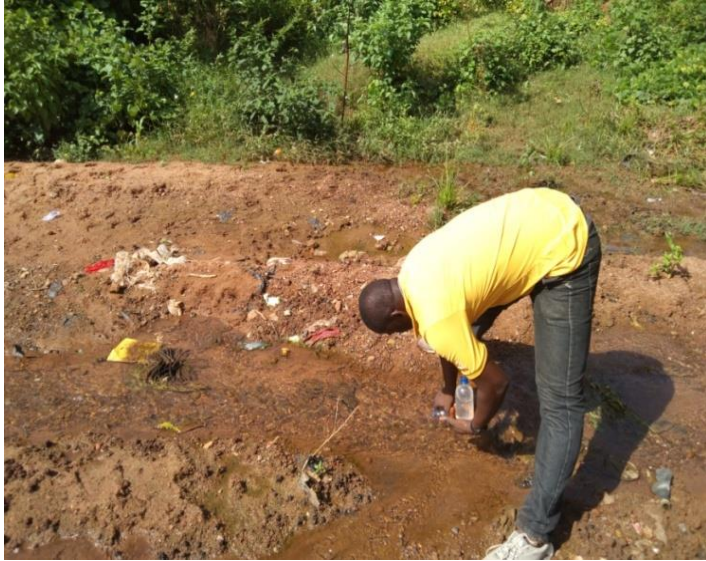
9° 12' 37" N 5° 36' 40" E

Sampling of stream water at River Toro, Kutigi

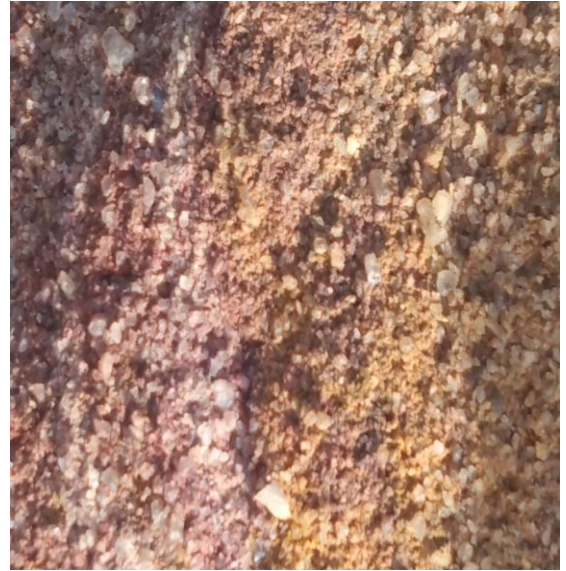
Poorly sorted sandstone

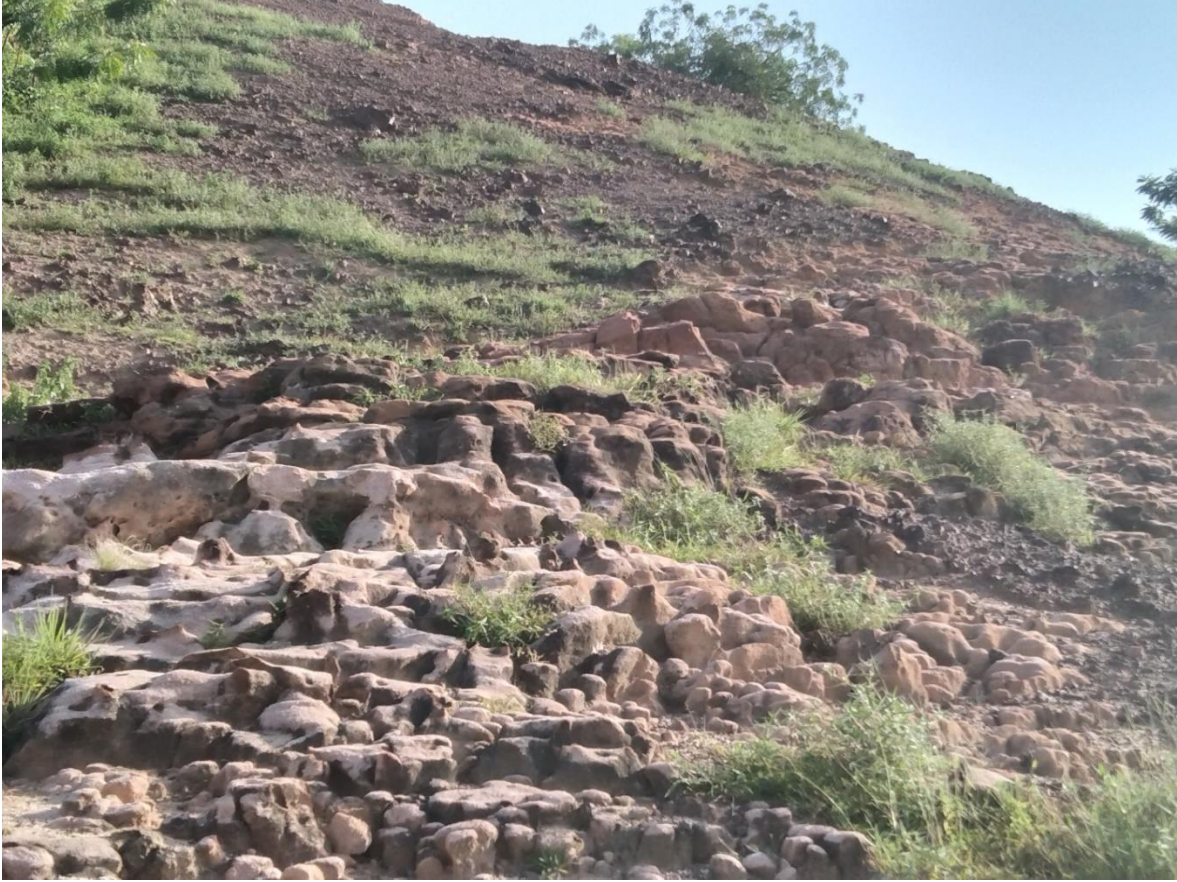
**Whitish Sandstone exposed at the base of an outcrop at Kutigi ( Kusogi Junction)**

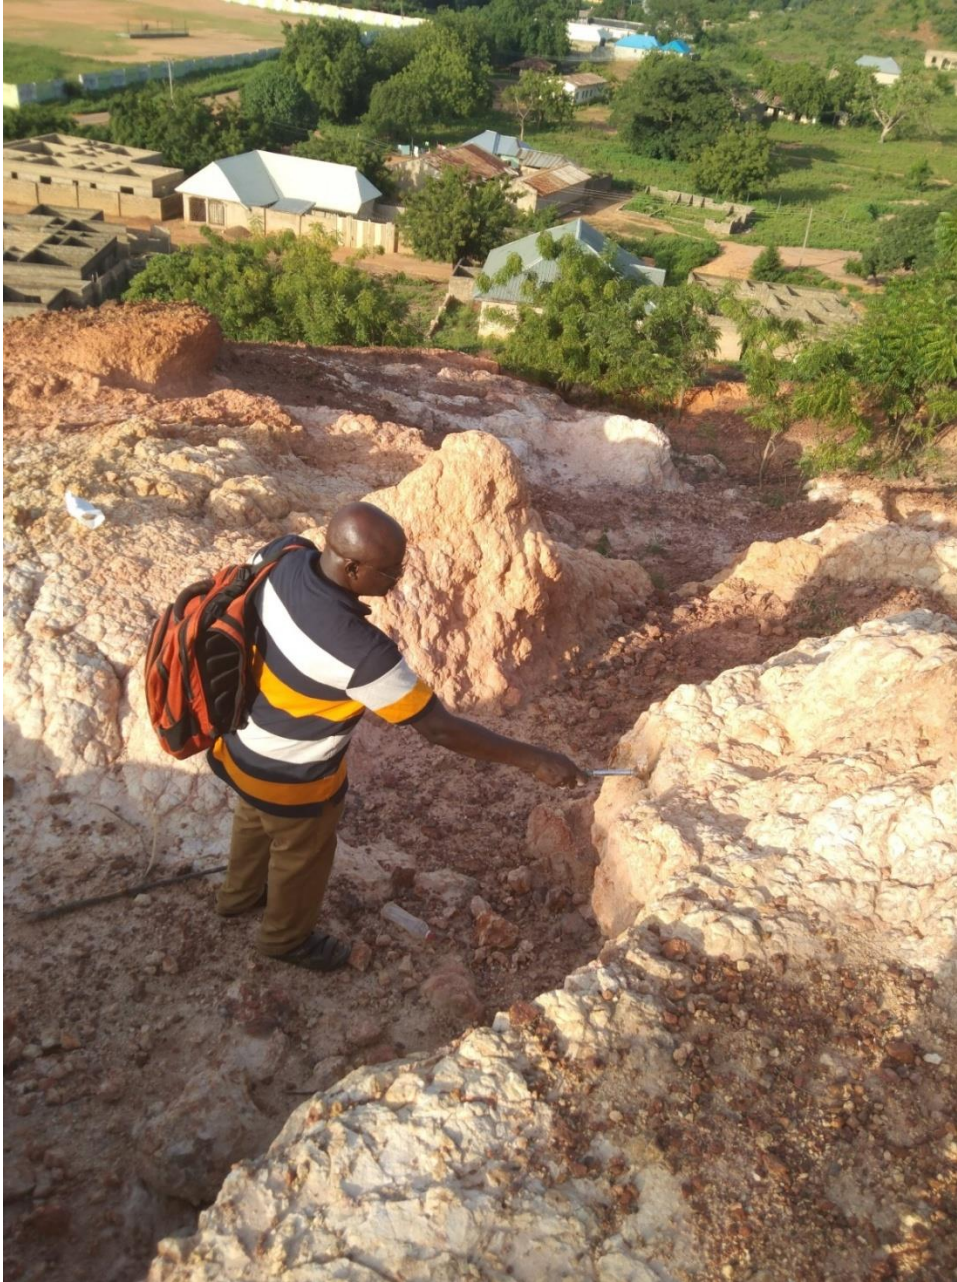
Claystone deposit exposed and quarried at Kutigi (Close to Kusogi Junction)  
9° 11' 59" N 5° 36' 36" E

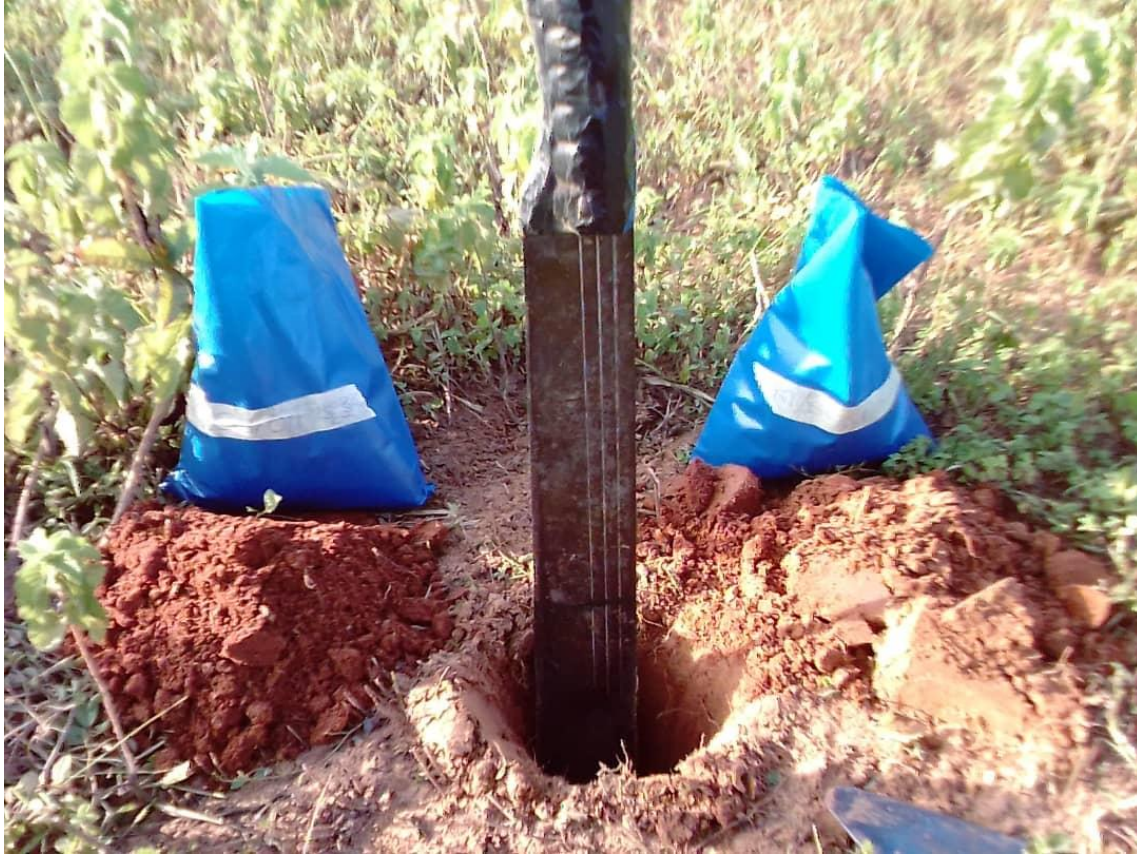
**Soil Sampling at 0-15 cm and 15-30 cm with the aid of a cutlass at one of the location**

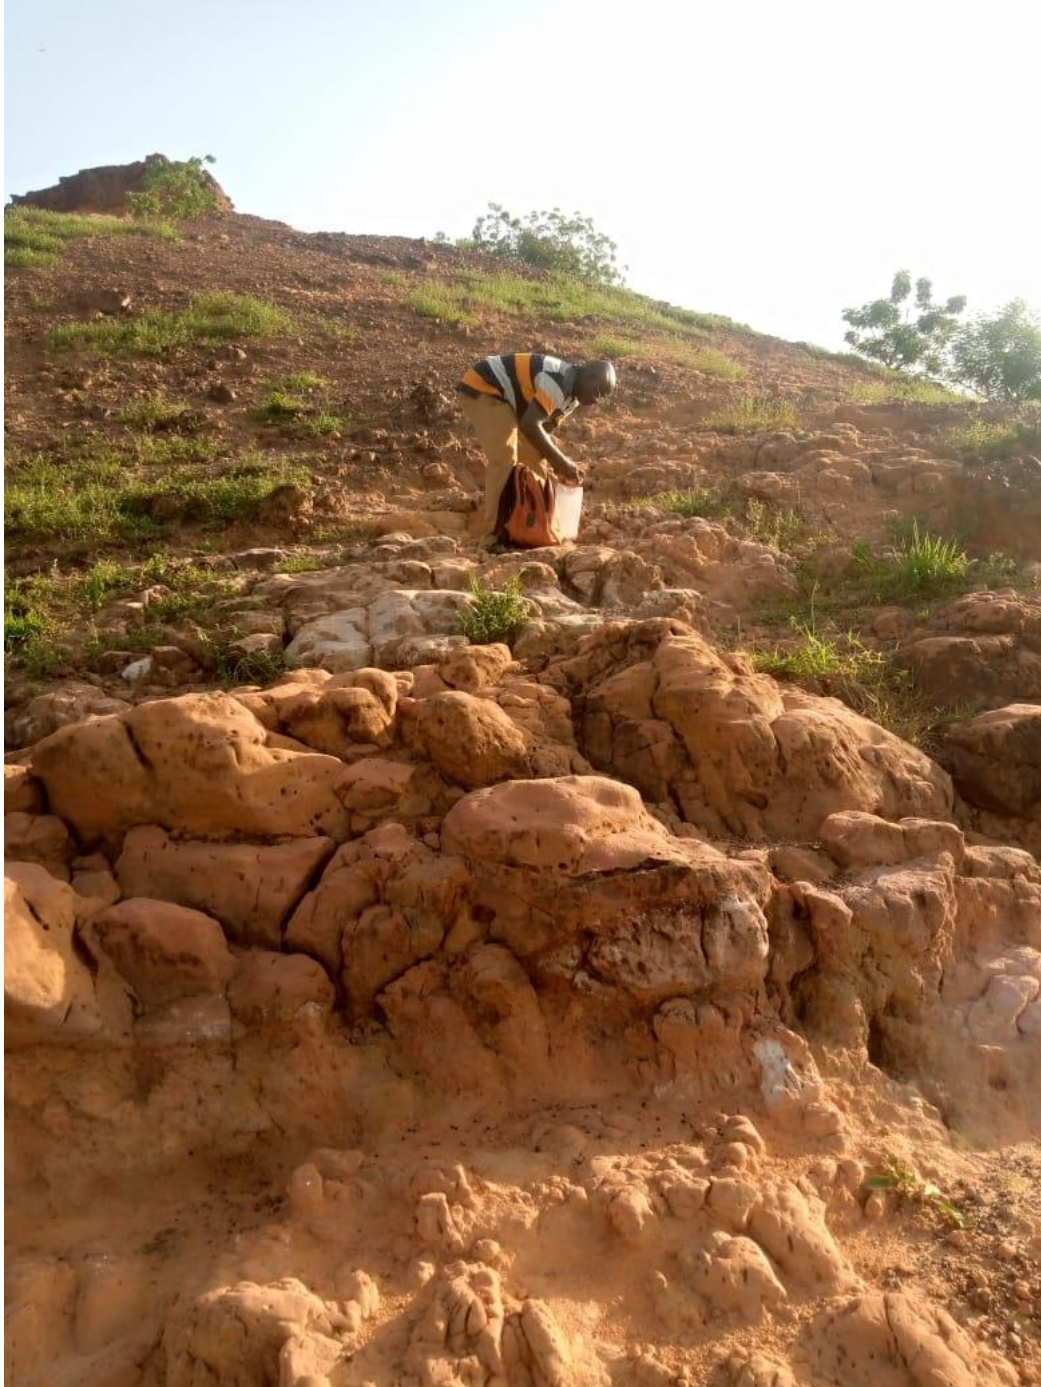
**Massive bed of poorly sorted sandstone at Kudu ( $9^{\circ}15'16''N5^{\circ}21'11''E$ )**

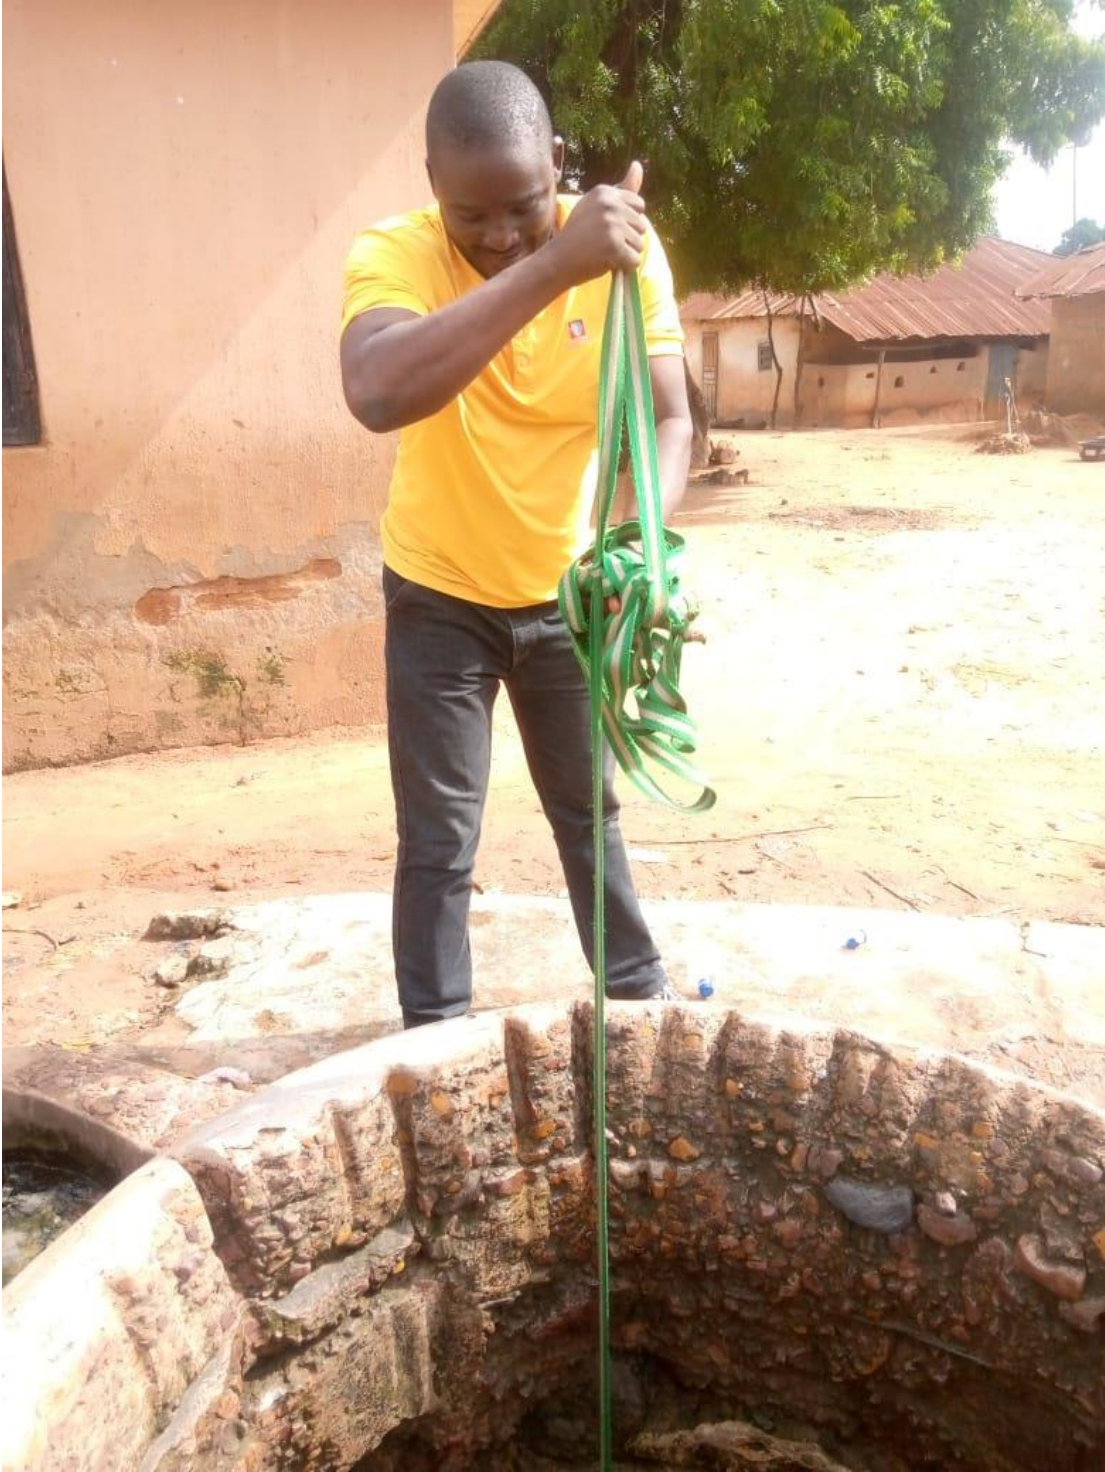
**Drawing well water at a location close to Village Head Compound at Kudu**

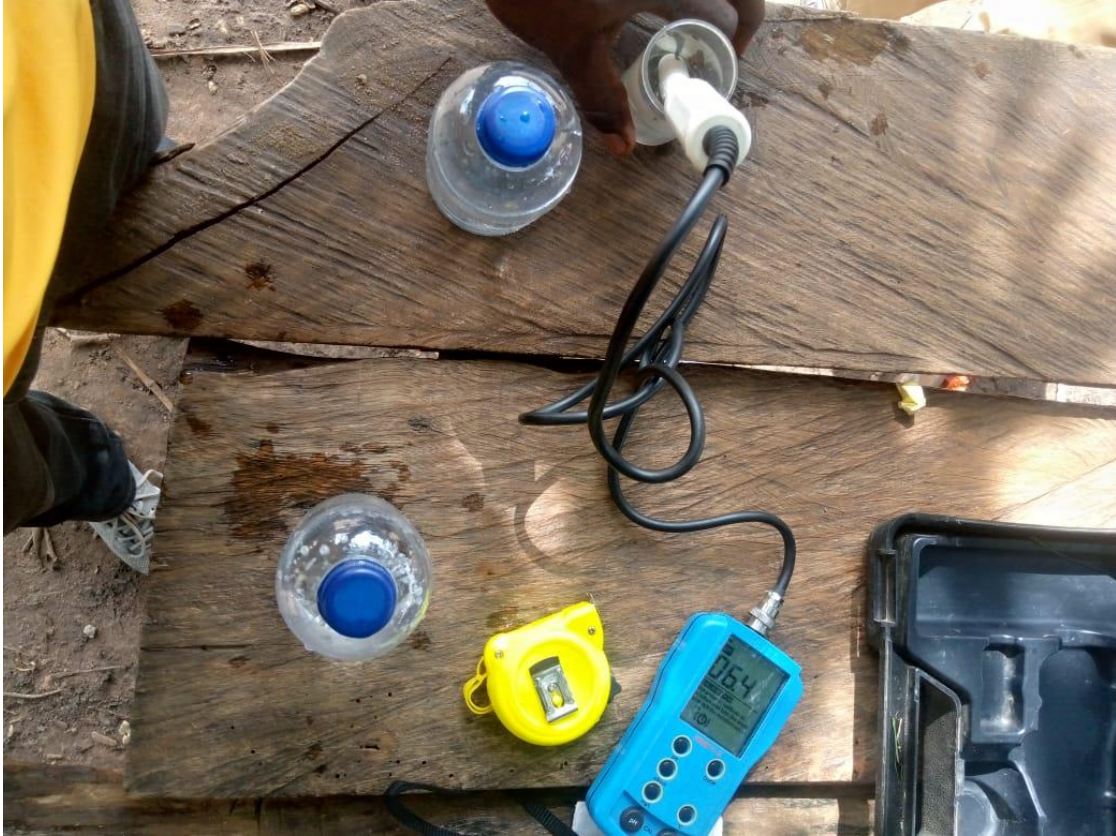
**Taking the values of the various water parameters with the aid a Multimeter at one of the locations at Kudu**
