## EVALUATION OF WATER QUALITY STANDARDS AND SANITARY CONDITIONS IN MONIYA ABATTOIR, IBADAN, NIGERIA

**Abstract:** This work examined the sanitary conditions and water quality standards in Moniya abattoir in Akinyele Local Government area of Oyo State, Nigeria. Samples were collected from the hand-dug well, bore hole and from strategic locations inside the stream that serves as discharge point for all the slurry from the abattoir. The samples were analysed for physico-chemical and biological parameters. The results showed that parameter like temperature 36.4°C was having value outside the WHO limits as a result of microbiological activities since the samples contain high level of BOD. Higher value of iron, 3.99mgL<sup>-1</sup> is suspected to come from blood washed into the water and leachates to underground water. There is also higher concentration of manganese, 3.73mgL<sup>-1</sup> but this was traced to the properties of aquifer on which the abattoir is located. From the bacteria assessment, the samples were polluted with pathogenic organisms of faecal origin.

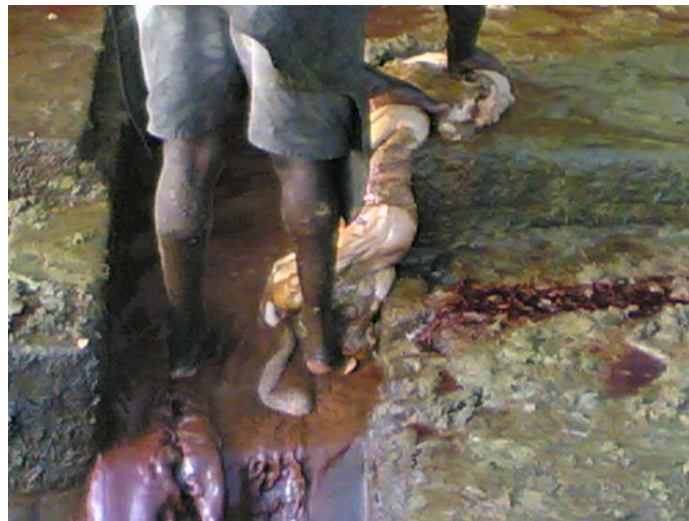
The abattoir under consideration in this study is located in Akinyele Local Government area of Ibadan, Oyo State. The city is located on geographic grid reference longitude 3°89' and latitude 7°38' with the average annual rainfall of 1466mm. Animals slaughtered in this abattoir accounts for 30% of the total animals being slaughtered in Ibadan daily [11]. The wastes from the slaughtering and dressing grounds in Moniya abattoir are washed into open drainages (Plate 1) untreated and are carried into a nearby Oluka stream. These wash waters has, as such turned the water inside this stream into slurry and has hampered its flow seriously (Plate 2).

Plate 1: Intestinal contents being washed into the open channel

From the bacteriological assessment, all the water samples except at BH<sub>1</sub> were heavily polluted with pathogenic organisms of faecal origin and the abattoir workers should be discouraged from using this water to clean or dress carcasses meant for human consumption. Also the high level of BOD at P<sub>0</sub>, P<sub>10</sub> and P<sub>20</sub> will lead to high odour generation which will in turn affect the life of abattoir workers. It is advisable that this pond is opened up and allowed to pass freely. Government can also provide a covered channel that will convey this abattoir wastewater to a safe place without creating any nuisance.

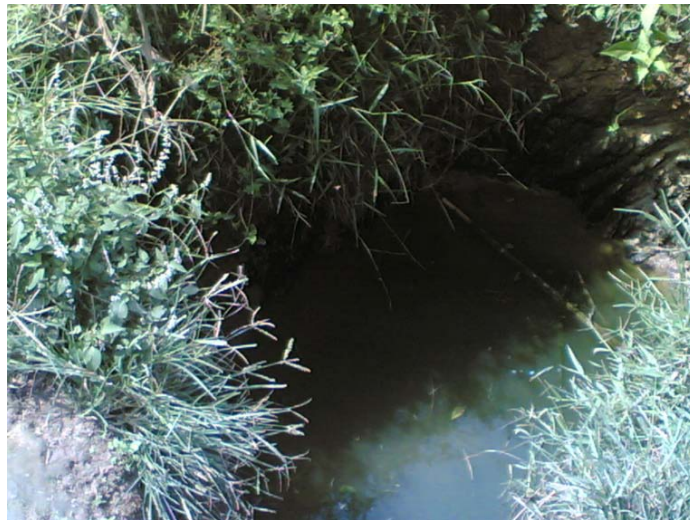
Plate 2: The stream that receives all the wash water from the abattoir

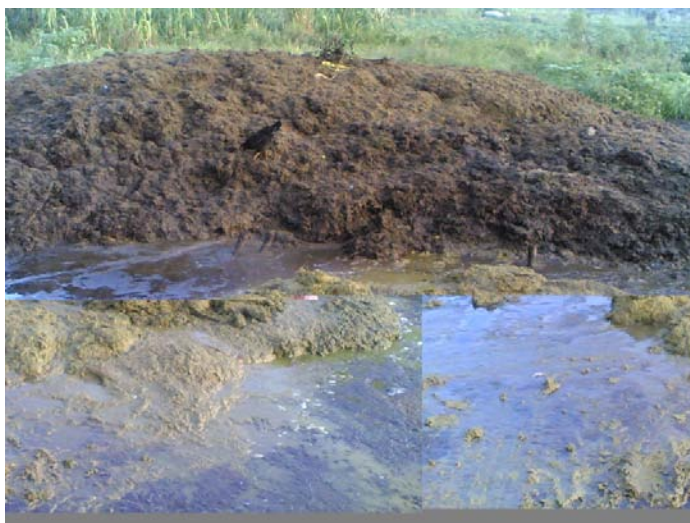
Leachates from the series of decomposition processes of these wastes percolate into the underlying aquifers to contaminate underground water [1] which serves the dual purpose of drinking water for the butchers and others working in the abattoir, and dressing of carcasses to be sold for human consumption. The animal wastes like intestinal contents are usually dumped in a place and have formed a dunghill which generates a lot of odour within the abattoir (Plate 3).

Plate 3: A dunghill formed by intestinal contents
