Influence of Geology and Groundwater Fluctuation on the Instability of Road Pavement between Shango and Paiko along Minna – Lambata Road, Central Nigeria

Article in *Universal Journal of Geoscience* · September 2015

S.H. Waziri¹, C.O. Okogbue², N.M. Waziri^{1,*}, I.N. Abdullahi¹

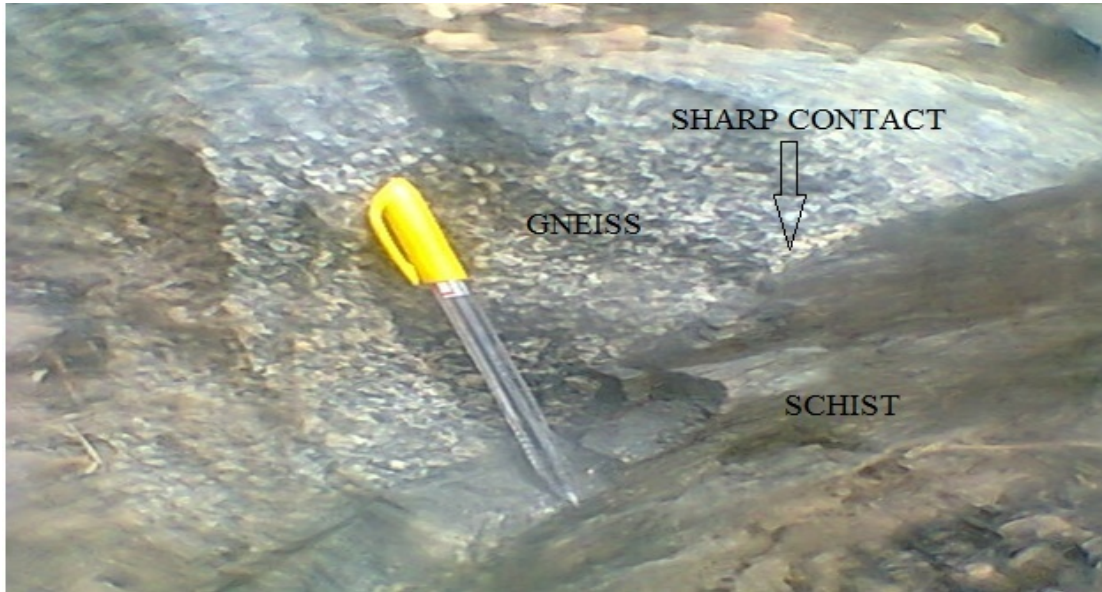
Figure 2. Schist intruded by granite gneiss in Minna area

The topography of the Minna area is largely controlled by the geology that comprises of schist, amphibolites and granites which forms part of the Basement Complex rocks of Nigeria. The geology of Minna area reveals that the schist has been intruded in places by the older granite (figure 1 and 2) that has led to intense jointing and fracturing of the schist. The schist is fine grained, foliated and dips at about 50°. Most of the drainages cut the narrow valley and water moves from the hills to the valley during raining season. The schists are mostly exposed along these river channels (River Chanchaga). Drainage pattern is the trellis while the major river found along the road is the Chanchaga River which is a tributary of the Kaduna River. The granitic hills are massive undulating terrains that range from 300m-800m high above
