Forensic Investigation of Premature Failure of a Roadway Pavement in Minna, Niger state, Nigeria

Amadi, A. A.¹, Alhaji, M. M.² and A. B. Sule.³ ^{1,2}Department of Civil Engineering, School of Engineering and Engineering Technology, ³Works and Maintenance Department, Federal University of Technology, Minna, Niger State, Nigeria

Field and laboratory studies were conducted to investigate the premature failure of a township roadway pavement in Minna, Niger state, Nigeria. Tests conducted on the pavement layers of the failed road included moisture content, particle size distribution of soil samples, Atterberg limit tests, in-situ density and dynamic cone penetrometer (DCP) tests. An empirical equation from published literature was used to compute the California bearing ratio (CBR) of various pavement layers from DCP data. Data from the tests indicate that the field moisture content of the pavement layers (i.e., subgrade, sub-base and base) were high, recording values above the optimum moisture content (OMC). Some soil materials from the pavement layers at the various failed sections had fines content above specification requirements for such layers. Atterberg limits tests revealed hi

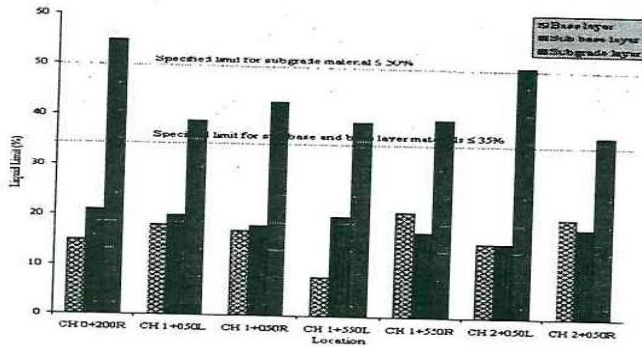
The results of the liquid limit (LL) and plasticity index (PI) along with the required specification limits for the various pavement layers are presented in Figs. 3 and 4 respectively. The LL of subgrade samples are all below the 50% threshold value with exception of sample from CH 0+200R while all sub base and base samples were well within the limit. For the PI requirement, the data in Fig. 4 shows that

Fig. 3: Liquid limit of soil samples collected from the pavement layers at the selected locations
