AN EVALUATION OF MUNICIPAL WATER SUPPLY IN BOSSO, NIGER STATE USING GEOSPATIAL TECHNIQUES

Keywords: Municipal Water Supply, Water Quality, Water Quantity

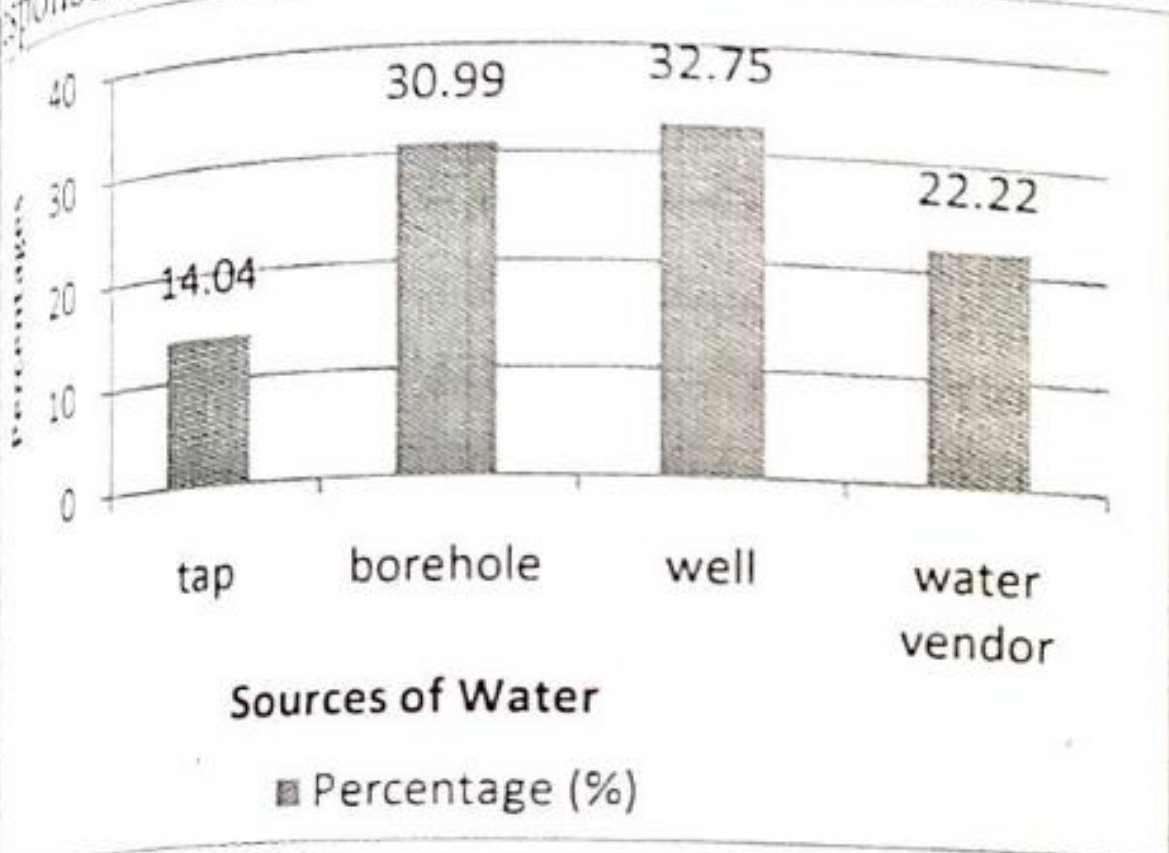
Fig. 2: Sources of Water
Source: Authors' Field Work

Figure 2 above shows that the respondents who use well water are highest in the study area, followed by those who use boreholes. Tap users have a percentage of 14.04 which is relatively low for a growing municipal area. This can be attributed to so many factors which include rusted pipes, old pipes, undulating terrain, poor funding to the sector and more which will be discussed subsequently. The last is the water vendor with which can be attributed to the fact that most of them get their water from boreholes and wells and sometimes from taps and other swamps and small water bodies. This consequently increases the cost of living in the area as residents are forced to buy water even when the portability is not guaranteed.

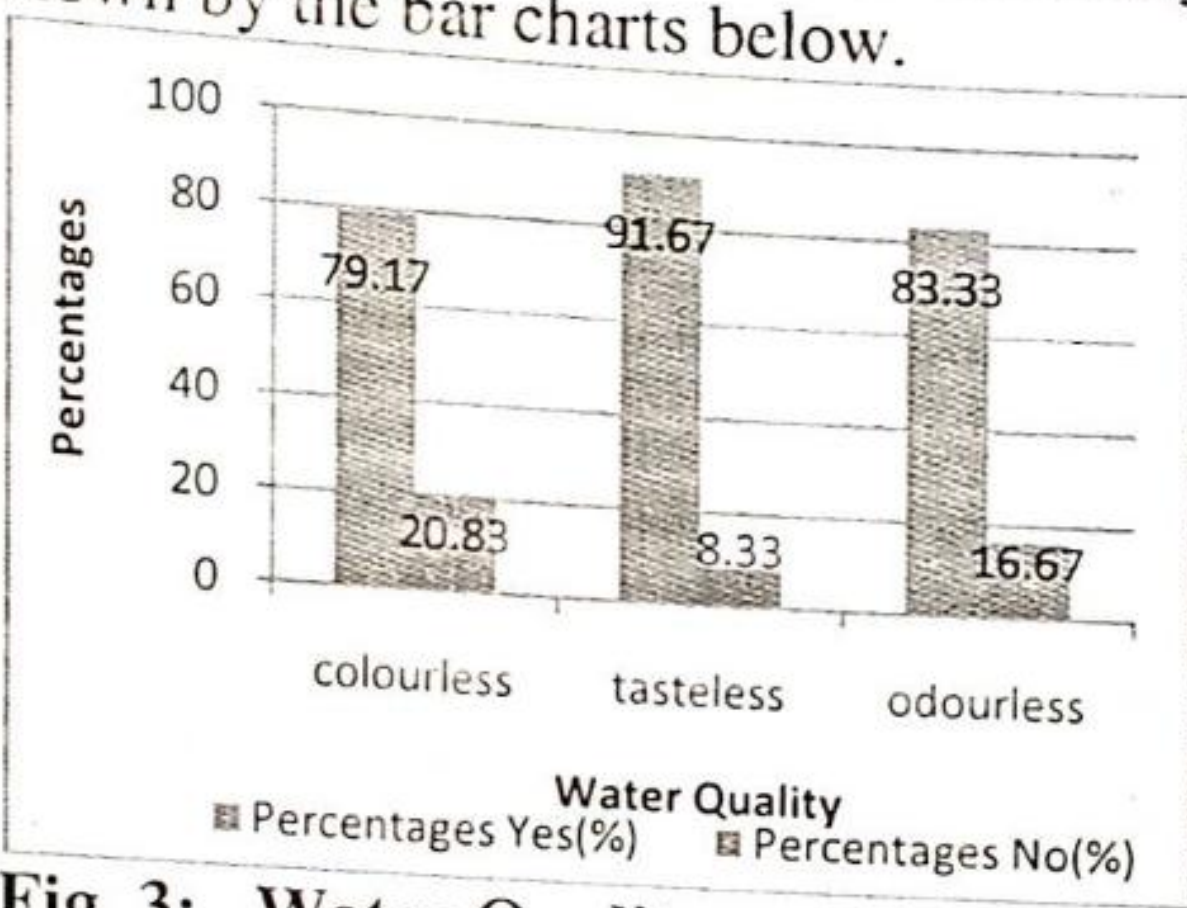
Fig. 3: Water Quality
Source: Authors' Field Work

Figure 3 above shows the quality of tap water using the colourless, tasteless and odourless parameters. The percentages of all the parameters used are high. This is an indication that even though the distribution of tap water is low the quality of the water is high. Figure 4 above reveals the frequency of water supplied. Only about 16.67 percent of the respondents receive tap water daily, then 29.17 percentage receive water twice a day, 20.82 receive water three times a day while 16.67 receive water every other day, the percentage of the respondents that receive water once or twice in a period of weeks or months as the case may be is 16.67 percent. Figure 5 above points out the quantity of water supplied to the respondents in terms of gallons is highest for 15gallons

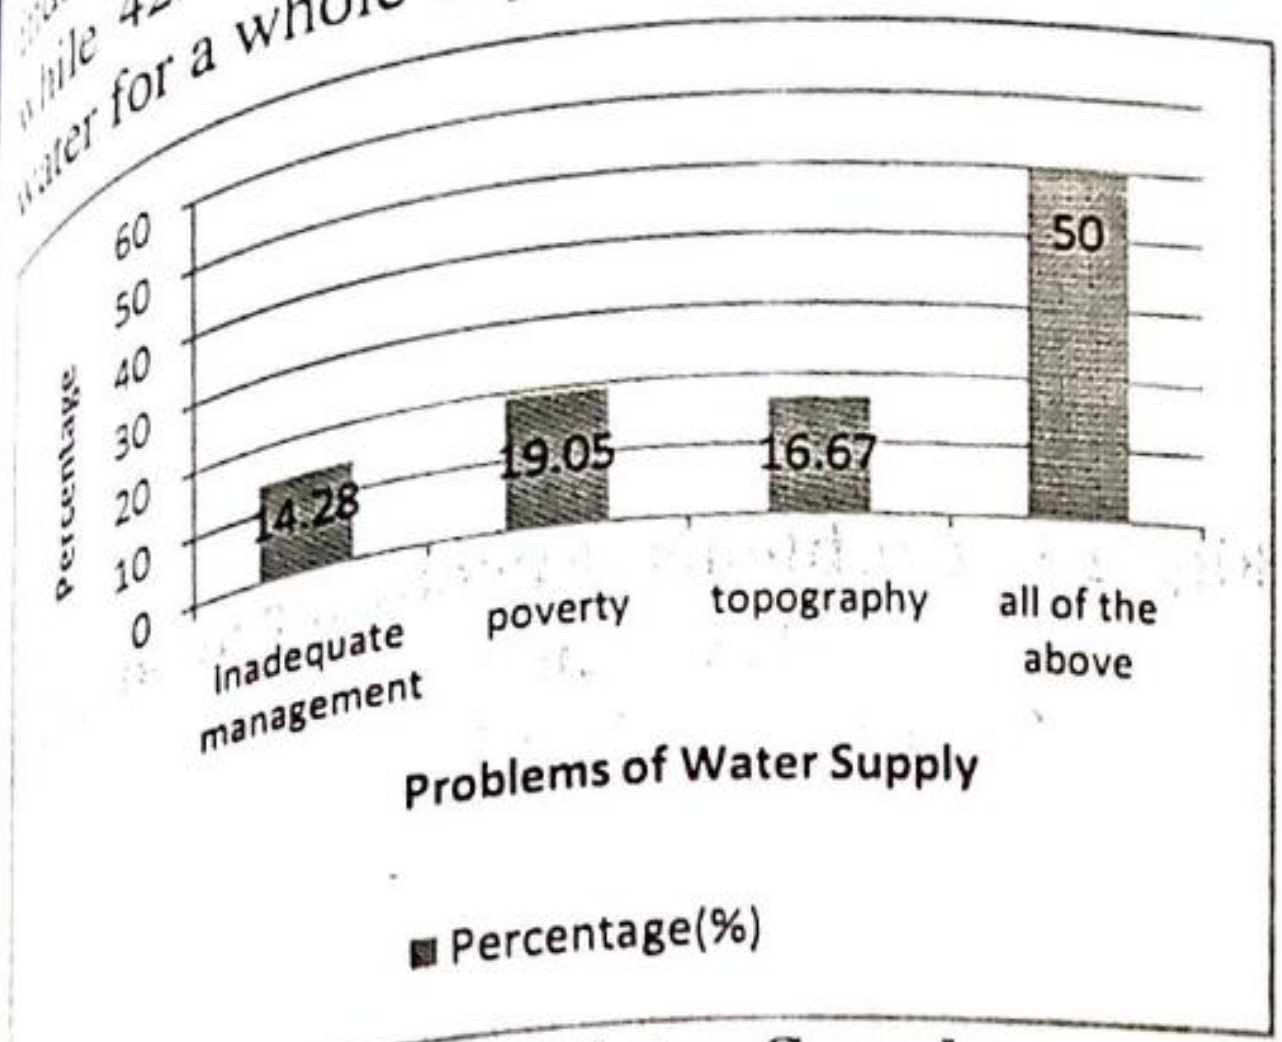
Fig. 8: Problems of Water Supply
Source: Authors' Field Work

Figure 8 shows that the problems of water supply are associated to inadequate management, poverty which is attributed to the inability of consumers to pay up their water utility bills, topography which accounts partly for insufficient taps in Bosso and generally all the problems pose negative effects on the water supply. Figure 9 above points out that seasonality affects both the volume of water and the quality of the water which implies that during the rainy season the volume increases and reduces during the dry season similarly, the pollution and deposition of sediments that contaminate the water from the source points is higher during the rainy season than during the dry season. Turbulence and turbidity of the water is also higher during rainy season. Figure 10 reveals that the expansion of the distribution system will improve water supply with the highest percentage. This is because the existing system is inadequate for the growing population of the area. The next is improved management, subsidized cost of water bill and construction of reservoirs for places that pipes might not be able to be laid due to the nature of the terrain. Figure 11 above indicates that a higher percentage of the respondents said that the topography of the area is a reason why there are insufficient taps, followed by poor maintenance which can be attributed further to the reasons like old laid down pipes, broken pipes etc.; negligence by the consumers, which include their inability to report breakages etc. Other respondents believed that all the above mentioned reasons can be attributed to the insufficient taps in Bosso. Figure 12 above indicates that the source of dissipated water is both Tagwai dam and Bosso dam Tagwai dam. While others said it was Tagwai dam alone which might be attributed to the fact that it stores more water and is more functional and reliable, then Bosso dam. Figure 13 above signifies that inconsistent power supply is a major problem encountered at the treatment plant, followed by inadequate funding, seasonality and inadequate professional manpower.
