GEOELECTRICAL INVESTIGATION OF ROAD FAILURE ALONG MINNA-BIDA ROAD, NIGER STATE, NIGERIA

A. A. Rafiu, T. A. Adesete, K.A Salako, A. A. Adetona, U. D. Alhassan, J. Shehu* and E. E. Udensi

Geophysics Department, Federal University of Technology, Minna, Niger State, Nigeria

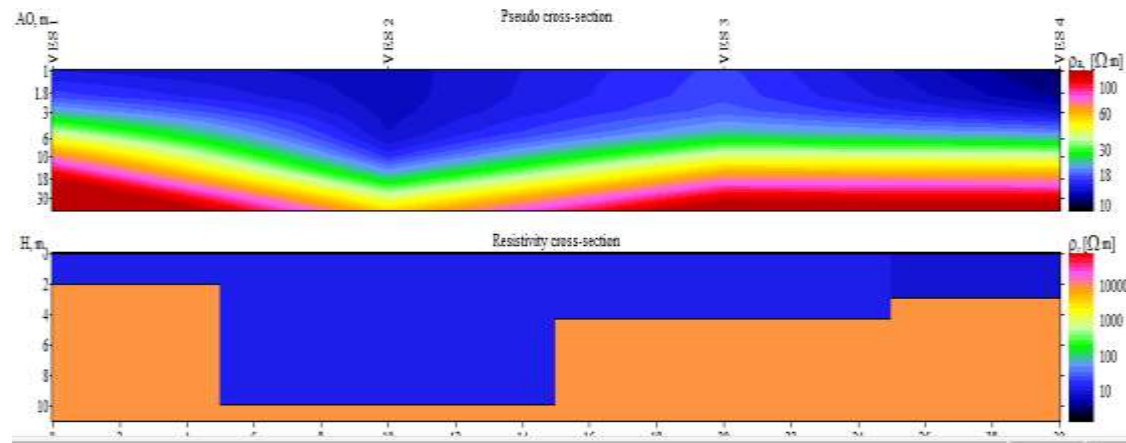
Figure 2I is the pseudo cross-section plot of apparent resistivity data for profile A with four VES points begins at coordinate 9.424° 5` N and longitude 6.483° 4`E, end at coordinate 9.724° 9` N and longitude 5.262° 7`E. The blue regions occurs along the four VES points especially at VES 2, where the depth of the blue region is about 10 m and it occur at all the four VES points, which indicates very low resistivity value of 13.52 Ωm at the first layer, where the road is badly affected. VES 1 shows 2 layers (Fig. B), having a resistivity of 11.18 Ωm for the first layer with 2.79 m depth and thickness of 2.79 m, and 9244 Ωm for the second layer. VES 2 shows 2 layers; having a resistivity of 13.52 Ωm for the first layer with 9.889 mdepth and thickness of 9.889 m and 9244 Ωm for the second layer. VES 3 shows 2 layers; with a

resistivity of 17.49 Ωm for the first layer with 4.276 m depth and thickness of 4.276 m and 9244 Ωm for the second layer. VES 4 shows 2 layers; having a resistivity of 11.18 Ωm for the first layer with 2.86 m depth and thickness of 2.86 m, and 9244 Ωm for the second layer. The topsoil is underlain by clay/sandy clay whose resistivity values range from 11.18 – 9244 Ωm. The bottom of the layer could not be delineated because of the short sounding spread. The failure along this segment of the road is apparently precipitated by differential settlement induced by the clayed substratum and this is line with the work of Michael *et al.* (2008).

Fig. 2I: (a) Pseudo cross-section plot of apparent resistivity data profile A and (b) Resistivity cross section

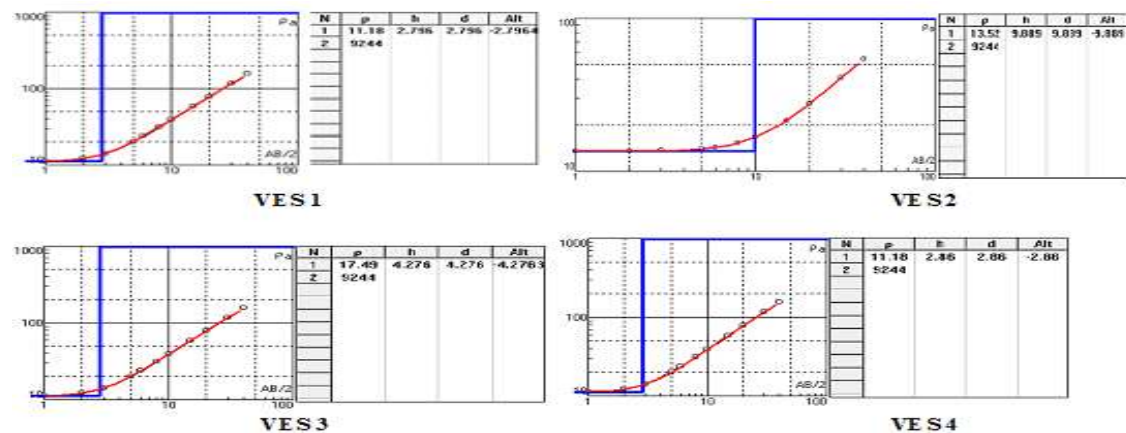
Fig. 2II: Resistivity pseudo section of profile A showing plots for VES 1, VES 2, VES 3 and VES 4

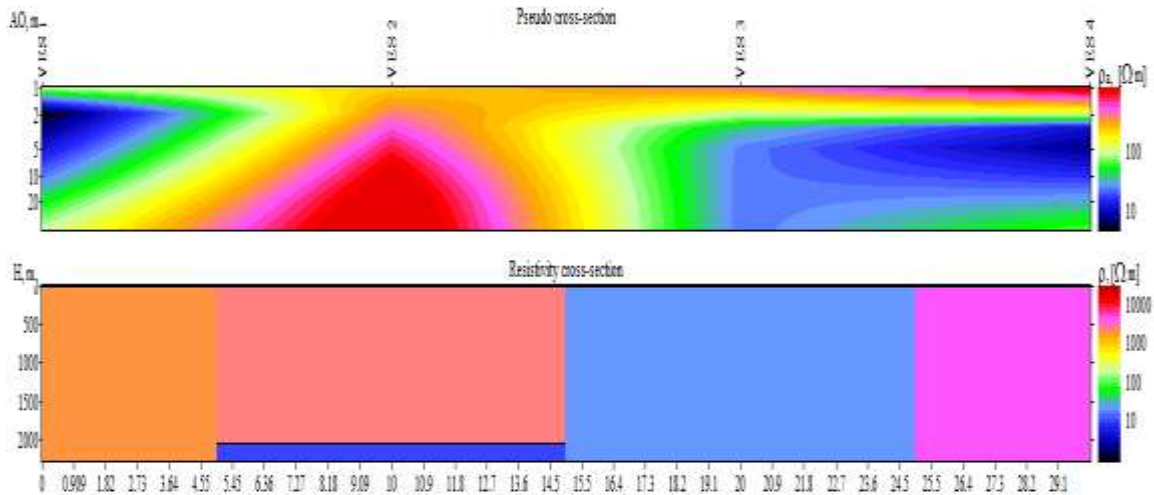
Figure 3 is a Pseudo cross-section plot of apparent resistivity data for profile B, VES 1 shows 3 layers; the first layer having a resistivity of 3083 Ωm with 0.232 m depth and thickness of 0.232 m, 1.69 Ωm for the second layer with 0.697 m depth and thickness 0.697 m and 2090 Ωm for the third layer.VES 2 shows 3 layers; the first layer having a resistivity of 10.79 Ωm with 0.05 m depth and thickness of 0.05 m, 2239 Ωm for the second layer with 2.054 m depth and thickness 2.054 m and 11.22 Ωm for the third layer. VES 3 shows 2 layers; the first layer having a resistivity of 743 and 24.9 Ωm for the second layer at 0.586 m depth and thickness of 0.586 m respectively. VES 4 shows 3 layers; the first layer having a resistivity of 4815 Ωm with 0.437 m depth and thickness of 0.437 m, 1.25 Ωm for the second layer with 0.776 m depth and thickness of 1.21 m, 3900 Ωm for the third layer. VES 1 and VES 4 falls within the standard resistivity of clay ranging from 1 – 100 Ωm. The unstable segment of the road is characterized by low resistivity of the near surface materials and shallowness of the aquiferrous zone on which the road pavement was founded Adiat *et al.* (2009).

Fig. 3: (a) Pseudo cross-section plot of apparent resistivity data profile B and (b) Resistivity cross section

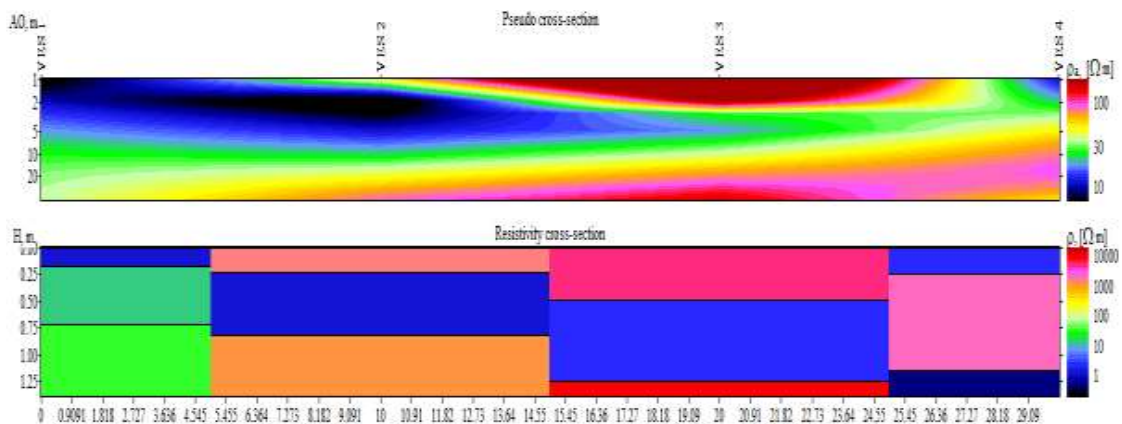
Fig. 4: (a) Pseudo cross-section plot of apparent resistivity data profile C and (b) Resistivity cross section

Figure 4 is a Pseudo cross-section plot of apparent resistivity data for profile C, VES 1 shows 3 layers; the first layer is made up of topsoil (clayey sand and sandy clay) which has resistivity of 1.588 Ωm with 0.1736 m depth and thickness of 0.1736 m, 38.62 Ωm for the second layer with the depth of 0.55 m and thickness of 0.7236 m, and 431.7 Ωm for the third layer. VES 2 shows 3 layers; the first layer having a resistivity of 1445 Ωm with 0.235 m depth and thickness of 0.235 m, 1.4 Ωm for the second layer with 0.584 m depth and thickness of 0.819 m and 1065 Ωm for the third layer.VES 3 showing 3 layers; the first layer having a resistivity of 5195 Ωm with 0.484 m depth and thickness of 0.484 m, 2.99 Ωm for the second layer with 1.25 m depth and thickness of 0.77 m and 9704 Ωm for the third layer.VES 4 shows 3 layers; the first layer having a resistivity of 2.521 Ωm with 0.2496 m depth and thickness of 0.2496 m, 220 Ωm for the second layer with 1.151 m depth and thickness of 0.9013 m and 0.6459 Ωm for the third layer. Average of 9704 Ωm at the third layer Ωm suggested a sedimentary environment while the low resistivity spectrum suggested areas of low permeability or clay intercalation. This is similar to the work of Ebhohimen and Luke (2014).

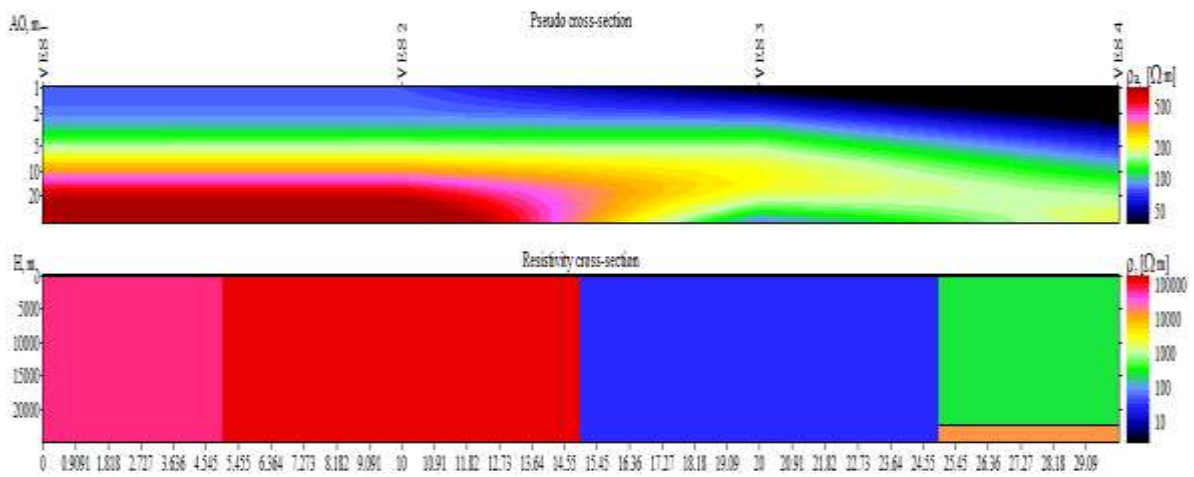
Figure 6 is a Pseudo cross-section plot of Apparent Resistivity data for profile E with four VES points, VES 1 shows 3 layers; the first layer having a resistivity of 395.4 Ωm with 0.0879 m depth and the thickness of 0.0879 m, 77.43 Ωm for the second layer with 2.509 m depth and the thickness of 2.421 m and 59450 Ωm for the third layer. VES 2 shows 3 layers; the first layer having a resistivity of 78.68 Ωm with a depth of 2.488 m and the thickness of 2.488 m, 80950 Ωm for the second layer with a depth of 12.71 m and thickness of 10.22 m and 146791 Ωm for the third layer. VES 3 shows 3 layers; the first layer having a resistivity of 16.73 Ωm with a depth of 0.4291 m and the thickness of 0.4291 m, 3043 Ωm

for the second layer with 1.442 m depth and the thickness of 1.013 m and 34.81 Ωm for the third layer. VES 4 shows 3 layers; the first layer having a resistivity of 7.308 Ωm with a depth of 0.3965 m and the thickness of 0.3965 m, 251.2 Ωm for the second layer with a depth of 22300 m and the thickness of 22300 m and 14302 Ωm for the third layer. The four VES points shows low resistivity at the first layer ranging between 16.73 – 78.68 Ωm which indicates fault zone and falls within the standard resistivity of clay ranging from 1 – 100 Ωm, respectively (Table 1); this indicates that the road is on soils and waters Nwokoma *et al.* (2015).

Fig. 6: (a) Pseudo cross-section plot of apparent resistivity data profile E and (b) Resistivity cross section

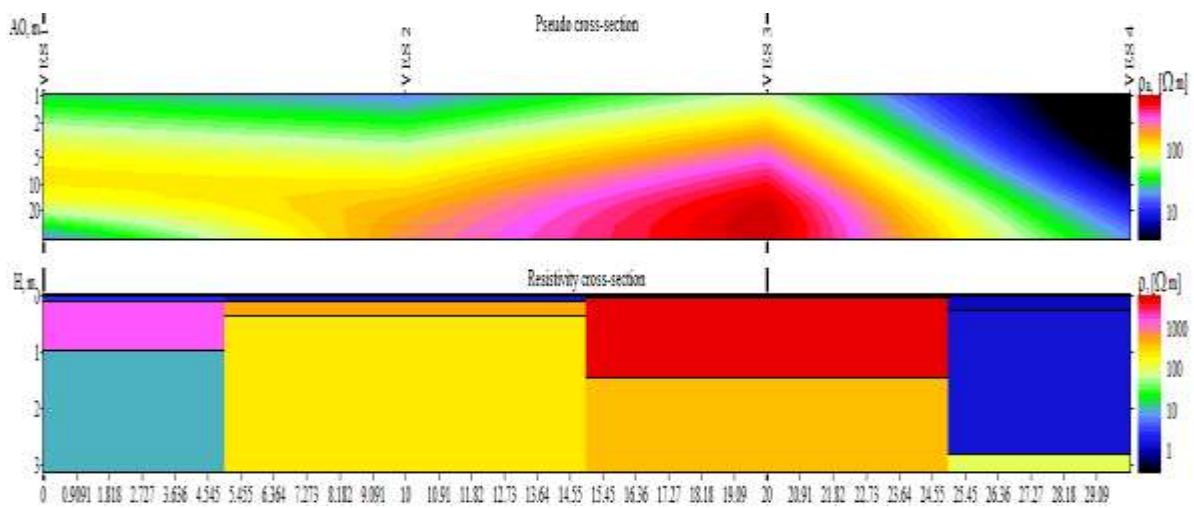
**Figure 7: (a) Pseudo cross-section plot of apparent resistivity data profile F and (b) Resistivity cross section**

Figure 7 is a Pseudo cross-section plot of apparent resistivity data for profile F with four VES points; begins at coordinate 9.429° 6ʹ N and longitude 9.542° 8ʹE and ends at coordinate 9.974° 9ʹ Nand longitude 9.527° 8ʹE. VES 1 shows 3 layers; the first layer having a resistivity of 3.396 Ωm with a depth of 0.1122 m and the thickness of 0.1122 m, 1334 Ωm for the second layer with a depth of 0.9716 m and the thickness of 0.8594 m and 12.23 Ωm for the third layer. VES 2 shows 3 layers; the first layer having a resistivity of 2.058 Ωm with 0.1039 m depth and the thickness of 0.1039 m, 488.1 Ωm for the second layer with a depth of 0.3687 m and the thickness of 0.2648 m and 261 Ωm for the third layer; the apparent resistivity at 0.3024 m ranges between 1.20983 to 4426.822 Ωm. VES 3 shows 3 layers; the first layer having a resistivity of 1.507 Ωm with 0.0230 m depth and the thickness of 0.0230 m, 11101 Ωm for the second layer with 1.442 m depth and the thickness of 1.419 m and 421.7 Ωm for the third layer. VES 4 shows 3 layers; the first layer having a resistivity of 1.397 Ωm with a depth of 0.2701 m and the thickness of 0.2701 m, 1.778 Ωm for the second layer with 2.811 m depth and thickness of 2.541 m and 115.2 Ωm for the third layer. Apart from the regions with few blue portions with low resistivity with indicates clay and water percolation. The vertical electrical sounding results indicates the occurrence of relatively thin topsoil of 0.1122 m composed of sandy-clay which is underlain by clay-shale formation to about 2.811 m depth, while the other portions with other colour shows competent zones with high resistivity as indicated above (Fatoba *et al.,* 2013).

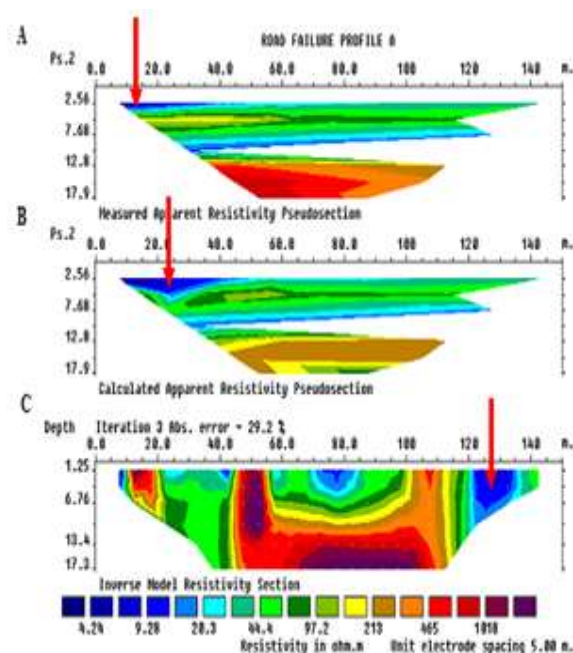
The 2-D dipole-dipole method was adopted to obtain the result in Fig. 8 and this was done by employing Wenner -2D modeling to produce two dimensional (2D) electrical imaging surveys which are widely used to map areas of moderately complex geology where conventional resistivity surveys and profiling may be inadequate (Table 1). Fig. 8 Shows measured apparent resistivity pseudosection where the blue portions indicate failed segments within the distances 7.5 - 47.5 m with low resistivity between 4.24 to 20.3 Ωm with the depth of 2.79 m and thickness of 2.79 m. The sub-grade soil which is the weathered layer beneath the topsoil is generally clayey within the distance between 20.5-120.5 m with resistivity range of between 4.24 and 20.3 Ωm. The mean thickness is 10.4 m. Fig. 8(b) shows calculated apparent resistivity pseudosection where the blue portions indicate failed segments within the distances 7.5 - 49.5 m with low resistivity between 4.24 to 20.3 Ωm with 7.5 m depth and thickness of 9.889 m. Fig. 8(c) shows computer interpreted iterated inverse model resistivity showing where the blue portions indicate

failed segments within the distances 70.0 – 85.0 m with the depth and thickness of 4.276 and 120 – 135 m with the depth of 13.4 m and thickness of 13.4 m having low resistivity between 4.24 to 20.3 Ωm. The stable segment is characterized by high resistivity lateritic subsoil in the upper 10-23 m, 45-68 m and 87 – 120 m. The composition of the topsoil is typical of sandy clay/clayey sand (Momoh *et al.,* 2008).

Fig. 8: Pseudosection plot shows apparent resistivity data of profile A showing the stratified layers for the Minna-Bida road. (a) Measured apparent resistivity pseudosection (b) Calculated apparent resistivity pseudosection (c) Inverse model resistivity section
The arrow indicates the affected portions of the road.

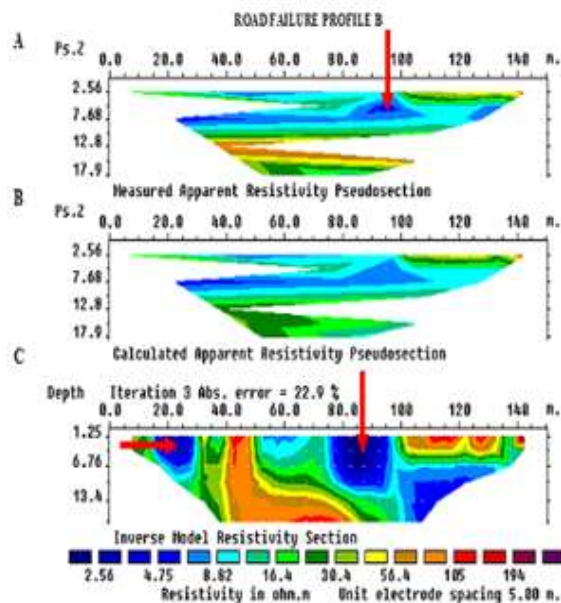
Fig. 9: Pseudosection plot of apparent resistivity data of profile B showing the stratified layers for the Minna-Bida road. (a) Measured apparent resistivity pseudosection (b) Calculated apparent resistivity pseudosection (c) Inverse model resistivity section

The arrow indicates the affected portions of the road.

Figure 9(a) is the measured apparent resistivity pseudosection where the blue portions indicate failed segments between the distances 20.0 – 100.0 m with low resistivity between 2.56 to 8.82 Ωm. The corresponding thicknesses of this layer range between 2.5 and 12.5 m with a mean value of 7.53 m for the first layer and 12.8 m for the second layer. Fig. 9(b) shows calculated apparent resistivity pseudosection where the blue portions indicate failed segments between the distances 20.4 – 140 m with low resistivity between 2.56 to 8.82 Ωm. The corresponding thicknesses of this layer range between 2.56 and 12.5 m with a mean value of 7.53 m. Fig. 9(c) shows computer interpreted iterated inverse model resistivity showing where the blue portions indicates failed segments between the distances 20.0 – 30.0 m and between 50.0 – 135.0 m, the corresponding thicknesses of this layer range between 1.25 and 16 m with a mean value of 8.6 m, with low resistivity between 2.56 to 8.82 Ωm. The blue portion along 120 – 140 m with about a depth of 13.4 m shows a very low resistivity of about 4.24 Ωm which indicates very high clay content and a bad portion of the road. The presence of clay soil in foundation materials is capable of causing swelling and brokerage of road surfaces when in contact with moisture during wet season. The portion of the road from Fig. 8(c) at the distance from 30 to 50 m and 100 to 140 m shows no evidence of any major geologic feature such as fault and fractured zone that could have precipitated failure. The overall results showed that poor foundation materials and poor Engineering construction have affected the rate of failure of the road especially the most affected portion that have gone through several rehabilitations (Ifabiyi *et al.*, 2013).
