Journal of Engineering and Applied Sciences 6 (2010) 60-67

# Effect of silane treatment on the impact strength properties of oil palm (EFB) fiber- reinforced polyester composites

A. N. Anyakora, O. K. Abubakre, E. Mudiare, <sup>1</sup>M. A. T. Suleiman

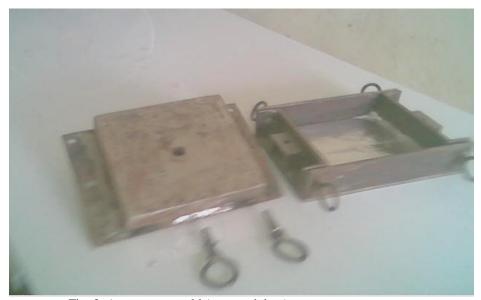
Fig. 3. A two-part mould (cope and drag).

A two-part mould facility (mild steel flat 4mm thick sheet) - of dimensions of 150mm x 150mm with active surfaces ground, pre-designed cavity of 5mm depth, with clamping bolts in place fabricated at the Dantata and Sawoe mechanical workshop, Abuja, as shown in Figs. 3 and 4, was adopted in the production of test specimen plates.

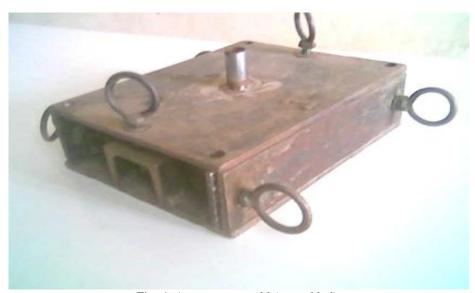
Fig. 4. A-two part mould (assembled).
