## THE EFFECT OF ROAD CONSTRUCTION ON THE ENVIRONMENT:-A CASE STUDY OF GOVERNMENT RESERVED AREA (GRA) AND KETEREN GWARI, MINNA

A. D. Isah & I.B. Muhammad

Department of Architecture, Federal University of Technology, Minna-Niger state.

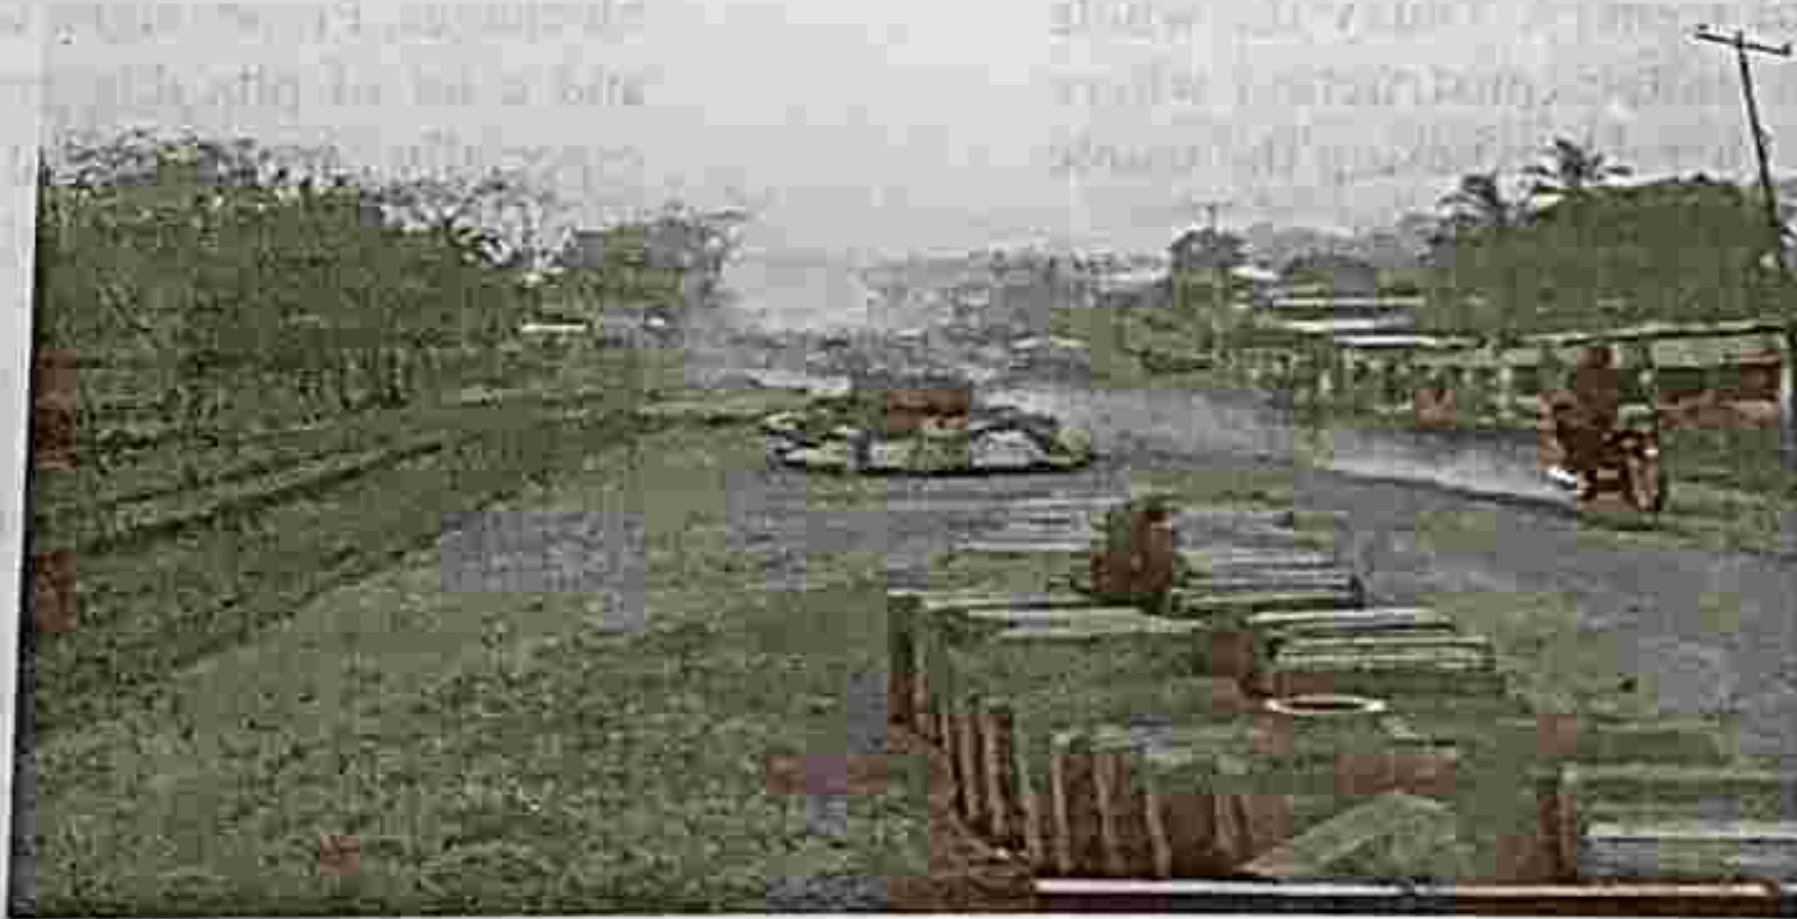
This is caused primarily from dust during construction especially while digging and backfilling of the road is going on. A lot of dust is experienced which defaces buildings and affect the

quality of air around the area of construction, this results into a lot of discomfort especially to those that have breathing related diseases such as Asthma. (Ojoye and Yahaya, 2007) are of the opinion that air pollution is generally the most easily widespread and obvious kind of environmental damage causative agent.

Plate 1. showing dust being raised by a motor cyclist. Source :field work ( April 2009)

The best management practice as specified in Caltrans' Standard Specification is to have the soil surfaces watered and also to have the trucks transporting dust producing material in and out of the site covered. This should enforced by the supervising government authority.

Adequate compensation such as painting should be made to ameliorate and correct the damages made onto the surface of defaced building structures around the construction area.

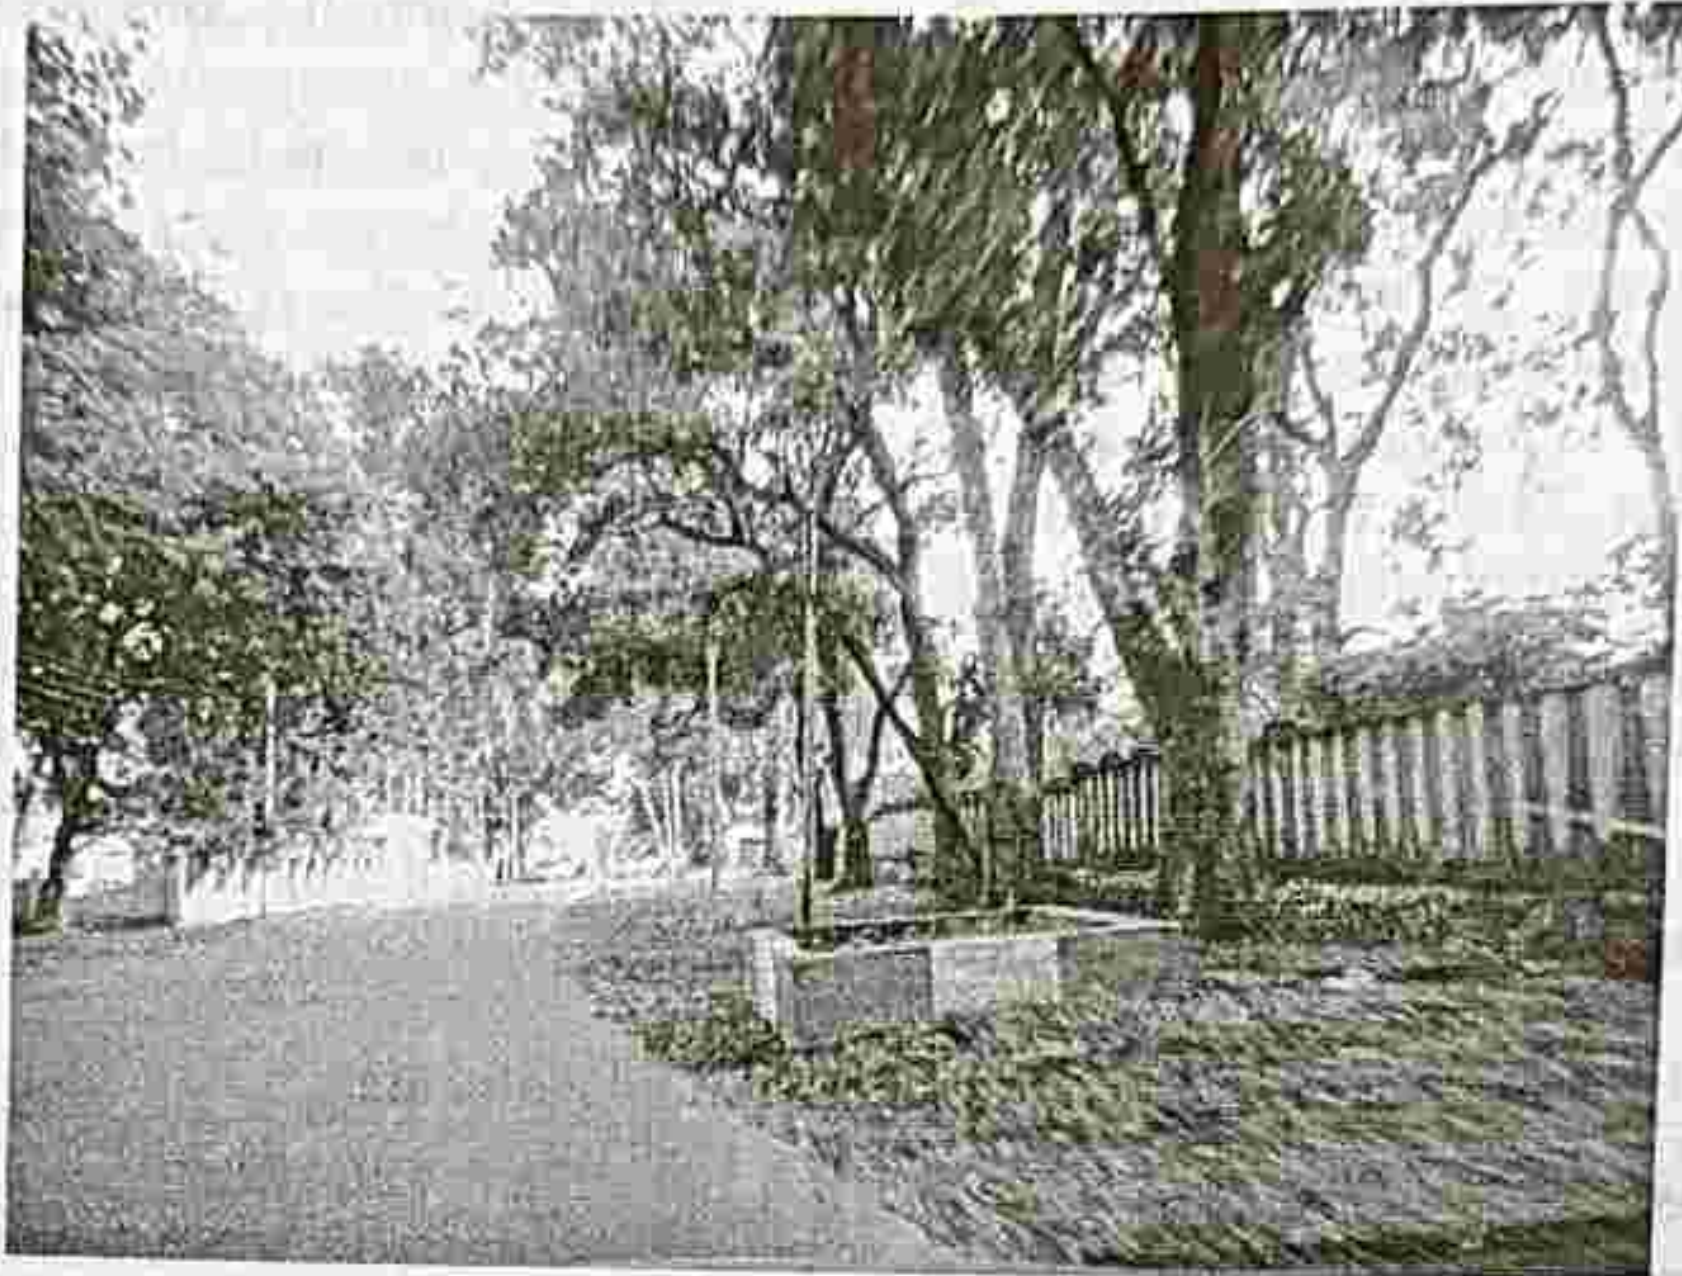
Plate 2: Showing the government house road before the cutting down of trees source field survey 2009

Government Reserve Area (GRA) was blessed with a lot of trees that were aligned along the road. These trees were not only a source of shade to pedestrians but also were highly valued trees amongst the locals; they also served as source of wind breakers to the structures and also formed beautiful scenery. Today the whole trees along the road under construction were cut-down completely thereby exposing the whole area to the harsh elements of weather.

The government should ensure that construction companies substitute noisy equipment for quiet ones. Survey should be taken to ensure that trees which do not necessarily affect the construction of the road are preserved and in situation where they have to be removed, new ones should be planted so as to get back the original scenery, this adds value to the roads and presents an aesthetically pleasing environment.

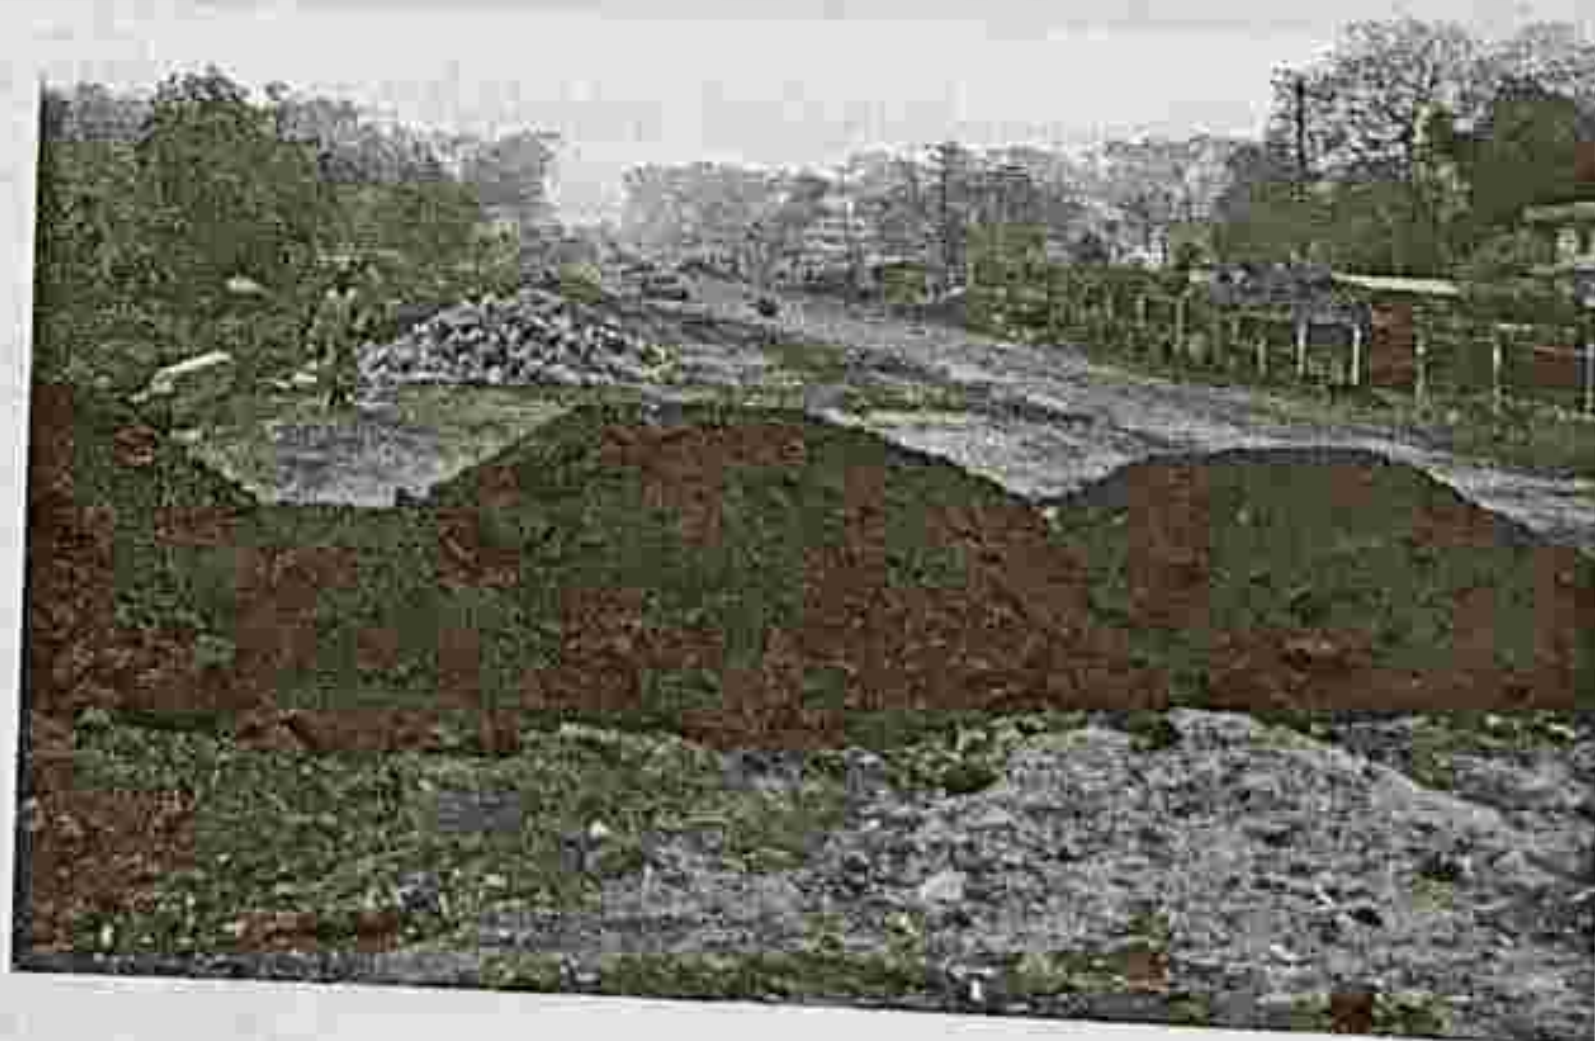
During the construction of the road, there was no proper planning cover respect to the

deposits of material on the road thereby blocking almost half of the road. In some instances vehicular entrances into some compounds were hindered, the residents were not pre informed and alternatives were not provided. The most devastating is that some accidents were experienced due to blockages. Proper signs were also not placed and a lot of pits dug could not be noticed especially by motorists at night. Road diversions were left at the instances of motorists as roads were closed and opened at will without any systematic planning. The picture below shows a blockage at the middle of the road without signs.

Plate 3. Showing road blockage without any signage. Source:- field work (April 2009)

The public ought to be alerted about detours, lane blockages and truck entrances through the use of appropriate signs. Temporary culverts also need to be placed along the entrances into the various compounds pending when the permanent ones are constructed. Critical areas need to be given priority and speedy completion.
