EXPANDED POLYSTYRENE (EPS) AS SUBSTITUTE FOR TRADITIONAL FASCIA MATERIALS.

Timber and reinforced concrete have been used for the construction of fascia for buildings over the years. However, these conventional materials have their shortcomings hence, the need for better materials. One of such materials is expanded polystyrene (EPS). This research therefore focused on the evaluation of the properties of expanded polystyrene with the view of using it as a substitute for the traditional materials as fascia. Company standards of expanded polystyrene was obtained and compared with those of timber and concrete. Also laboratory tests were carried out to ascertain the effects of moisture on weight, cost benefit analysis and construction requirements were evaluated for the three materials. The susceptibility of the materials to fire was evaluated. It was found that, the cost of constructing reinforced concrete fascia is 46% higher than EPS fascia of comparable size. Also, timber gains 16.67% increase in weight when exposed to moisture while EPS gained only 7.69%. In terms of fire resistance, timber has the least tolerance with a temperature range of 140-180°C followed by EPS with 180-210°C

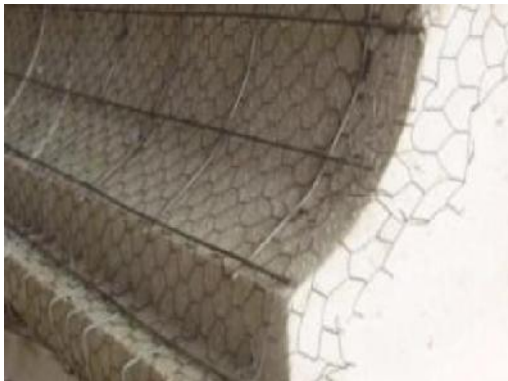
Fig. 1 (a) Structural polystyrene fascia reinforced with wire mesh and shotcreted (b) Non-structural fascia finished with a thin layer of plaster

The EPS fascia is an alternative to the conventional concrete fascia and the cast in-situ roof cornices that require formwork for construction. There are two different categories of fascias which are the structural and the nonstructural fascias. The structural is reinforced with wire mesh and shotcreted on the site whereas the non-structural is finished with a thin layer of plaster from the factory. The non-structural fascias are usually used for improved aesthetics only where no load will be imposed.

The EPS sash or cornice is a distinct option for the customary solid belt and the cast in-situ rooftop belts that requires formwork for development. EPS sashes are in different shapes and sizes, ranging from 3000mm x 300mm x 300mm to 3000mm x 600mm x 600mm. There are two distinct sorts of EPS belts. These are the auxiliary and the non-structural sashes. The basic belt is fortified with wire network and shotcreted on the site while the non-basic is done with a meagre layer of mortar from the manufacturing plant. The non-basic sashes are generally utilized for upgraded style just where no heap will be forced.
