NIGERIAN METREOLOGICAL SOCIETY (NMETS)

**“CLIMATE VARIABILITY AND CHANGE: IMPACT,
SCIENCE, INNOVATION AND POLICY”**

VULNERABILITY OF AGRICULTURAL PRACTICES TO CLIMATE INDUCED FLOODS IN COMMUNITIES DOWNSTREAM OF KAINJI DAM, NIGERIA

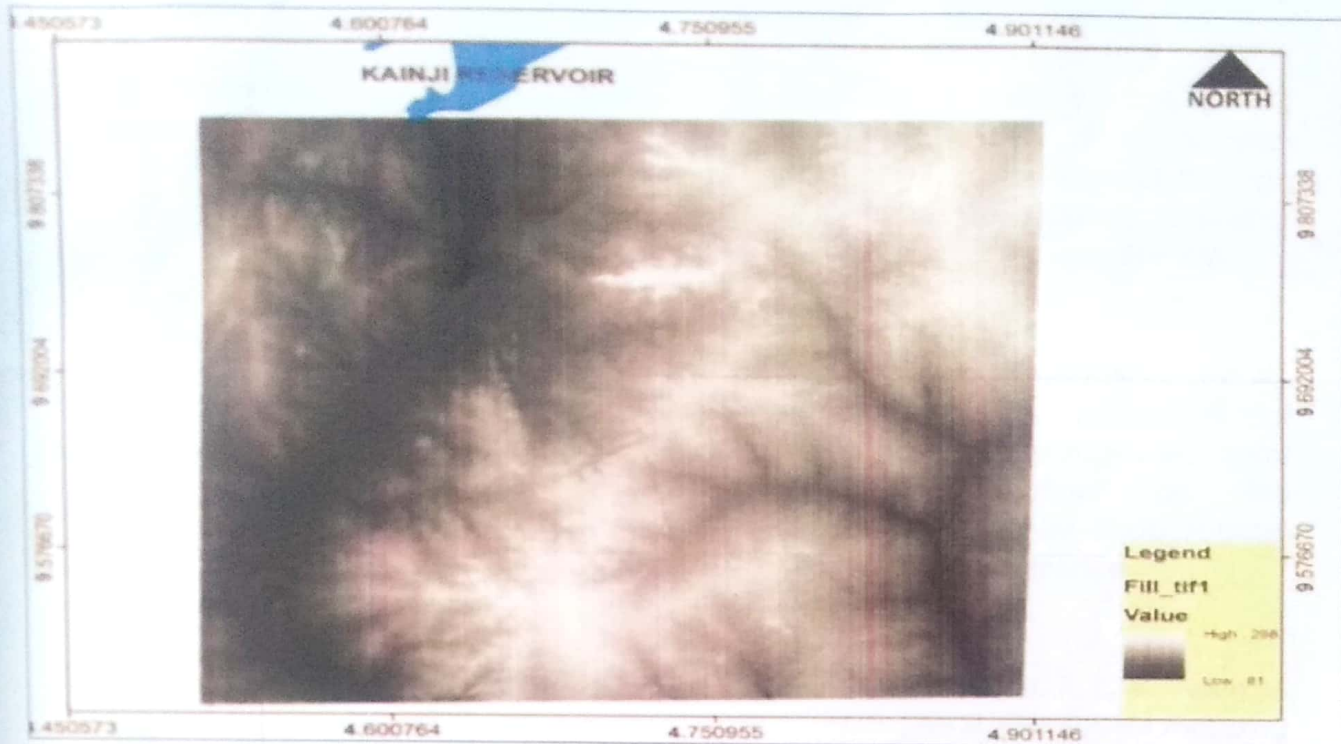
Figure 11: Digital Elevation Model of the Study Area

The Digital Elevation Model (DEM) of the study area extracted from SRTM data of 30m resolution depicts the elevation of communities within the study area. The

highest elevation is 298 metres while the lowest elevation of 81 metres above mean sea level.
